Inspection Report 2025

Complete Inspections

John Smith Dr, Proserpine, Qld, 4800

Pest And Building Inspection

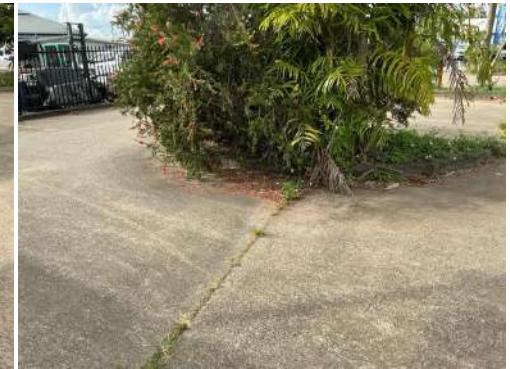
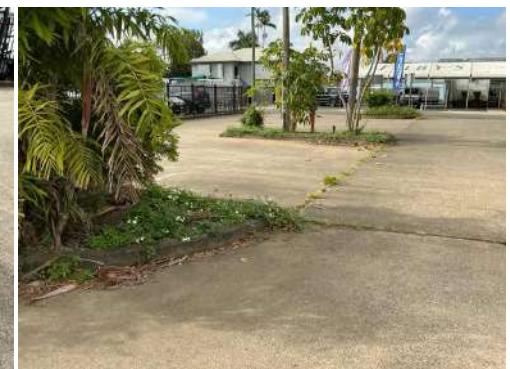
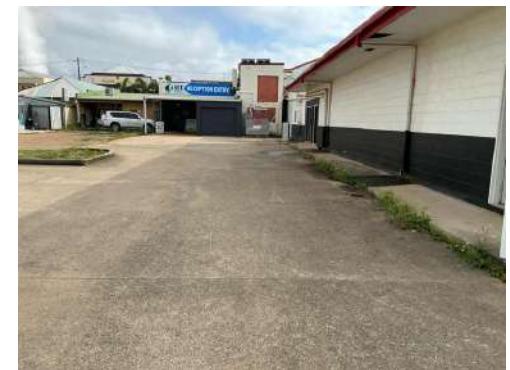
On visual inspection, the general condition of the driveway is serviceable.

Common cracks were observed on the driveway. Whilst these cracks appeared to be typical at the time of inspection, we strongly recommend you monitor these cracks and if worsening occurs contact a concreter for further advice.

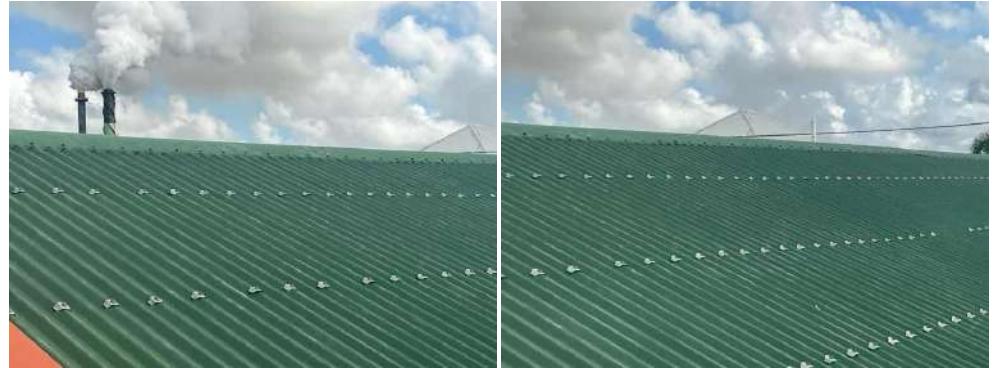
#1. Corrosion noted to the screw fixings of the metal roof. Have these checked and replaced by qualified roofing contractor.

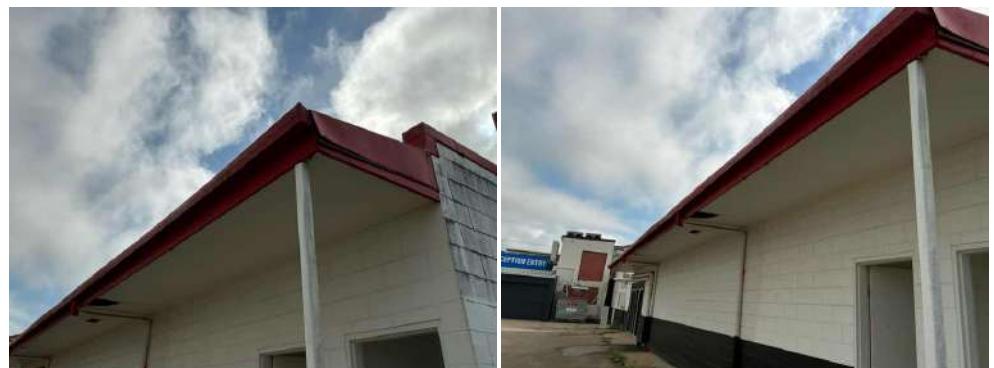
#3. Impact/Denting damage observed. Replace as required.
#4. The gutter join/s have separated and will leak in rainy periods. A qualified roof plumber should be engaged for advice and recommendations.
#5. Gutters should be finished in a protective coating to preserve integrity and minimise the likelihood of corrosion.

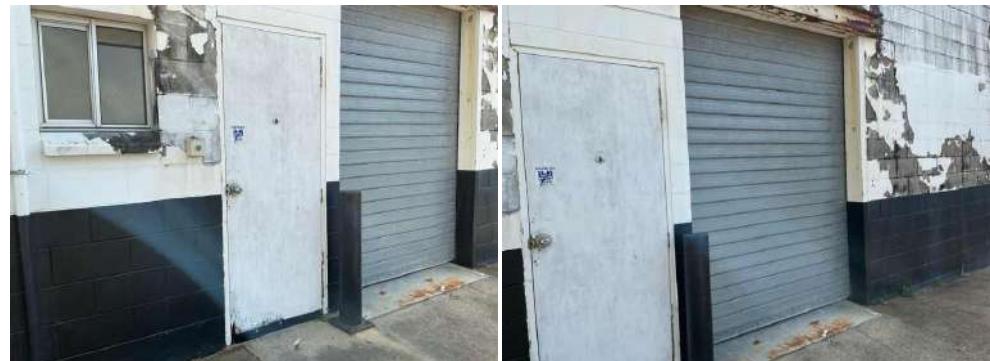
- #10. Door frames are damaged. A carpenter or a builder should be consulted for repairs.
- #11. The frame is separated with movement and separation noted. Contact a licensed carpenter for repairs.
- #12. Rust in door/door frame - Recommendations: General repairs required.

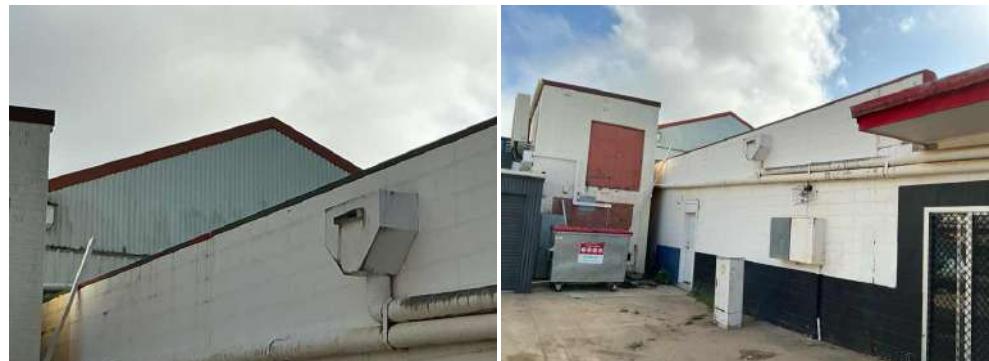
- #13. Minor deterioration & ageing evident. Recommendations:
Maintenance works, general upkeep should be carried out.
- #14. Paint / finish was deteriorated in areas and is in need of maintenance
 - Sanding back affected areas and painting required.
- #15. Separated on corner.
Recommendations: A qualified carpenter should be engaged for advice and recommendations.
- #16. Impact/Denting damage observed.

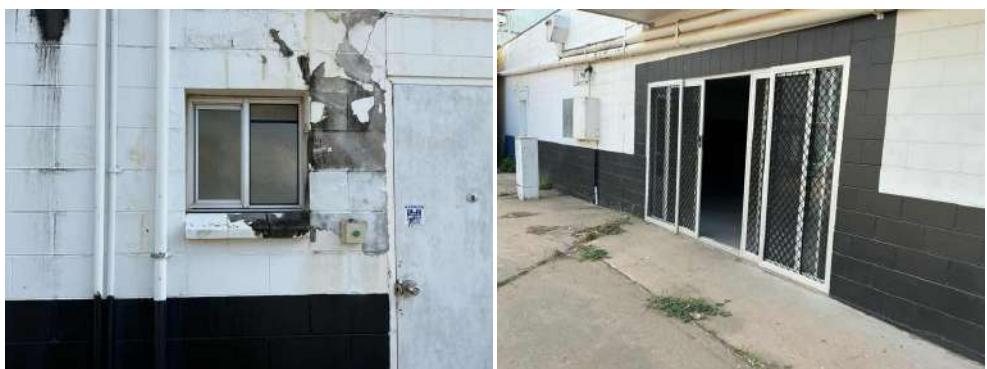
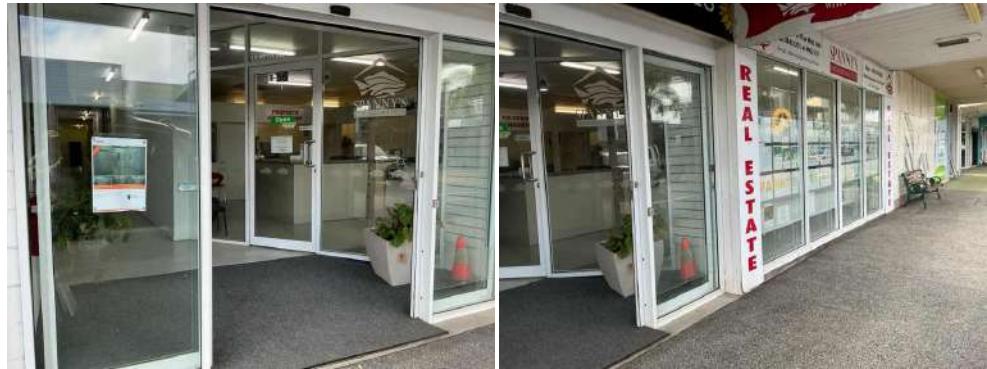
- #22. General age/damage has occurred to window components. Recommendations: Restoration work recommended. A qualified carpenter should be engaged for advice and recommendations.

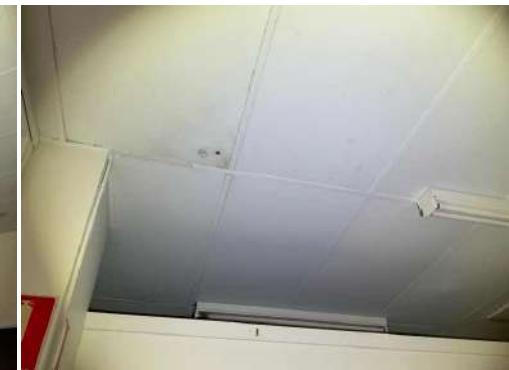
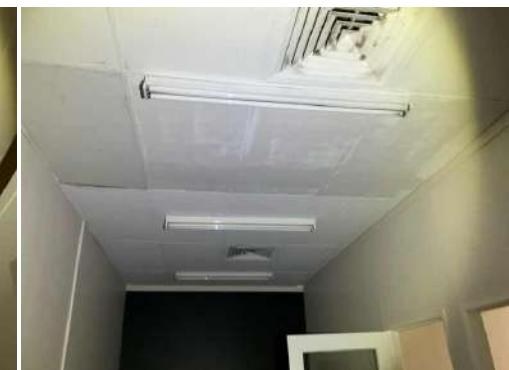
#23. A penetration opening was observed. It is recommended that this be sealed off and re-finished.
#24. Ceiling stains - No moisture readings obtained. These may have been repaired however you will need to monitor after a prolonged period of rainfall. If leaking persists, a qualified plumber should be engaged for advice and recommendations. All water damaged plaster should be replaced.

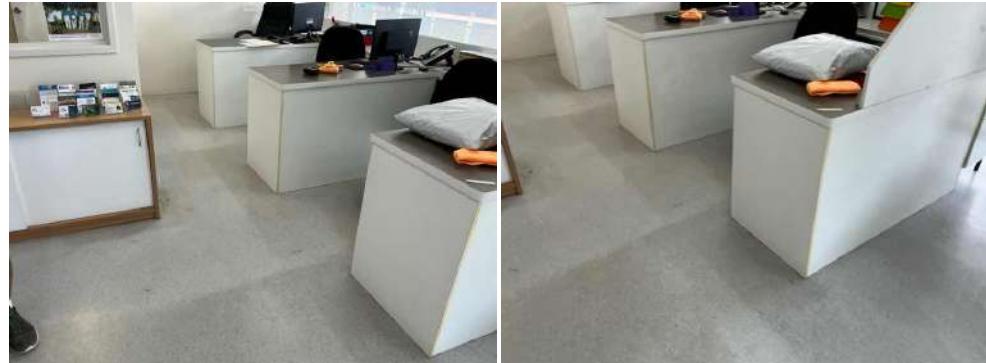
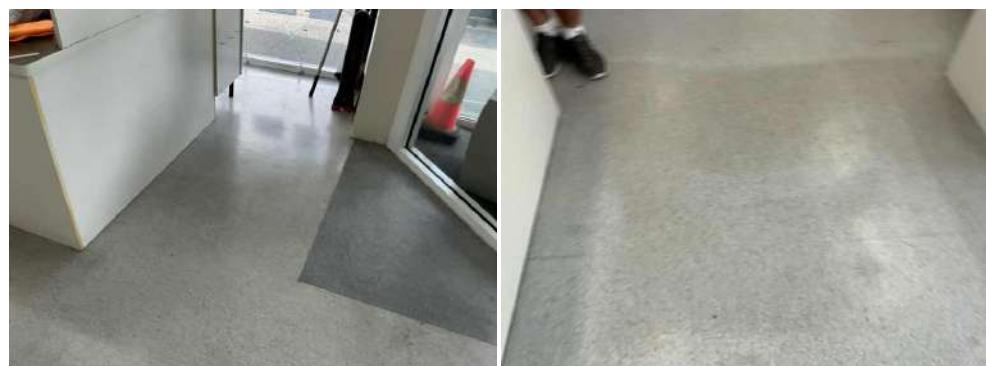
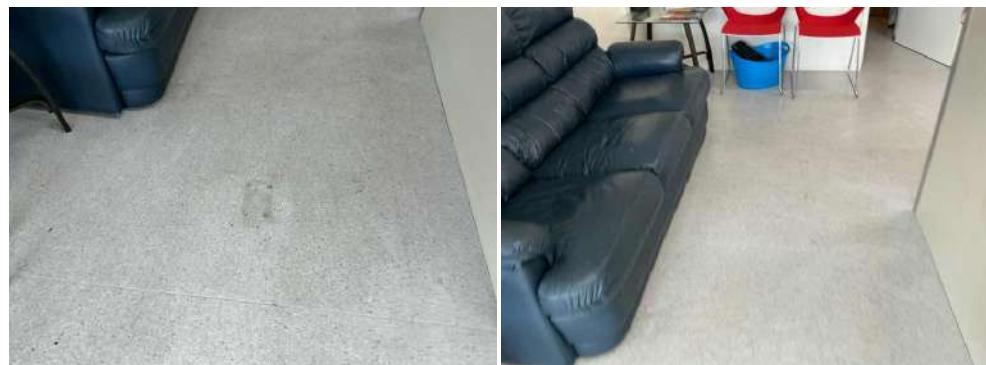
#34. Lino Damage

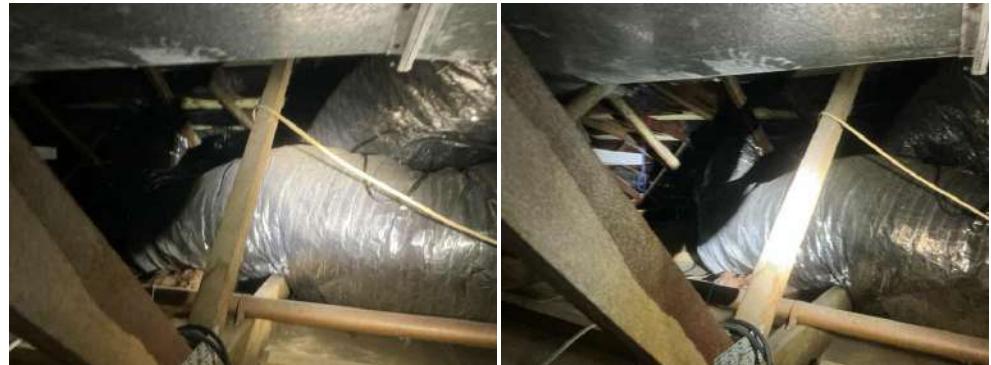
#40. There is evidence to suggest that there is some leakage into the roof void. In the absence of rain it is difficult to determine if this is an old leak or it's active. Monitoring during periods of rain should reveal any leaks, if leaks are active contact a qualified roofing contractor for repairs.

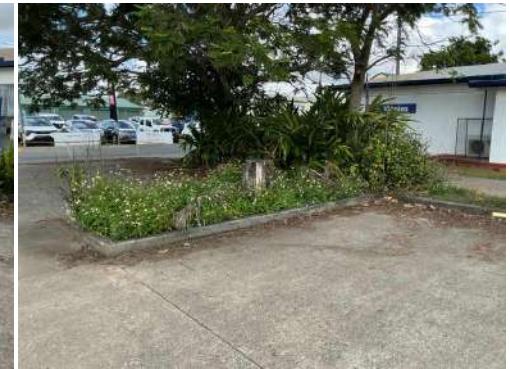
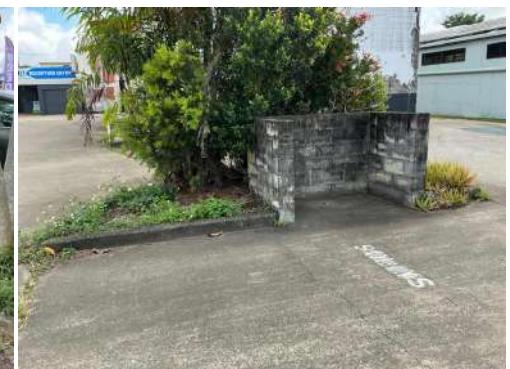
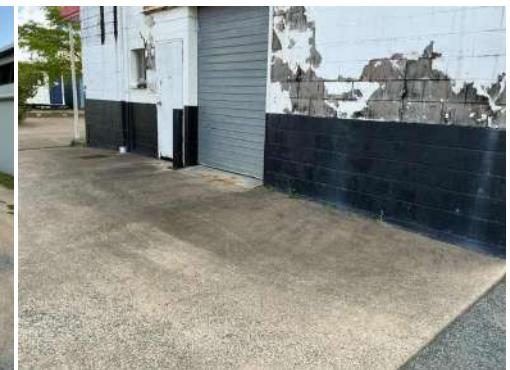
Tree stump/s are located at the site. These need to be removed by a suitably qualified tradesperson as they are conducive conditions for a termite nest.

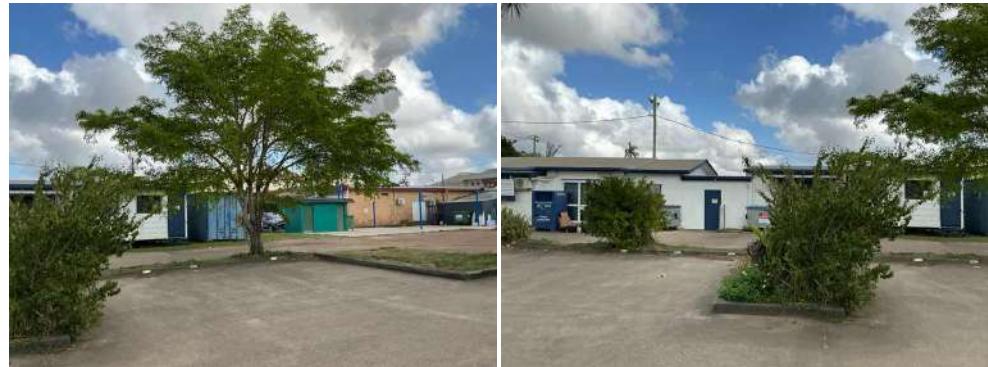
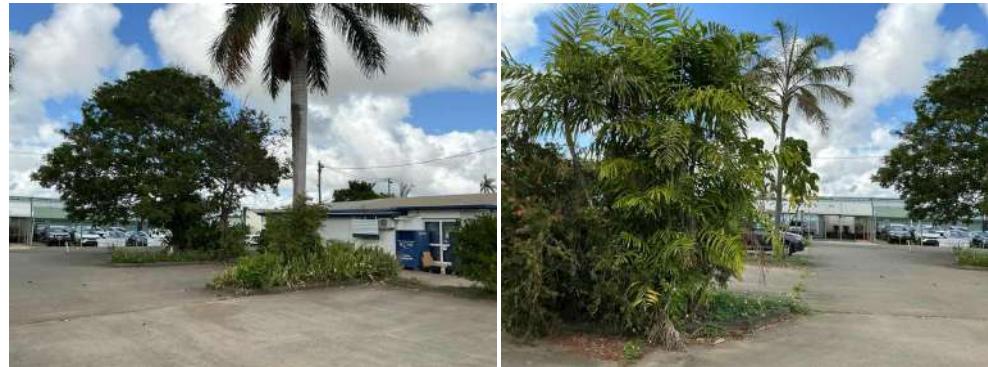
Trees are in close proximity to the dwelling and within the termite foraging area. These are a favorable influence for termite infestation. Regular inspections recommended.
