# Inspection Report 2025

## Complete Inspections

**John Smith Dr, Paget, Qld, 4740**

### Building Inspection

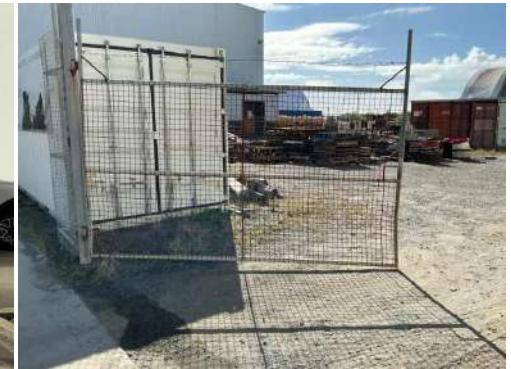
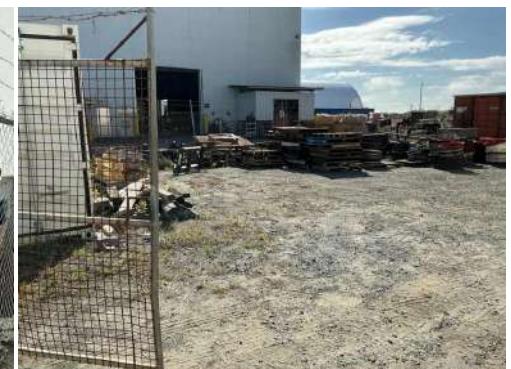
#1. General age to fence components - Recommendations:  
General upkeep and maintenance. A qualified fencing contractor should be engaged for repairs

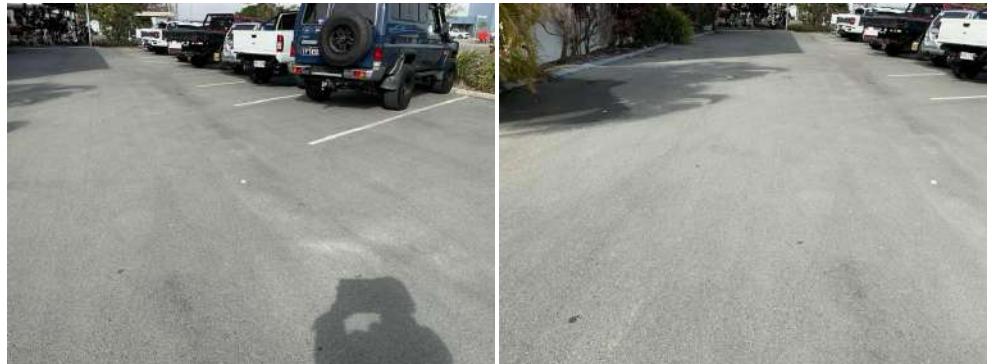
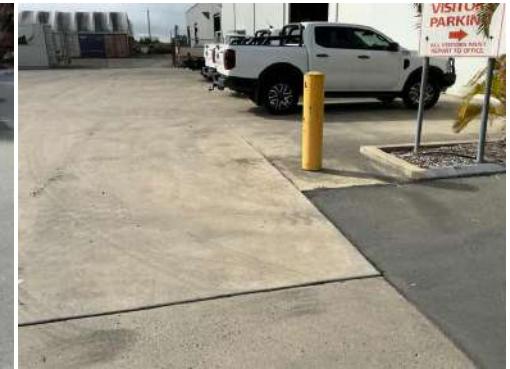
#2. There is evidence around the home paths that ponding near walls has occurred. Recommendations: A qualified landscaping contractor or a plumber should be engaged for advice and recommendations.

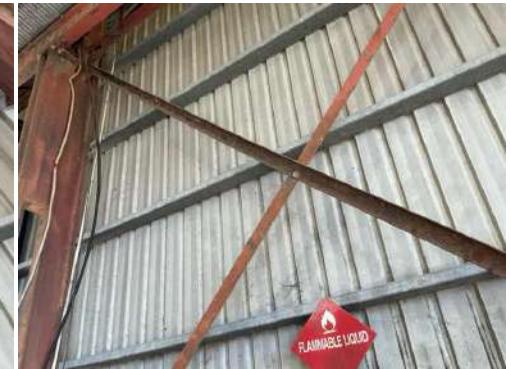
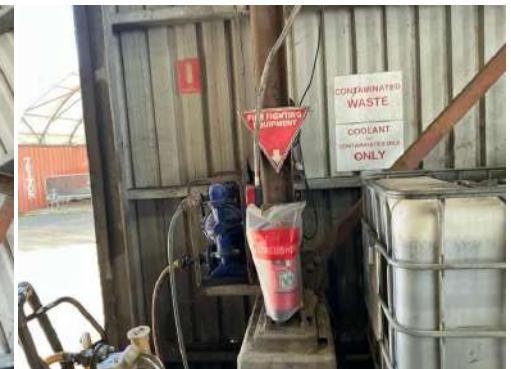
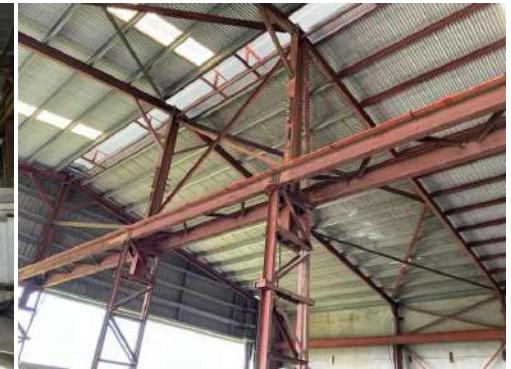
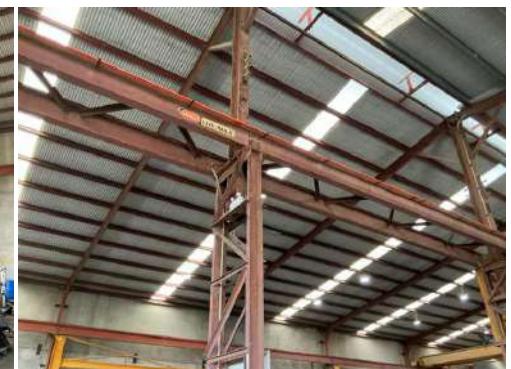
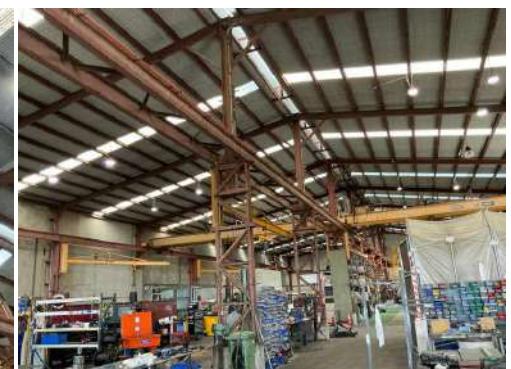
#4. Rust developing on steel frame  
recommend a full scope of works  
prior to settlement  
N/A

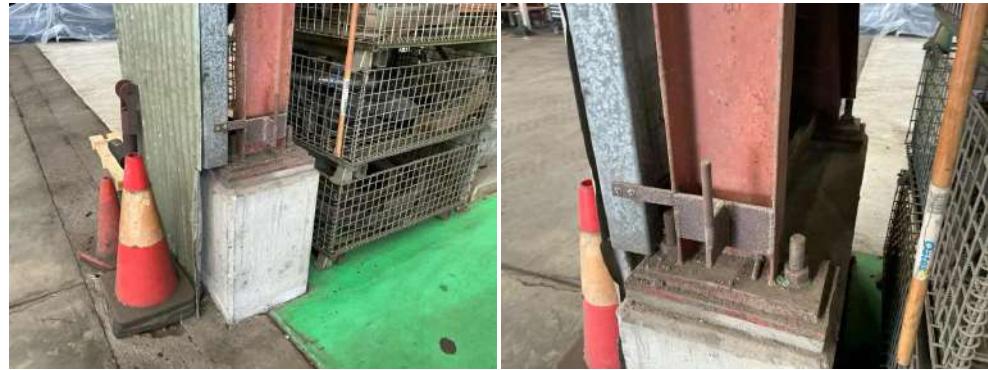
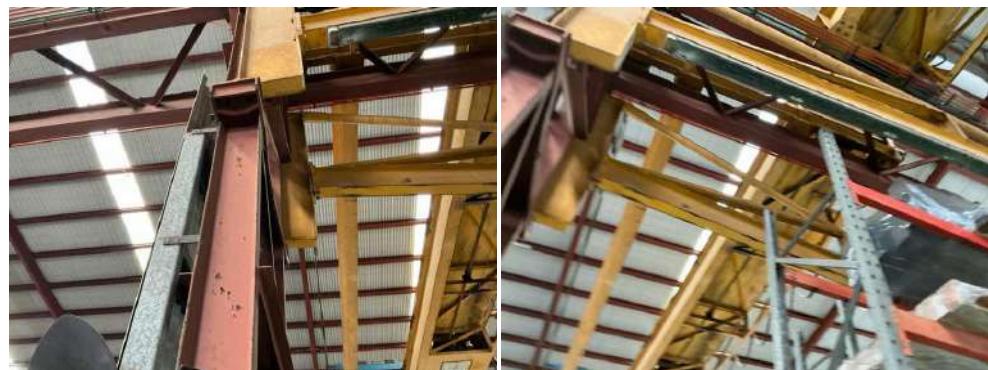
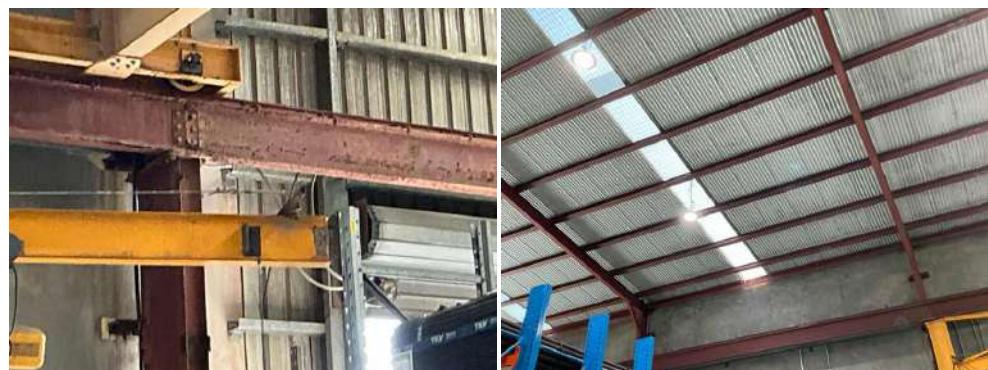
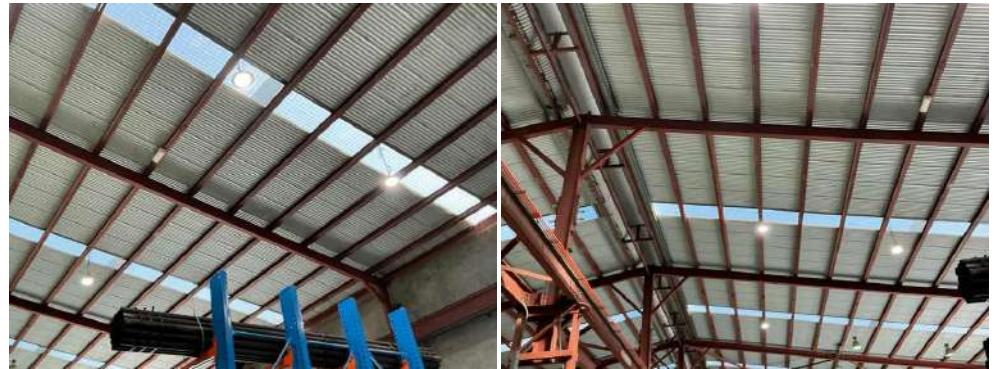
#5. Rust developing on steel frame  
recommend a full scope of works  
prior to settlement

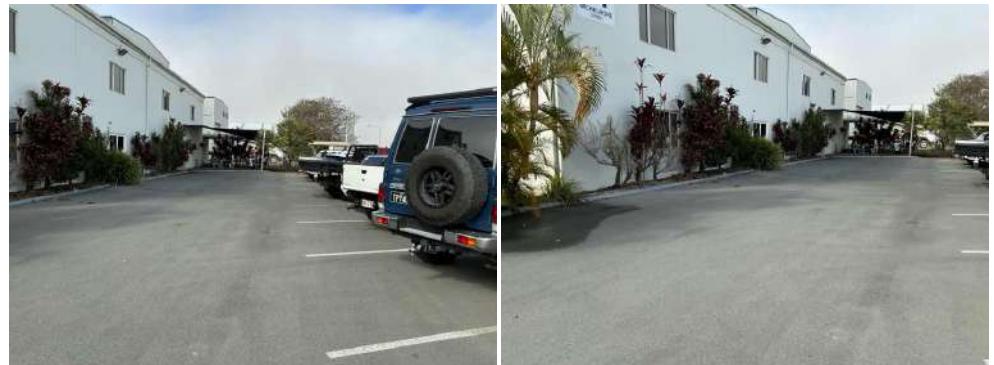
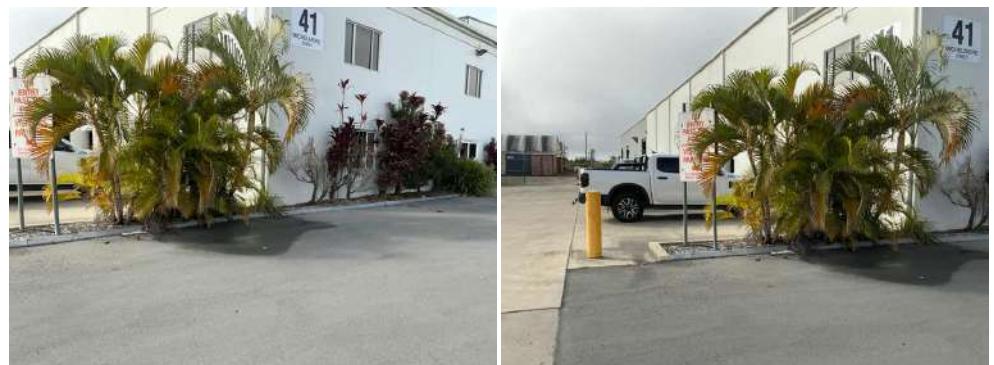
Trees are close to the dwelling. These currently do not appear to have caused any defects/wall cracking. Recommendations: Engage a qualified arborist to carry out an assessment on potential issues.

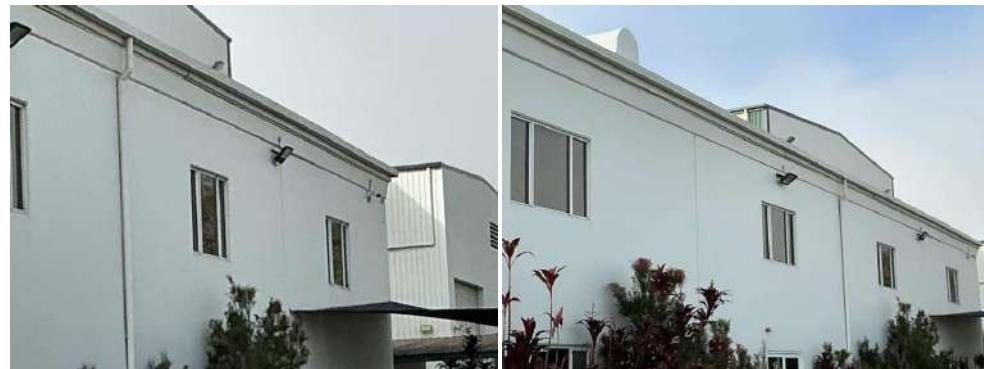
#6. The gutter join/s have separated and will leak in rainy periods.

#7. Gutter rust/penetrations- The guttering has excessive rust where leaking will occur.

Recommendations: A qualified roof plumber should be engaged for advice and recommendations.

Recommendations: The gutters require replacement by a roof plumber.

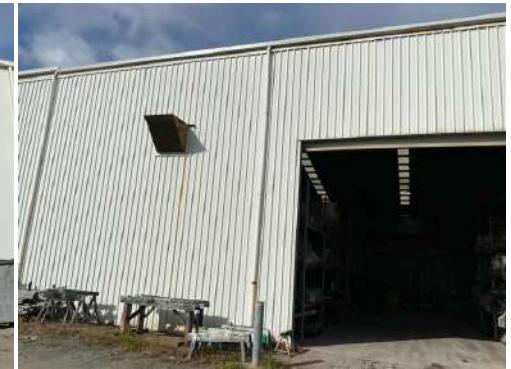
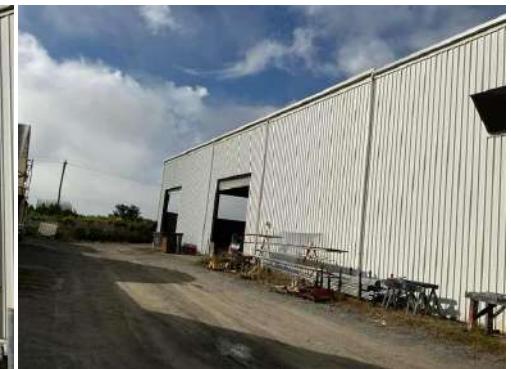
The down pipe/s wall clips is detached or missing.

#8. Down pipe/s not connected to storm water discharge - Down pipes not connected to storm water have the potential to cause differential settlement to the footings, cause rising damp and is also conducive to termite infestation.

#9. Minor down pipe rust visible.

Recommendations: Although minor and easily rectifiable, we recommend a licensed roof plumber be engaged for repairs

Recommendations: A qualified plumber should be engaged for advice and recommendations.

Recommendations: A qualified plumber should be engaged for advice and recommendations - Replacement may be necessary.

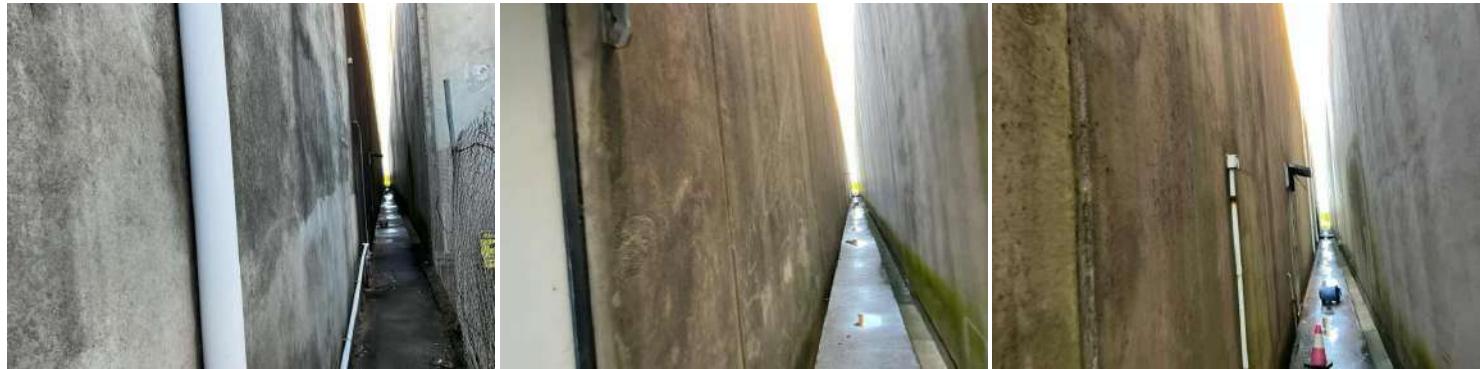
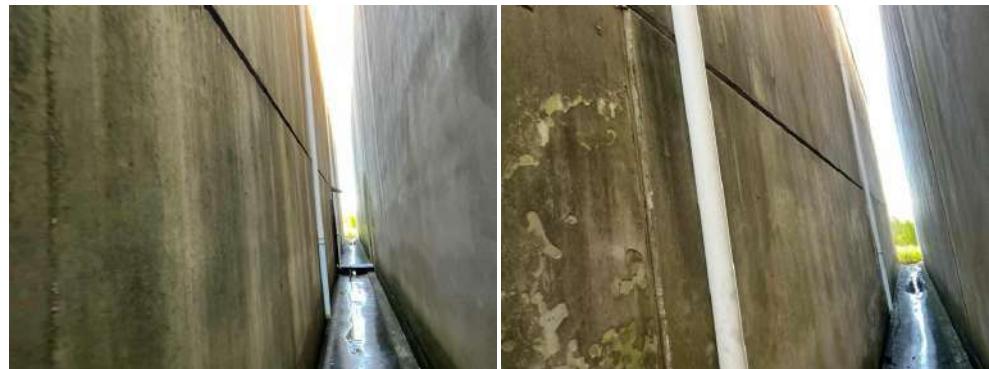
#10. There appears to have been some settlement in the building which has caused some cracking to the walls. These cracks are categorized as 0 to 2. This can also cause some doors to bind or be out of square. In the inspectors opinion these cracks are due to settlement, usually due to ground movement and subsequent movement to building materials can be expected. Any cracks should be monitored and if cracks increase in size, further investigation should be carried out by a structural engineer.

#11. Rising damp detected. A qualified damp proof specialist should be engaged for advice and recommendations. Accurate diagnosis of the cause and extent of the damp problem is very important. Note: It is imperative that specialist advice be sought to obtain accurate diagnosis of the cause and extent of the damp problem and it is advised that you have assessed prior to purchasing the dwelling as can be quite costly if a damp proof course has to be reinstated.

#12. Brick face deterioration - Age/damp related. Recommendations: Engage a brick layer for advice and recommendations.

#13. Penetration openings observed. I recommend sealing these off so as to avoid vermin and other pest infestation.

#14. Rust to metal cladding recommend a qualified professional to repair

#15. Mould is not part of the inspection it has been noted recommend a full scope of work

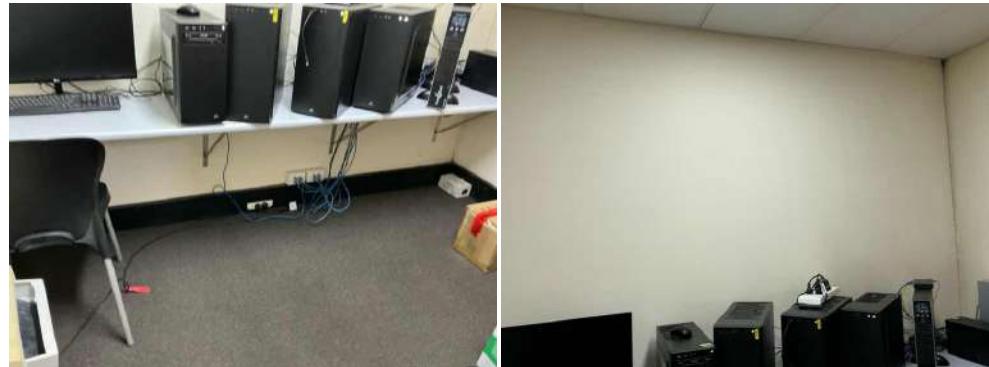
#18. General carpet deterioration - Recommendations: Replacement may be required A qualified carpet layer should be engaged.

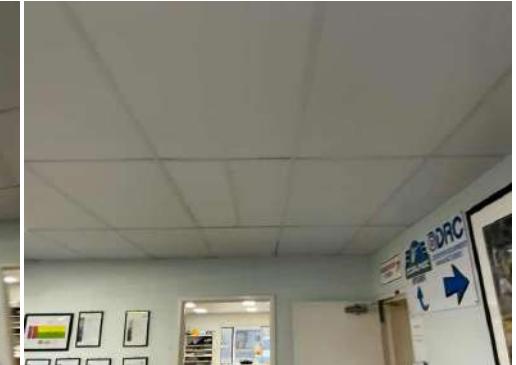
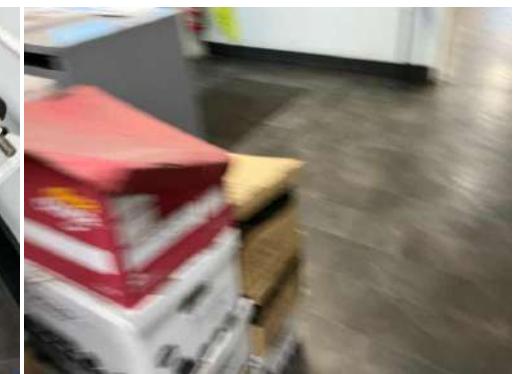
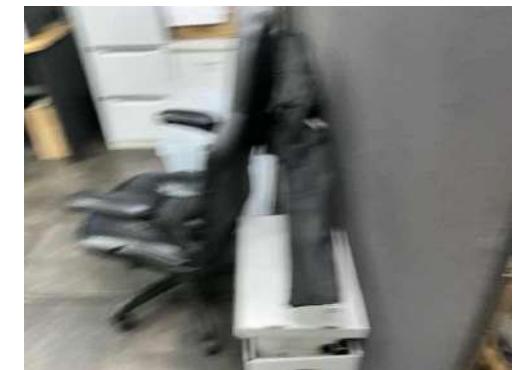
#20. Lino damaged recommend a qualified tradesman to repair/ replace

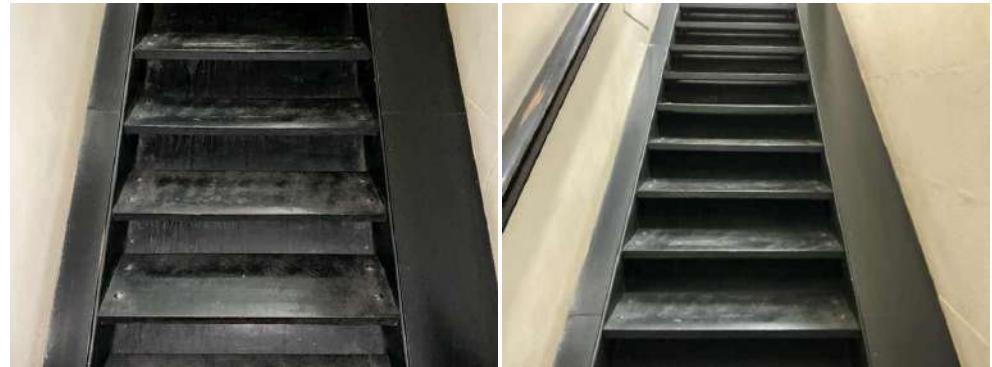
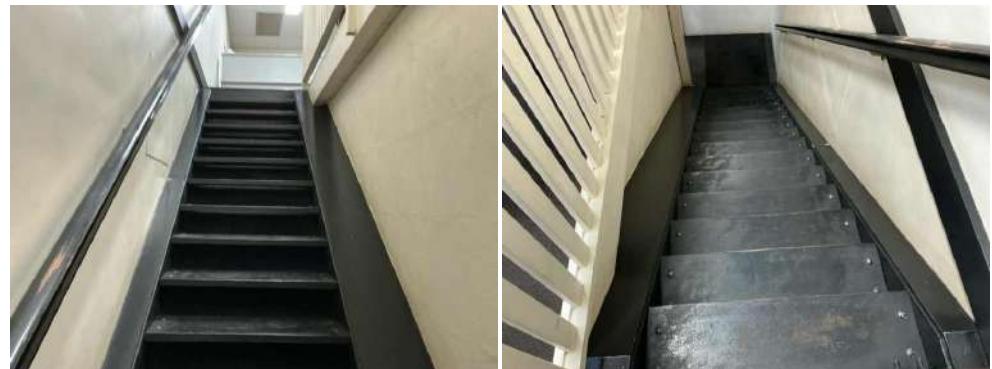
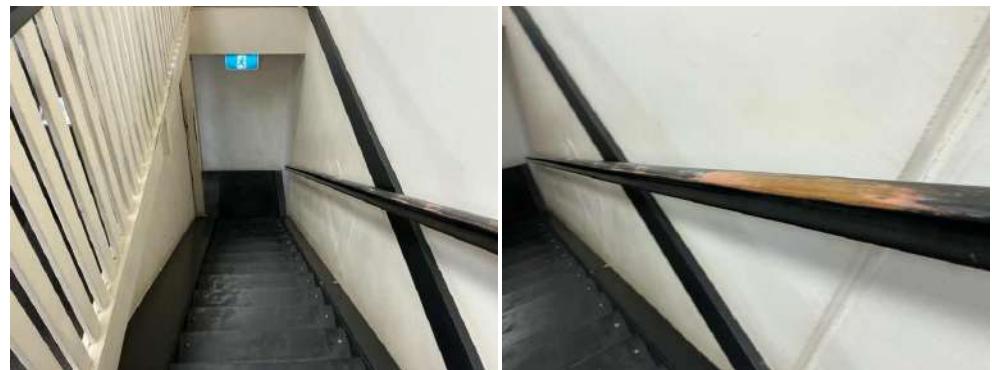
#21. Incomplete Patch/Paint repairs noted. Call a licensed painter for repairs

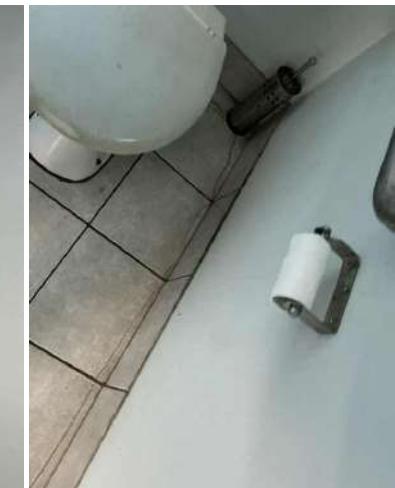
#22. Cracked tile/s noted. This can cause extensive floor and floor frame damage and is conducive to termite infestation if water is leaking through the cavity. A qualified tiler should be engaged for advice and recommendations.

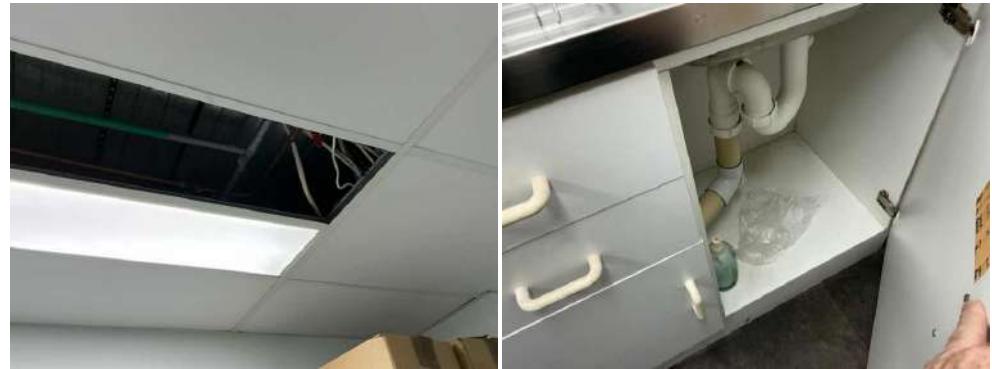
#23. Penetration opening recommend a qualified tradesman to repair
