# Inspection Report Qld 2021 Complete

**Complete Inspections**

**Smith St , Smithville, QLD , 4802**

### Pest And Building Inspection

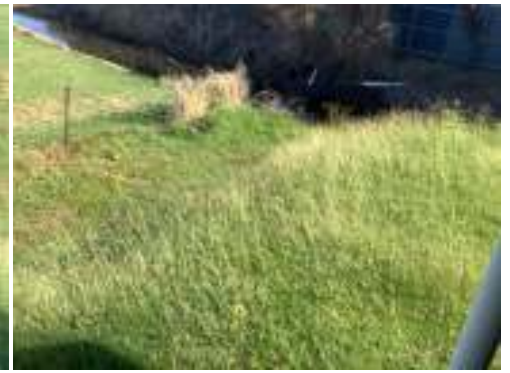
The ground levels along the perimeter walls at the rear of the home did not appear to fall away from the property walls sufficiently due to the natural landscape and contour. This will need to be assessed during a period of rainfall and if surface water appears to be entering the sub floor if applicable or ponding against the perimeter walls, engage a plumber or landscaper to assess and rectify as required. All drains should be regularly checked by a plumber and kept clean of debris to allow surface water to be carried away from the dwelling.

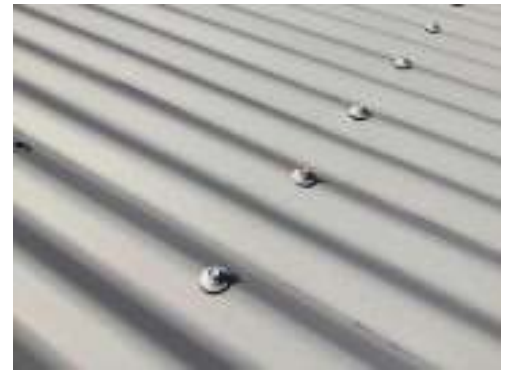
### Roof Clad Condition

Corrosion noted to the screw fixings of the metal roof. Have these checked and replaced by qualified roofing contractor.

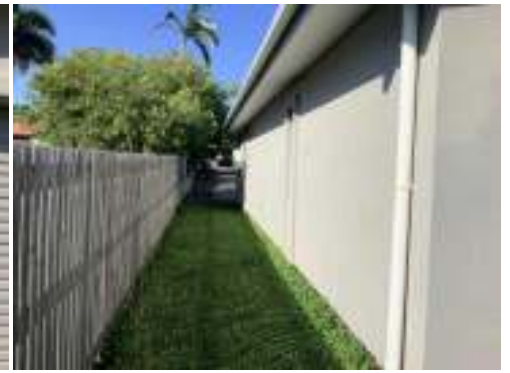
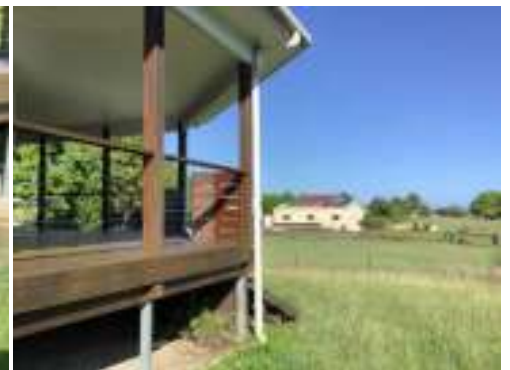
### **Downpipe Findings**

The downpipe base is damaged/ cracked. This has the potential to cause leaking. Recommendations: A qualified plumber should be engaged for repairs.

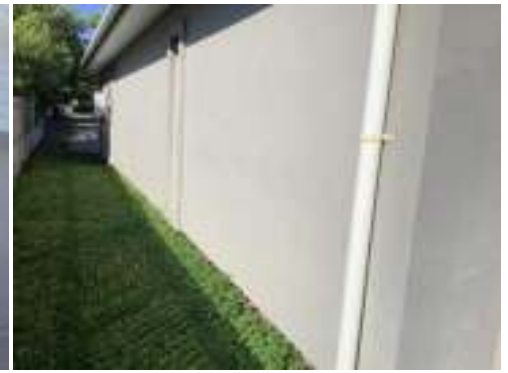
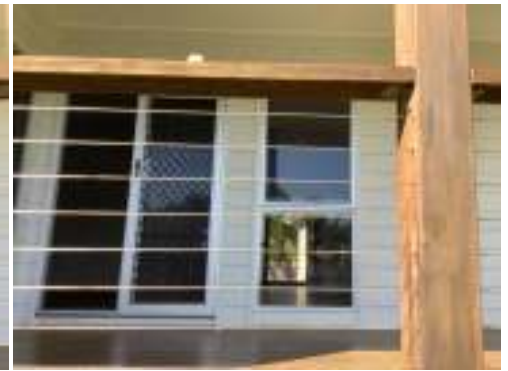
There appears to have been some settlement in the building which has caused some cracking to the walls. These cracks are categorized as 0 to 2. This can also cause some doors to bind or be out of square. In the inspectors opinion these cracks are due to settlement, usually due to ground movement and subsequent movement to building materials can be expected. Any cracks should be monitored and if cracks increase in size, further investigation should be carried out by a structural engineer.

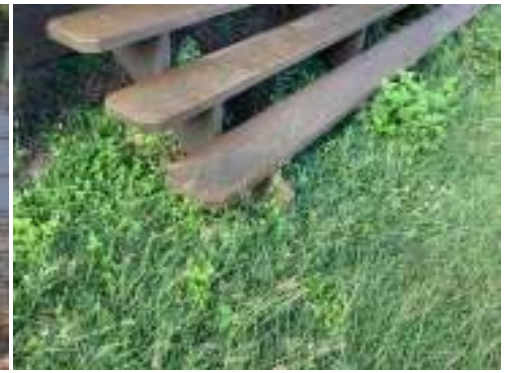
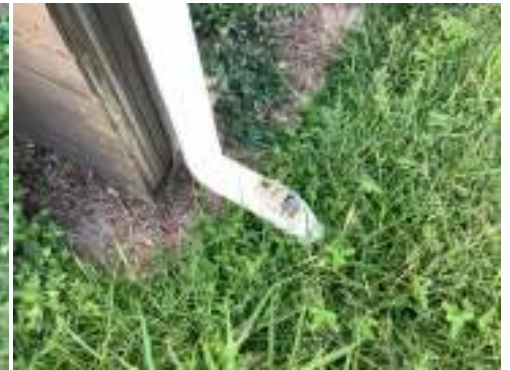
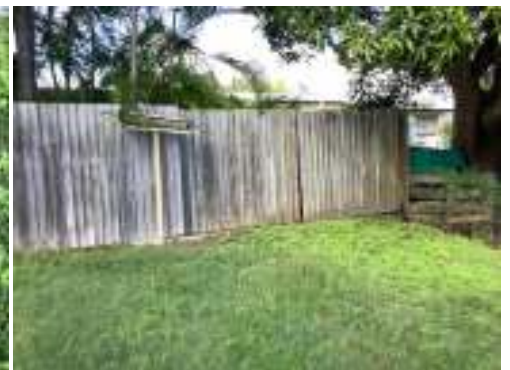
Timber in contact with ground. This provides conducive and concealed conditions and concealed entry for termite infestation.

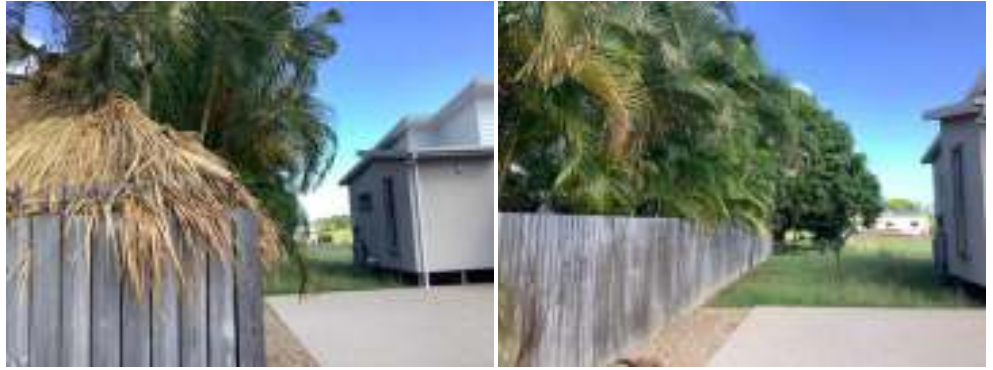
### **Are Trees Close to Home**

Trees are in close proximity to the dwelling and within the termite foraging area. These are a favorable influence for termite infestation. Regular inspections recommended.
