Inspection Report 2025

Complete Inspections

John Smith Dr, Proserpine, Qld, 4800

Pest And Building Inspection

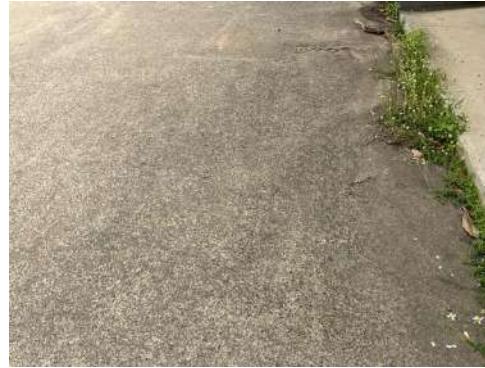
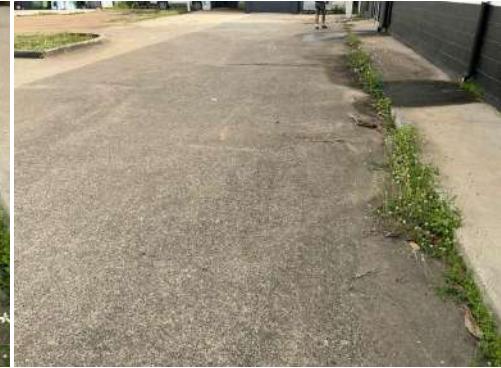
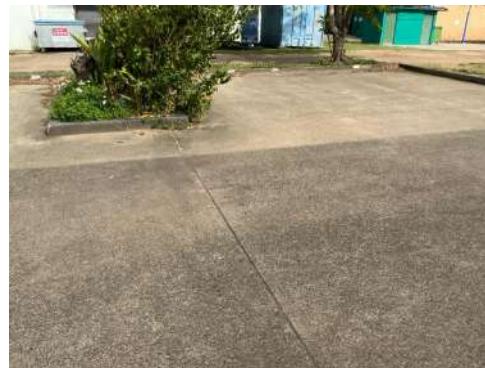
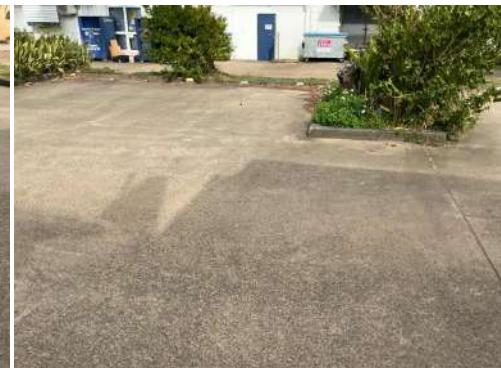
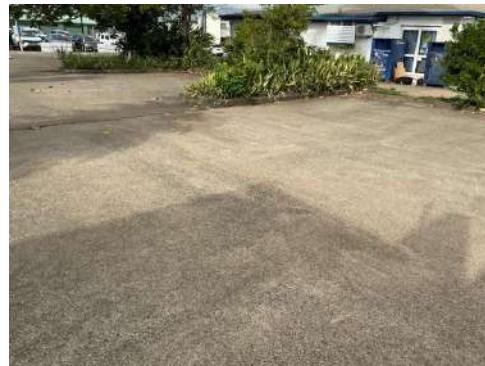
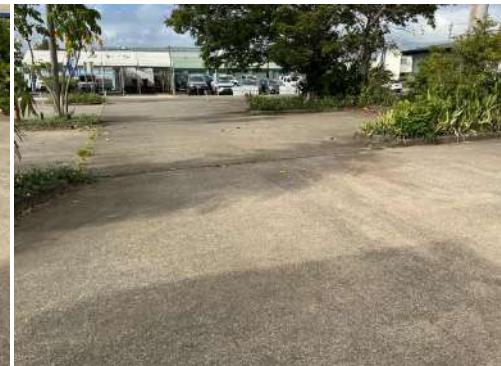
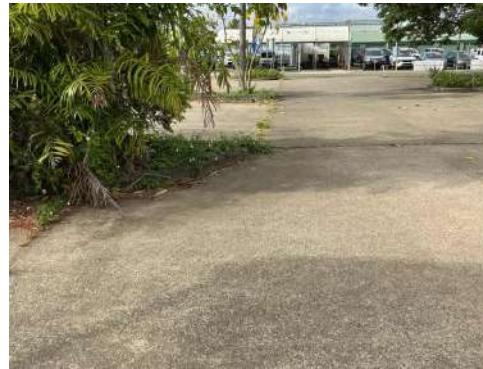
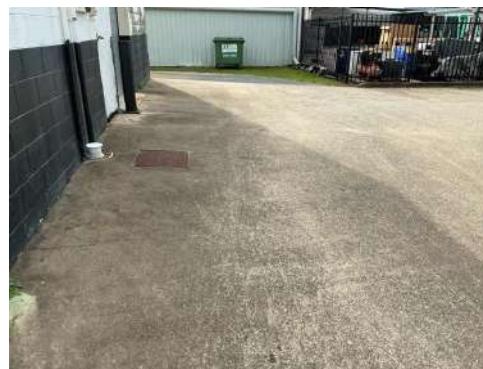
Driveway Condition

On visual inspection, the general condition of the driveway is serviceable.

Common cracks were observed on the driveway. Whilst these cracks appeared to be typical at the time of inspection, we strongly recommend you monitor these cracks and if worsening occurs contact a concreter for further advice.

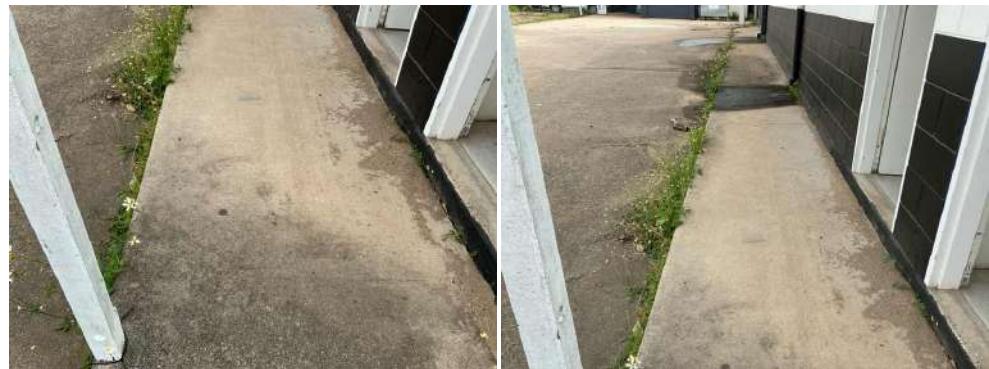
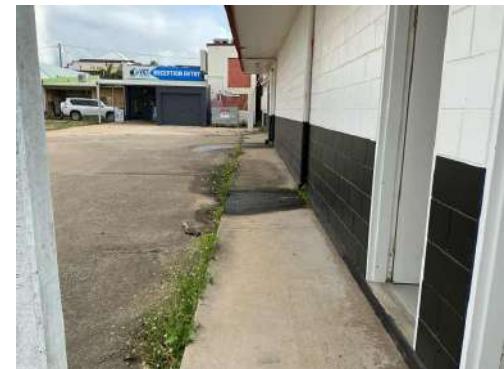
Pathways Condition

The paths around the home are in a serviceable condition for the age of this dwelling with no major defects visible.

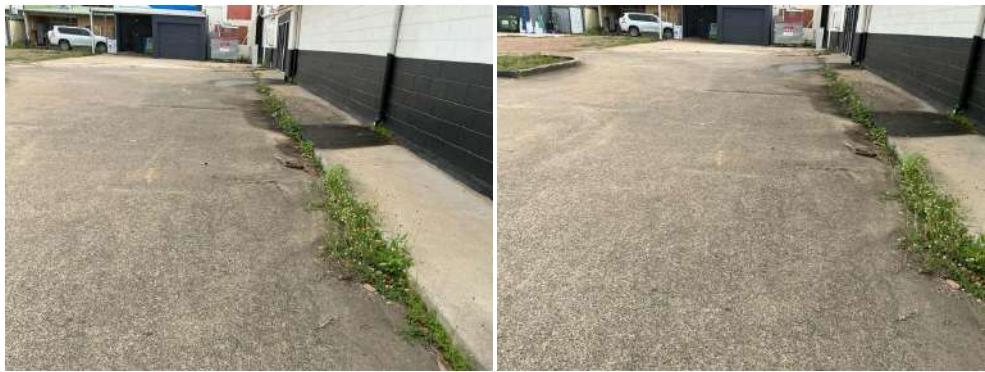
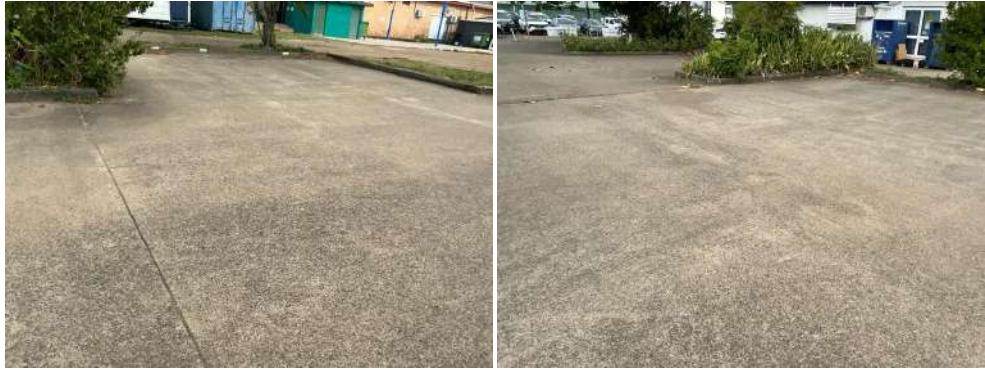
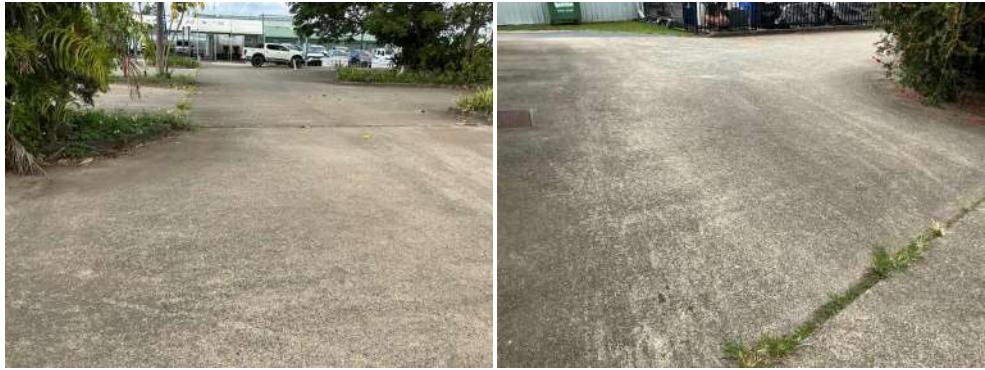
Drainage Findings

There was no visible evidence of excess ponding or fall towards the property walls at the time of the inspection. Regardless, it is difficult to ascertain in dry conditions and it is therefore recommended that you assess same after a rainfall period to be able to sufficiently ascertain if any problems exist in this regard. If water is ponding around perimeter walls and paths or appears to be flowing into the footings/foundations you must have assessed by a qualified plumber or landscaper.

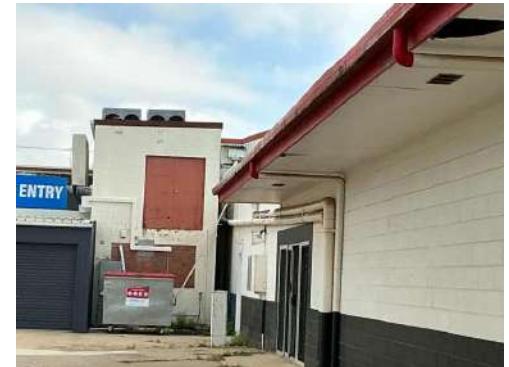
#6. The gutter fall appears inadequate in areas. This will lead to slow evacuation A qualified roofing plumber should be engaged for repairs and recommendations.

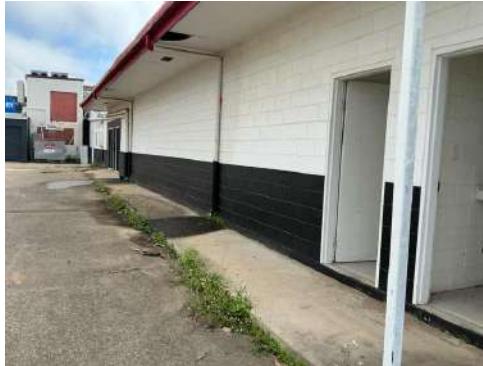
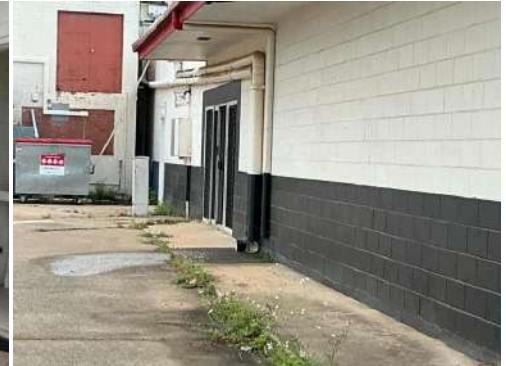
Downpipe Findings

#7. Downpipe/s not connected to storm water discharge - Downpipes not connected to storm water have the potential to cause differential settlement to the footings, cause rising damp and is also conducive to termite infestation. A qualified roof plumber should be engaged for advice and recommendations.

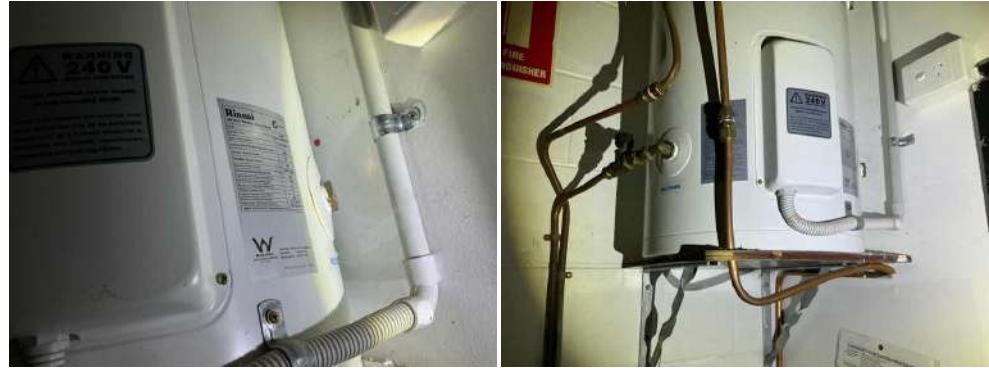
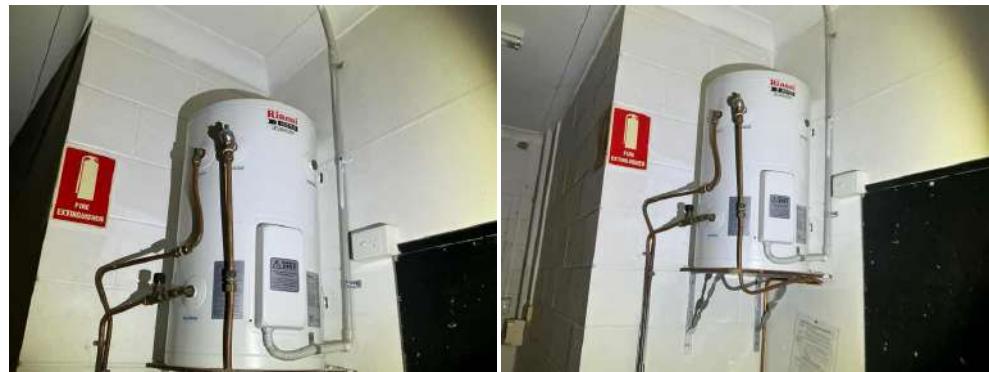
Traditional storage tank water heaters have a life span of **around 10 years**. Tankless hot water systems such as instantaneous hot water systems can last up to 20 years.

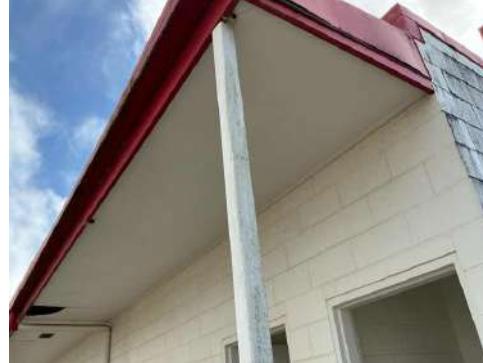
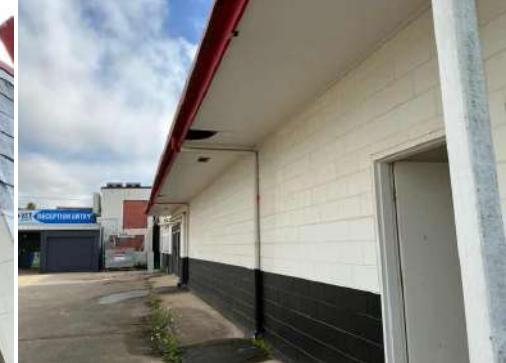
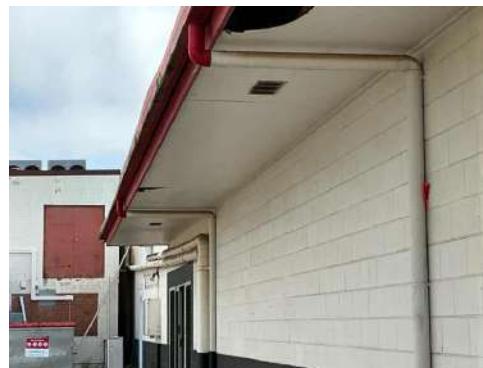
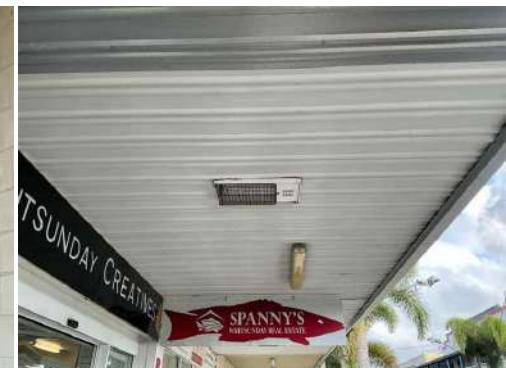
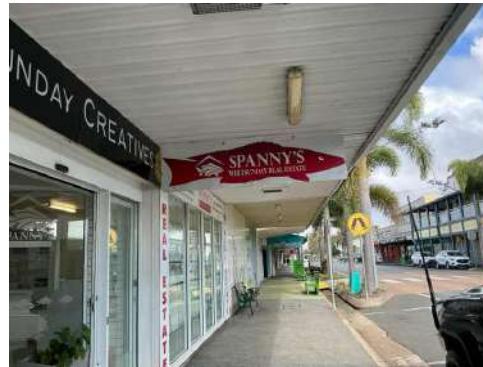
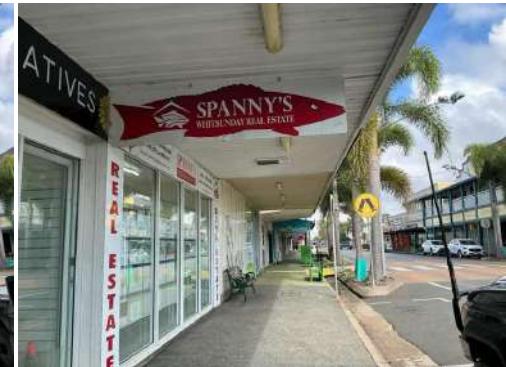
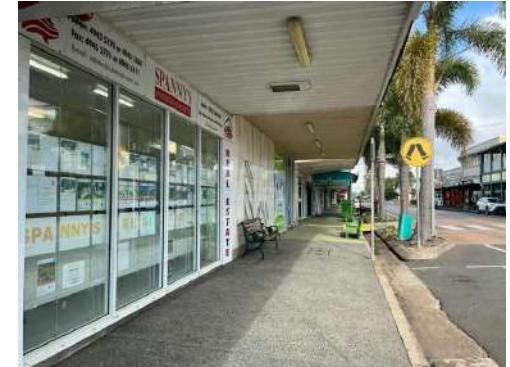
#9. Paint flake/deterioration is evident. Recommendations: General maintenance / painting as required.

Recommendations: A qualified carpenter should be engaged for repairs.

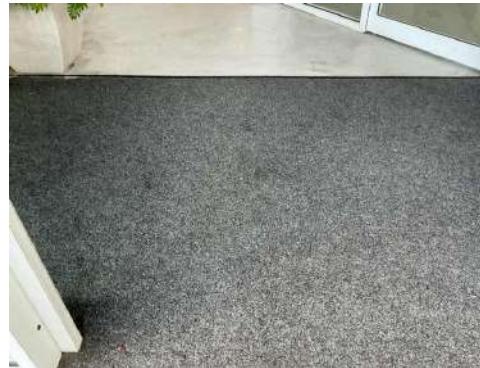
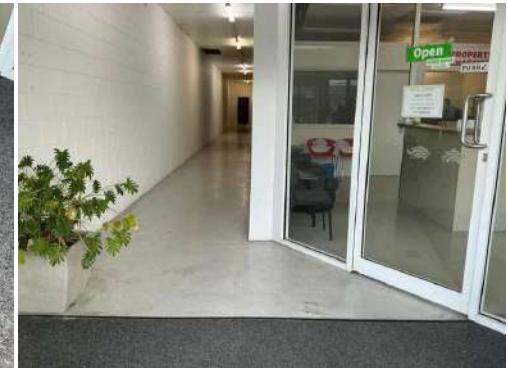
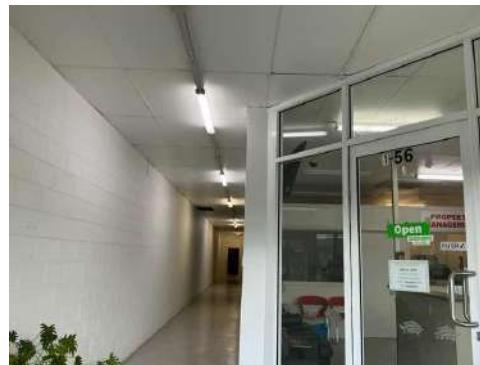
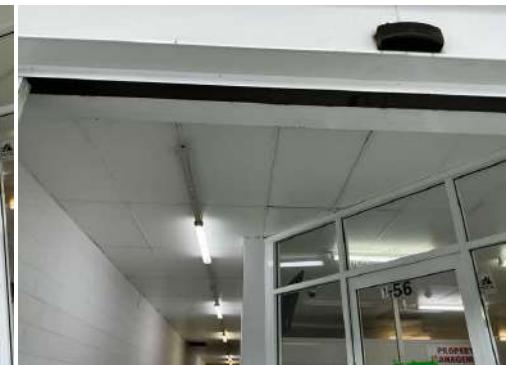
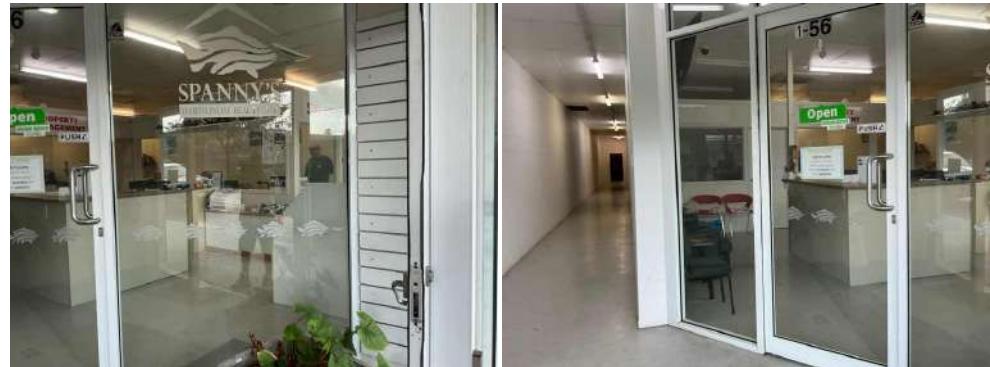
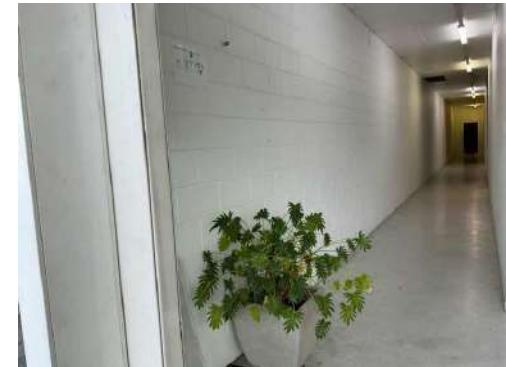
Overall Condition

The entry porch serviceable or in reasonable or condition for the age of this dwelling.

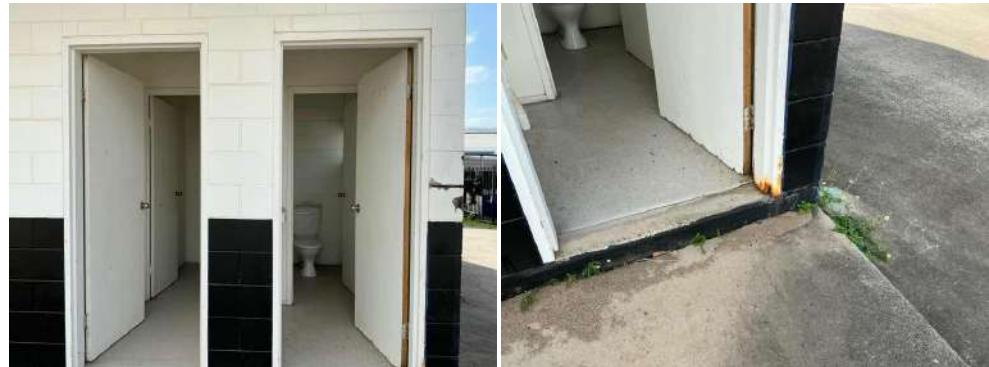
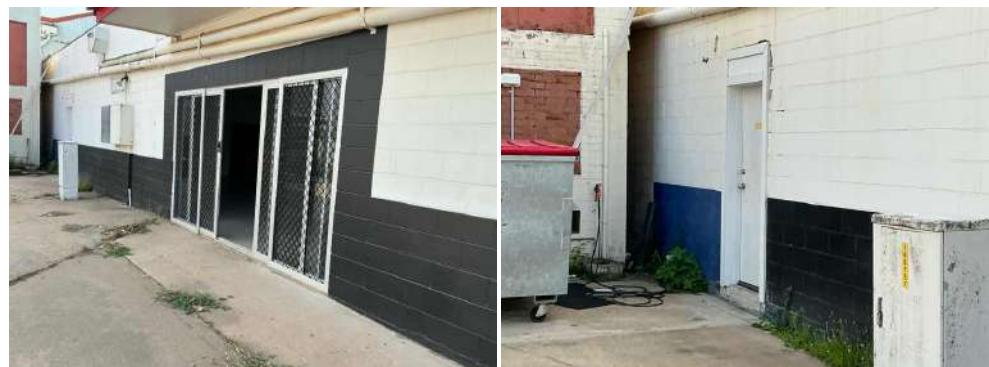
- #10. Door frames are damaged. A carpenter or a builder should be consulted for repairs.
- #11. The frame is separated with movement and separation noted. Contact a licensed carpenter for repairs.
- #12. Rust in door/door frame - Recommendations: General repairs required.

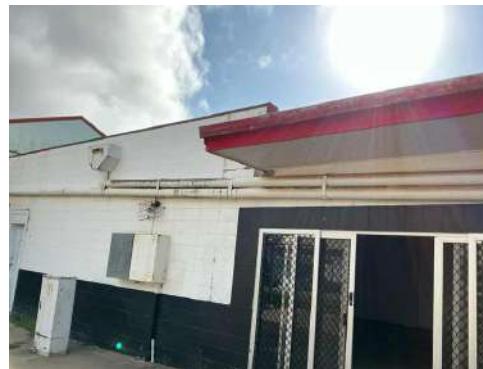
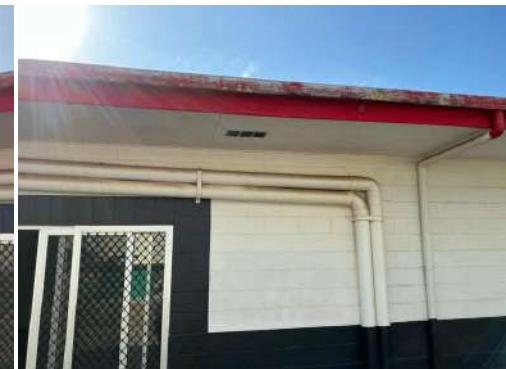
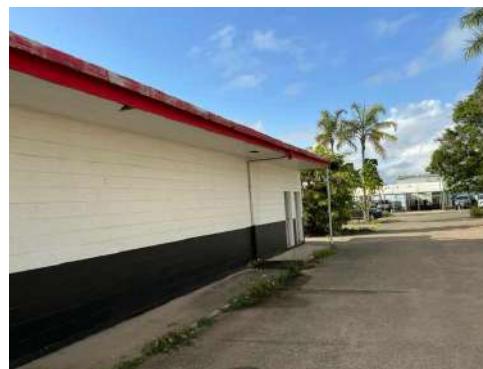
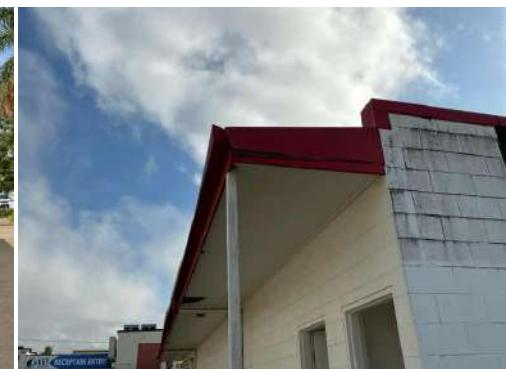
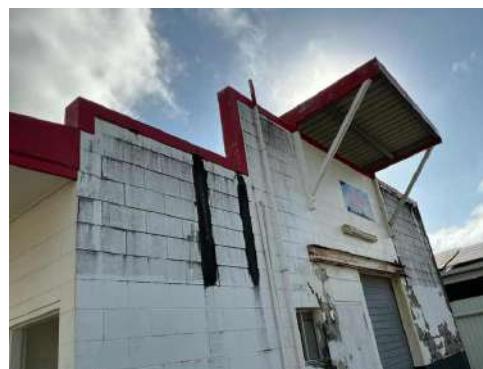
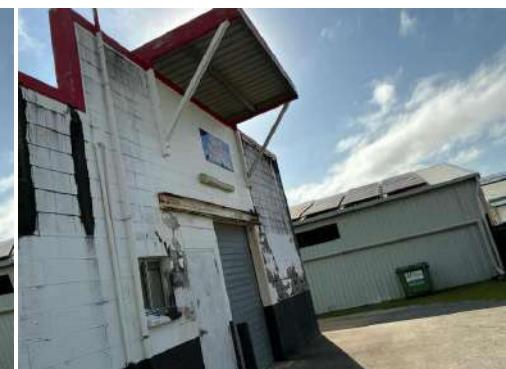
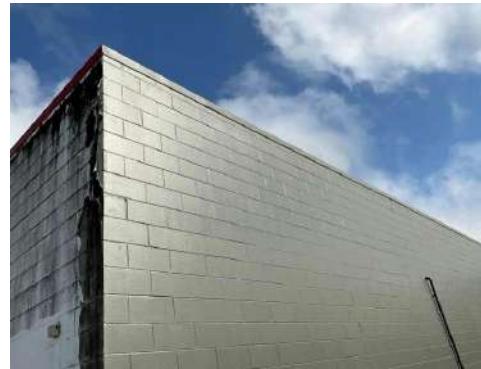
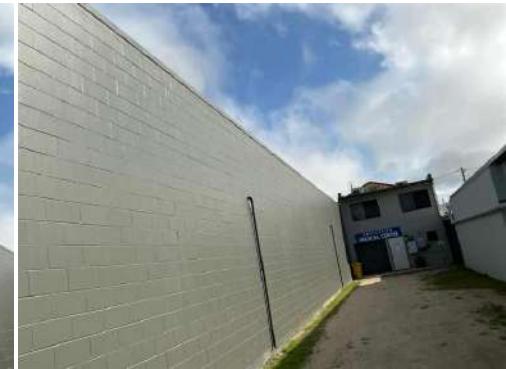
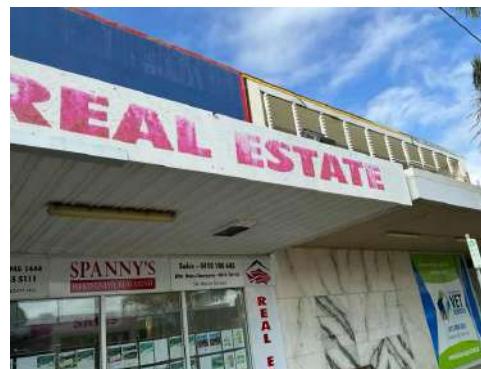
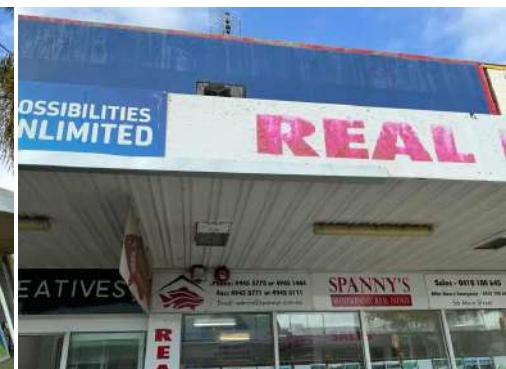
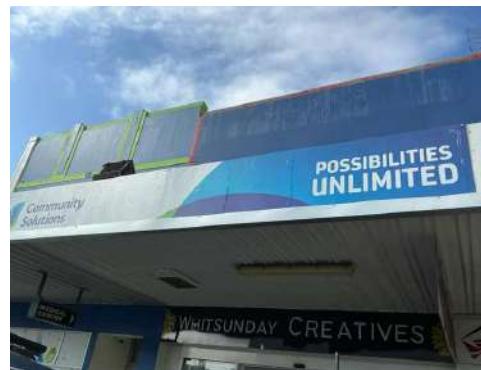
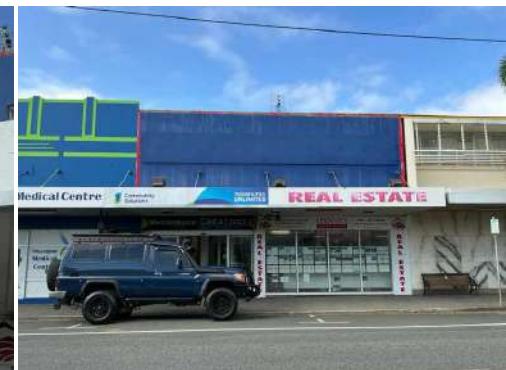
- #13. Minor deterioration & ageing evident. Recommendations:
Maintenance works, general upkeep should be carried out.
- #14. Paint / finish was deteriorated in areas and is in need of maintenance
 - Sanding back affected areas and painting required.
- #15. Separated on corner.
Recommendations: A qualified carpenter should be engaged for advice and recommendations.
- #16. Impact/Denting damage observed.

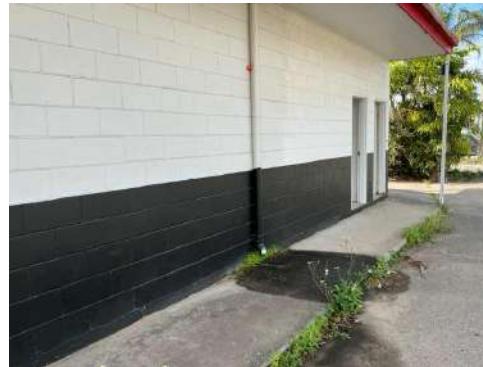
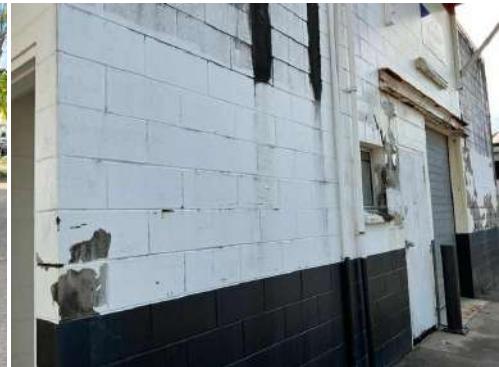
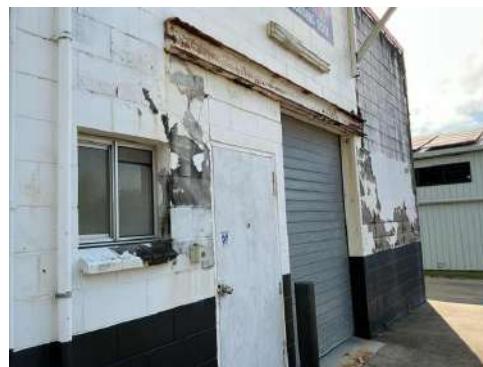
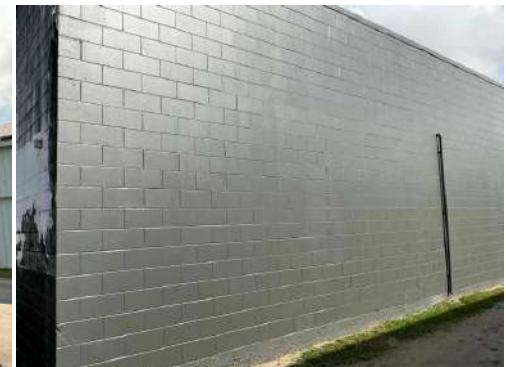
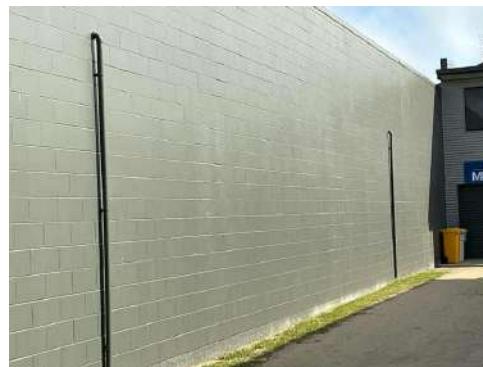
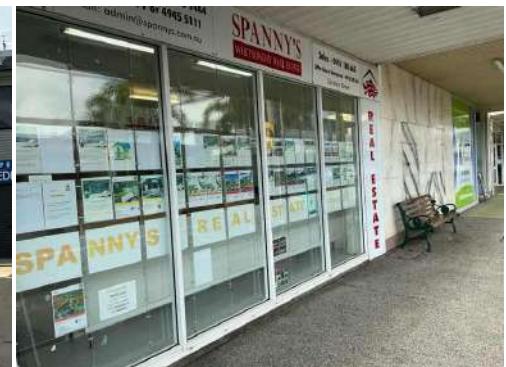
- #17. Minor brick damage observed to the brickwork. Have repaired by a qualified brick layer.
- #18. Paneling/cladding damaged. Have a suitably qualified tradesman assess and repair.
- #19. There appears to have been some settlement in the building which has caused some cracking to the walls. These cracks are categorized as 0 to 2. This can also cause some doors to bind or be out of square. In the inspectors opinion these cracks are due to settlement, usually due to ground movement and subsequent movement to building materials can be expected. Any cracks should be monitored and if cracks increase in size, further investigation should be carried out by a structural engineer.

- #20. The external paint has deteriorated. External wall paint preserves and protects the building elements. Contact a qualified painter for repairs.
- #21. Penetration openings observed. I recommend sealing these off so as to avoid vermin and other pest infestation.

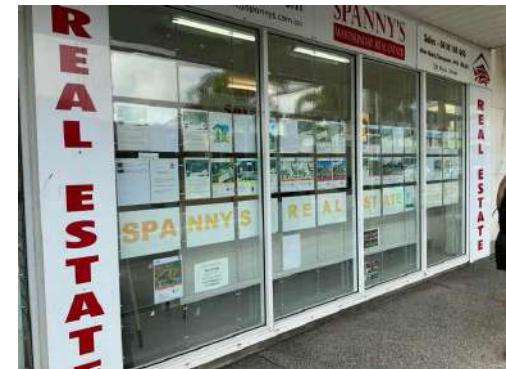
- #22. General age/damage has occurred to window components. Recommendations: Restoration work recommended. A qualified carpenter should be engaged for advice and recommendations.

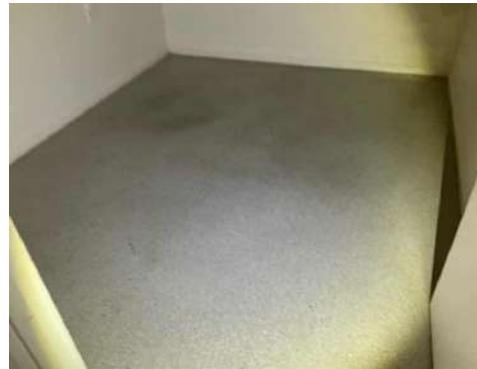
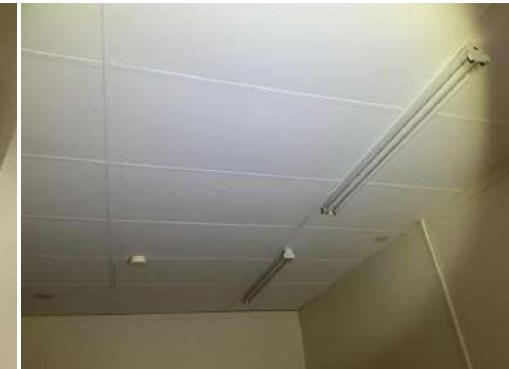
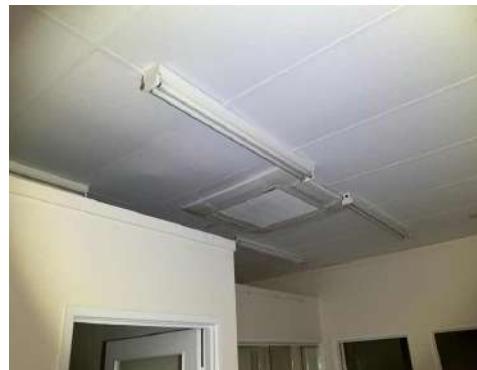
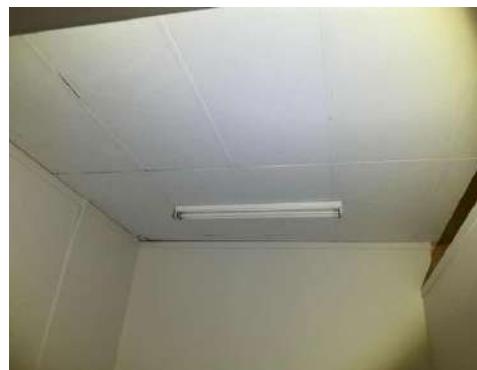
#23. A penetration opening was observed. It is recommended that this be sealed off and re-finished.
#24. Ceiling stains - No moisture readings obtained. These may have been repaired however you will need to monitor after a prolonged period of rainfall. If leaking persists, a qualified plumber should be engaged for advice and recommendations. All water damaged plaster should be replaced.

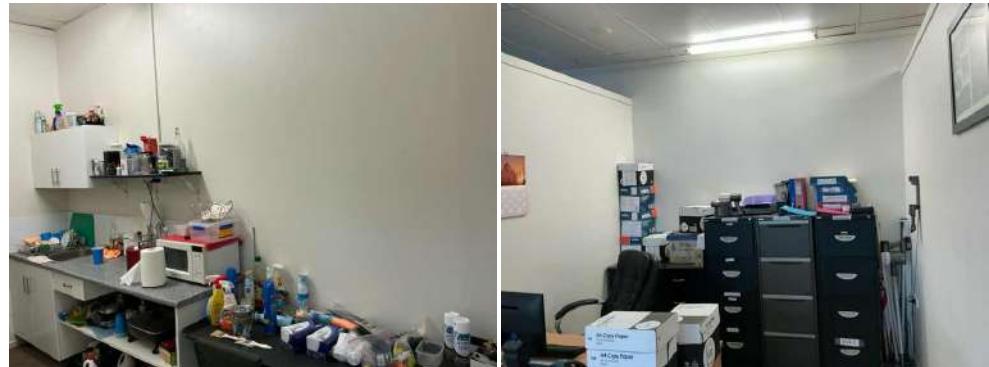
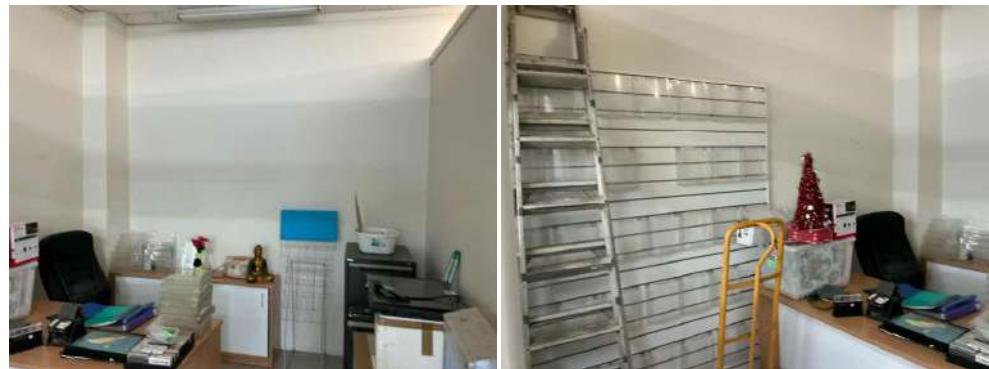
On inspection, defects were present that will require further assessing and recommendations by a qualified trades persons, please read below for details.

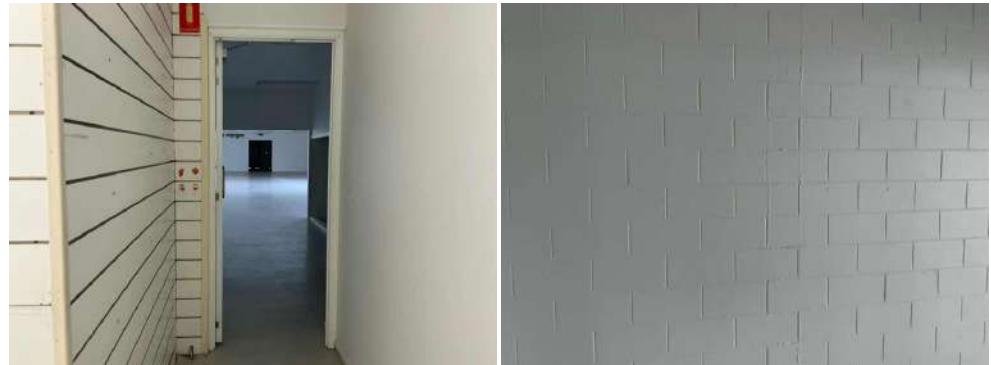
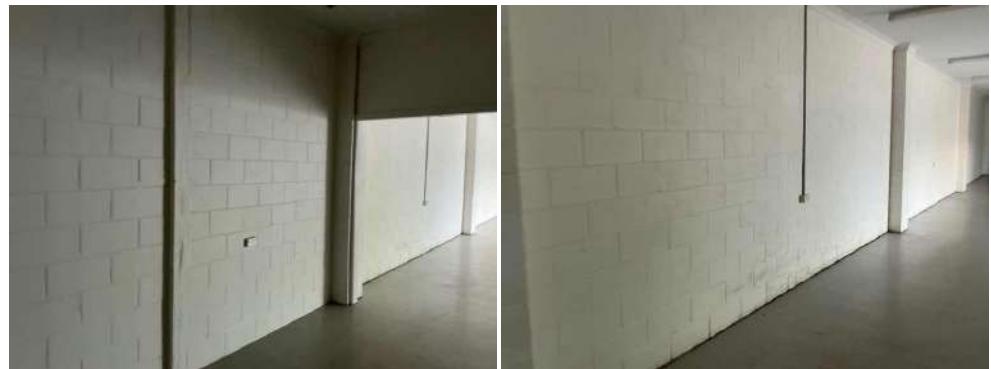
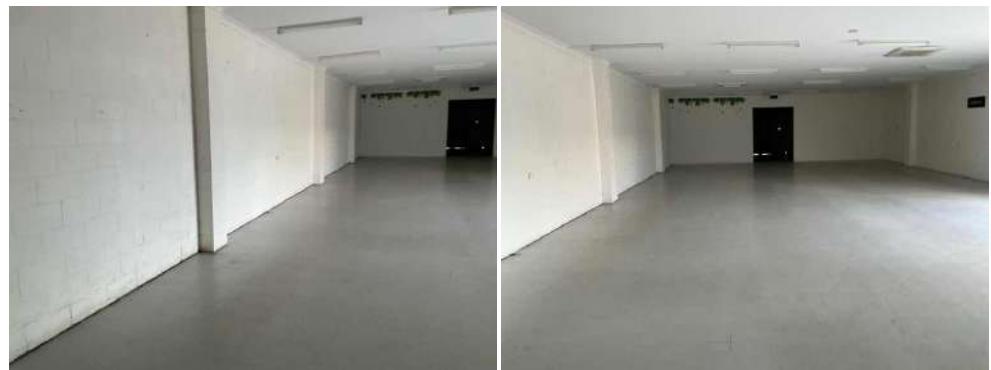
Study(2)

On inspection, defects were present that will require further assessing and recommendations by a qualified trades persons, please read below for details.

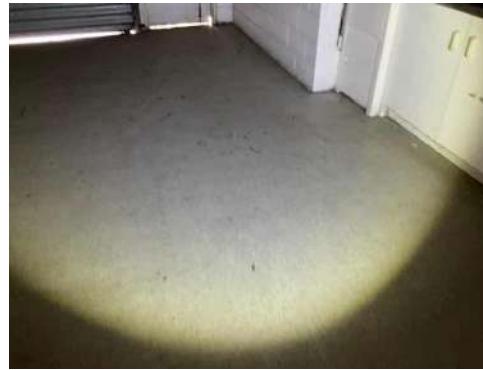
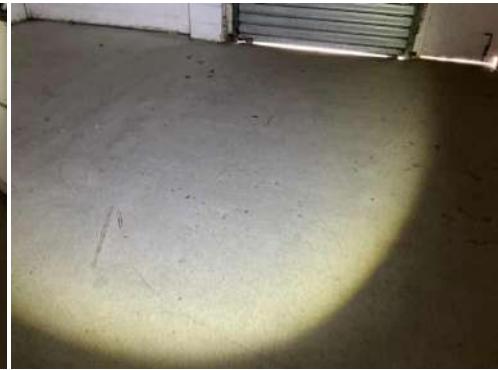
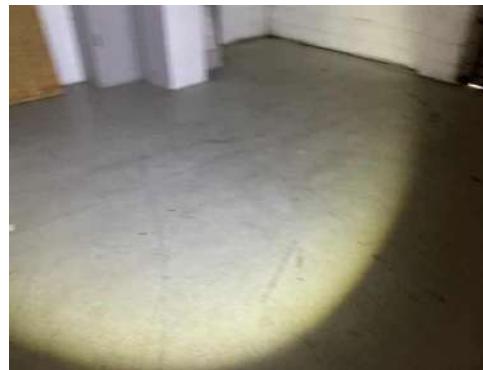
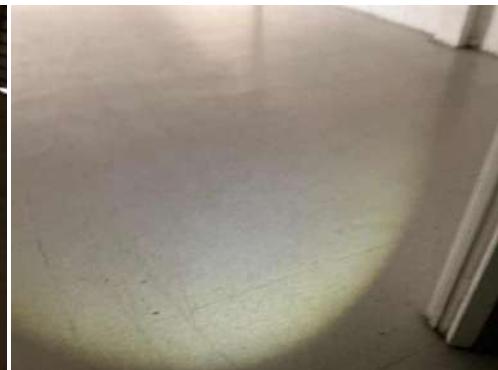
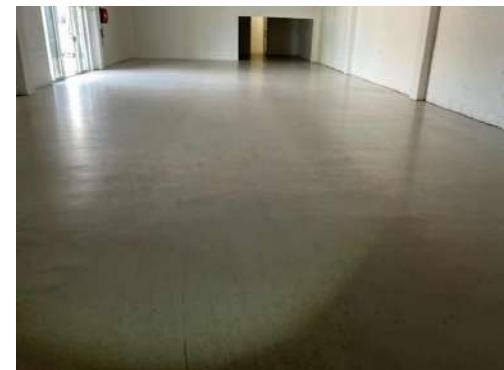
#37. Stained recommend a qualified professional to repair

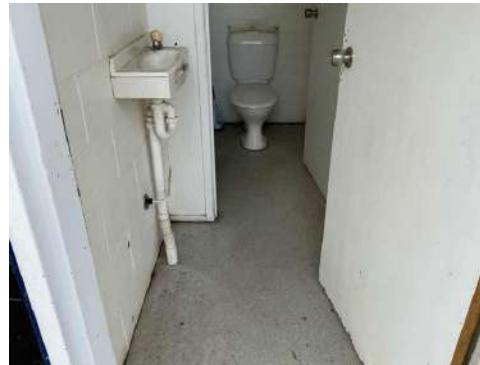
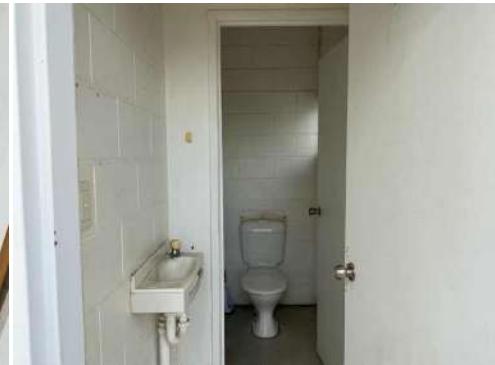
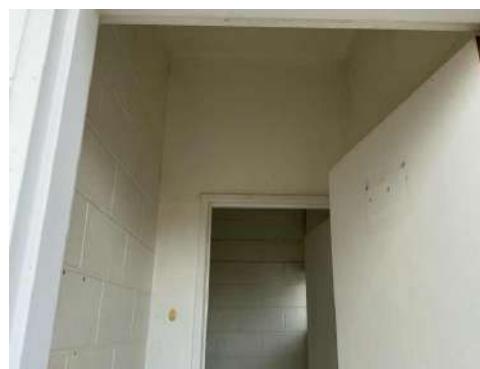
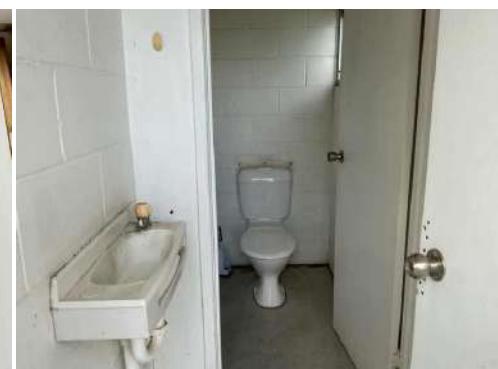
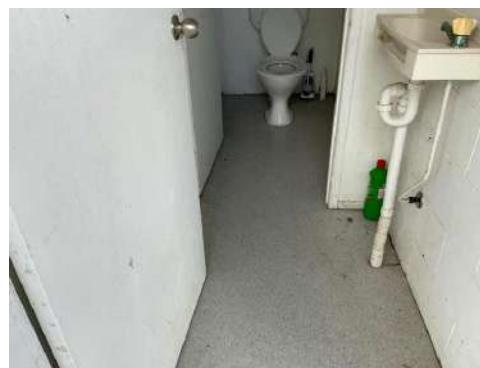
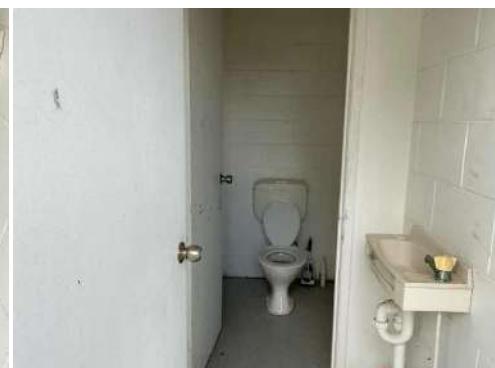
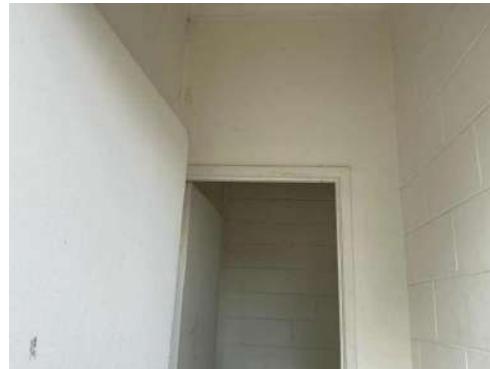
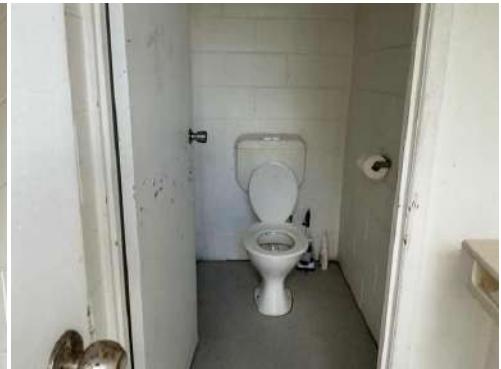
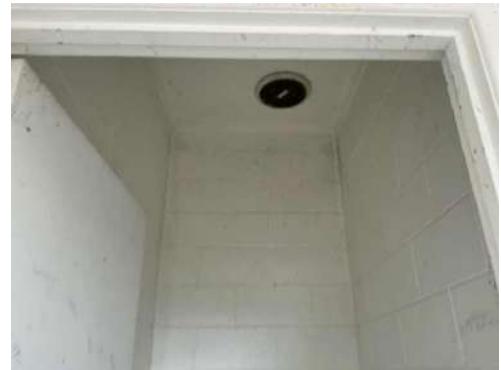
Of the visible areas, the general condition of this bathroom is serviceable or in reasonable condition for age of dwelling.

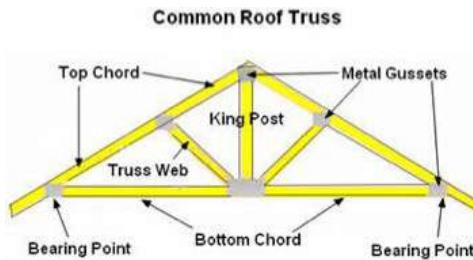
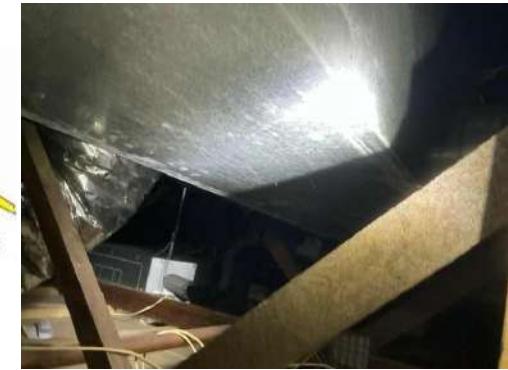
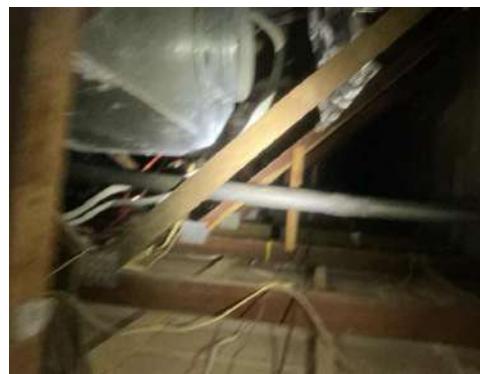
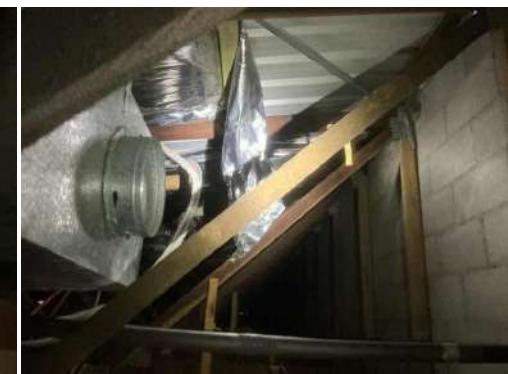
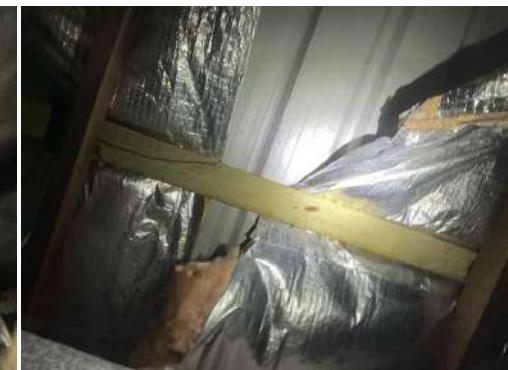
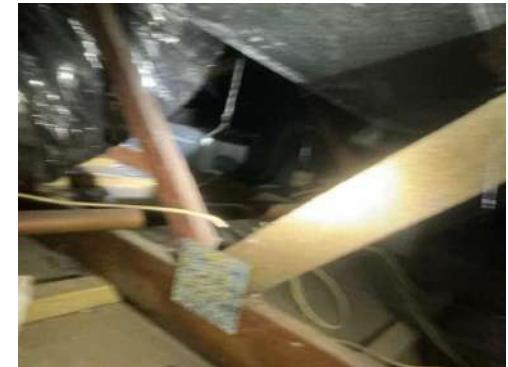
The roof frame is a truss timber frame.

Visible sections of the roof void is in a serviceable condition for age of this dwelling.

#40. There is evidence to suggest that there is some leakage into the roof void. In the absence of rain it is difficult to determine if this is an old leak or it's active. Monitoring during periods of rain should reveal any leaks, if leaks are active contact a qualified roofing contractor for repairs.

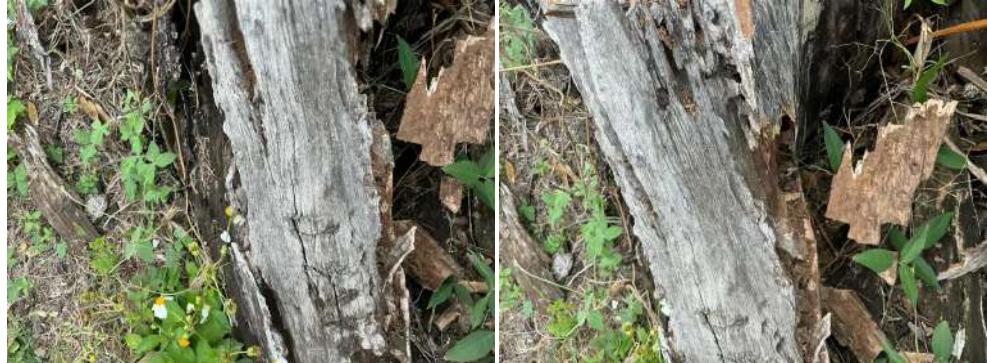
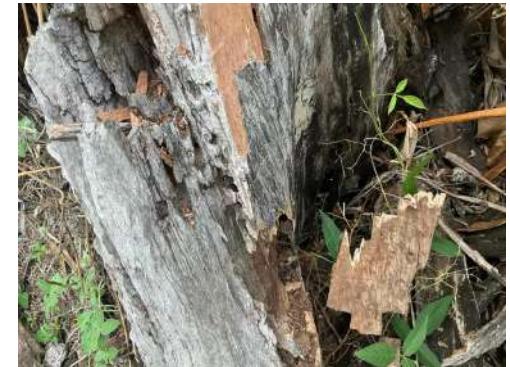
Was there any Termite Workings or Damage Found

Yes: Please read this report in its entirety.

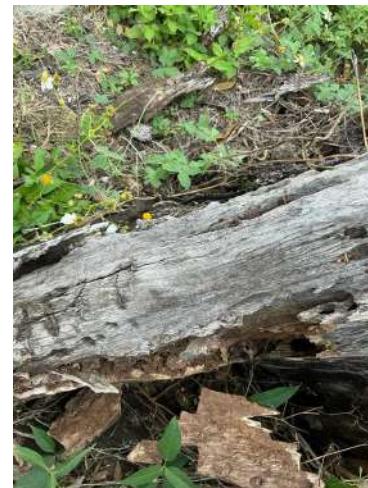
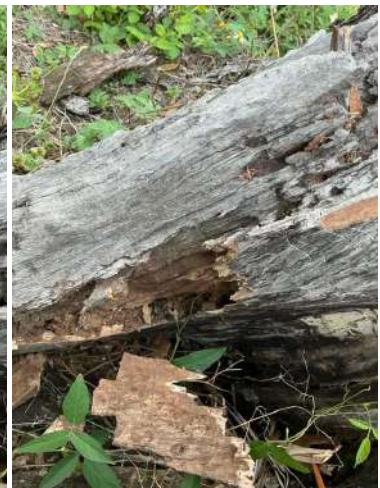
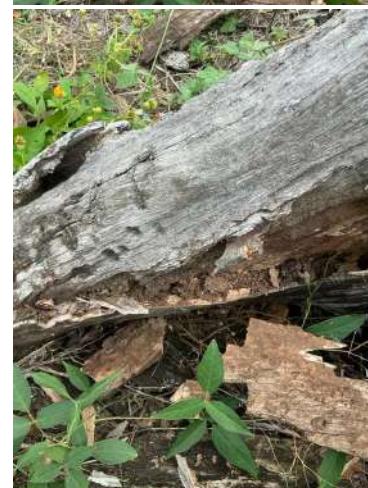
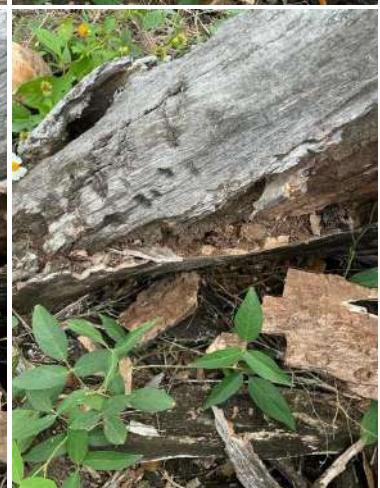
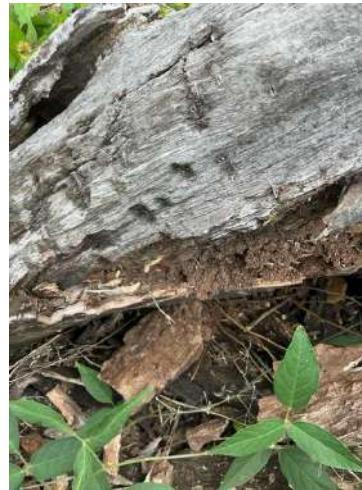
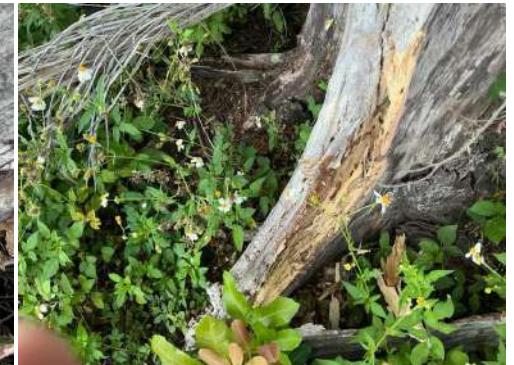
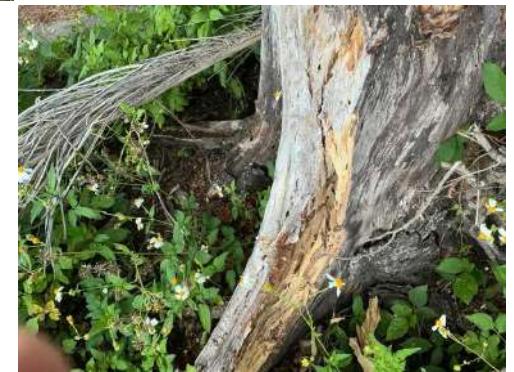
Were Any Live or Active Termites Found

Yes. Please read this report in its entirety.

Note: Any evidence of termite activity or workings in the grounds or building structure assumes that the risk to buildings is extremely high. We strongly recommend a treatment to eradicate the termites and to protect the building.

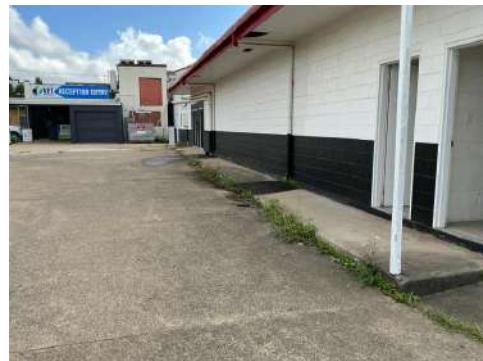
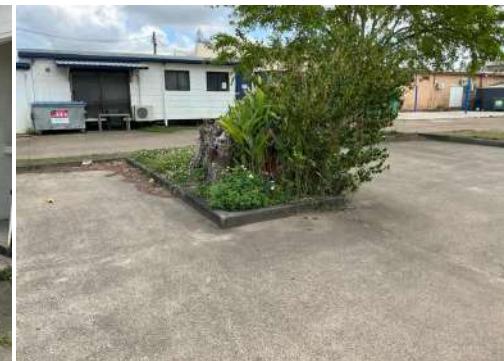
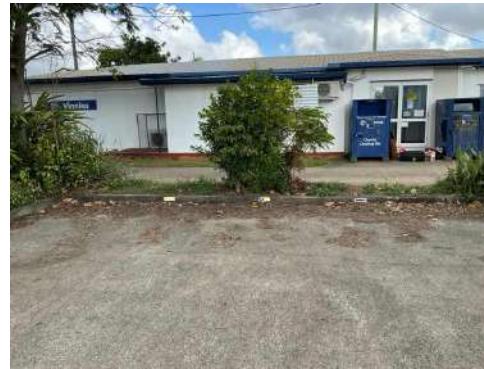
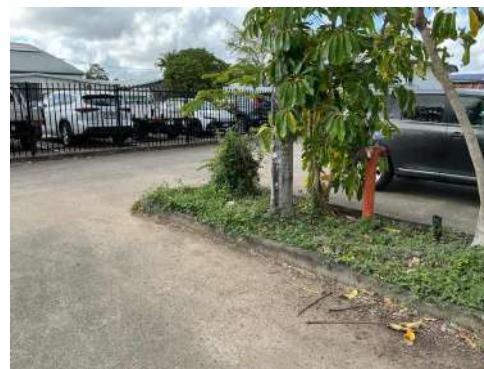
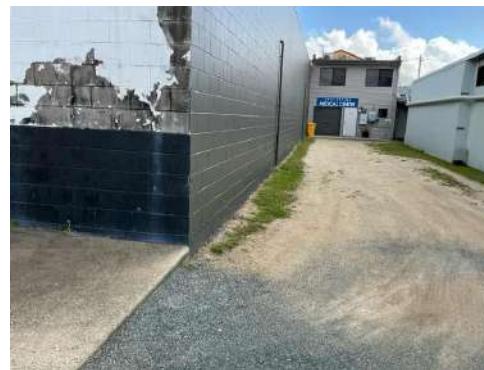
Timber in contact with ground. This provides conducive and concealed conditions and concealed entry for termite infestation.

Tree stump/s are located at the site. These need to be removed by a suitably qualified tradesperson as they are conducive conditions for a termite nest.
