# Inspection Report 2025

## Complete Inspections

**John Smith Dr, Paget, Qld, 4740**

### Building Inspection

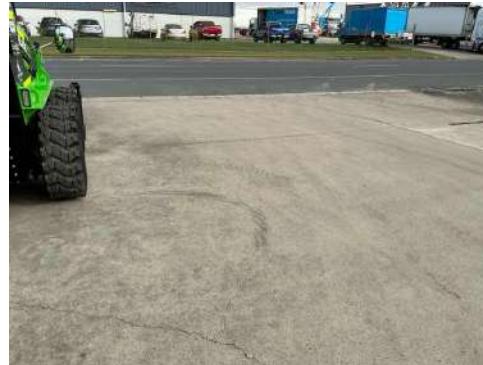
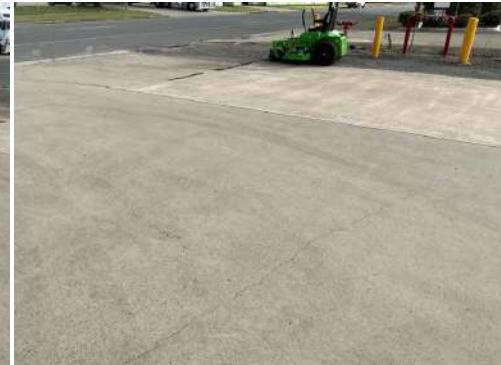
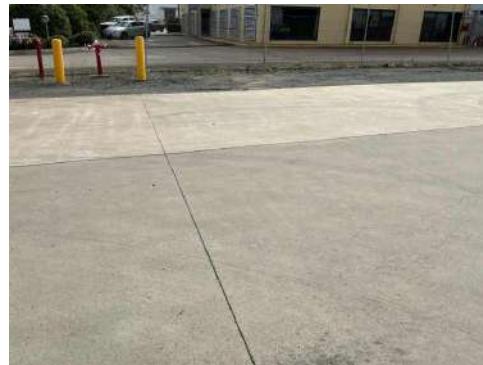
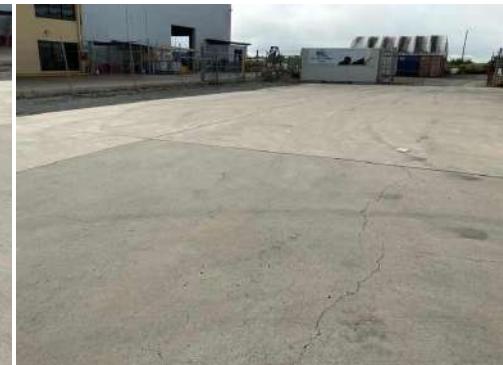
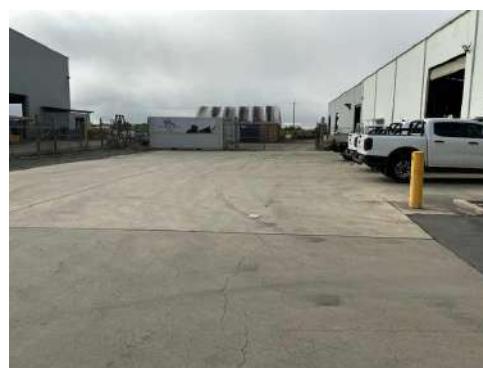
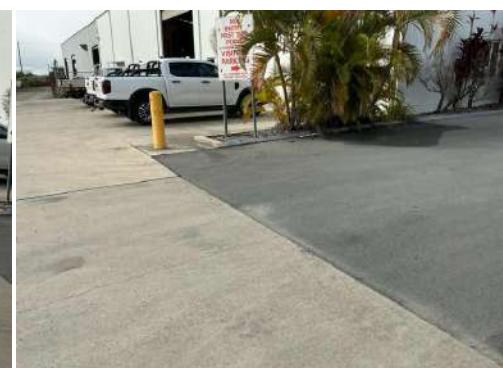
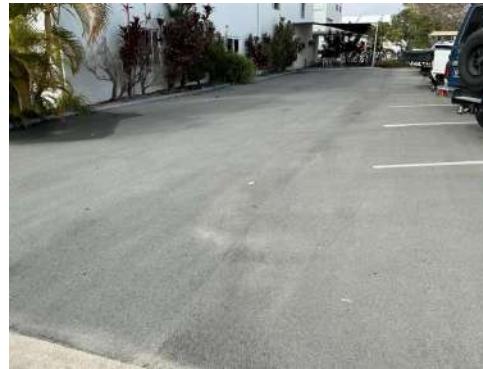
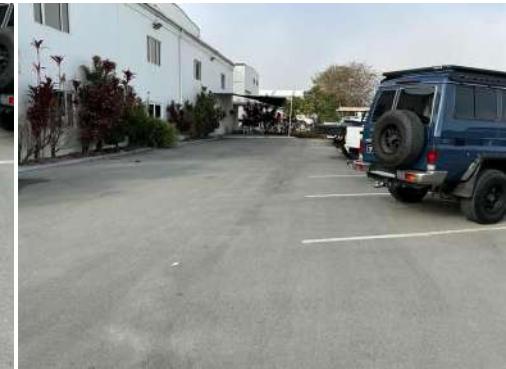
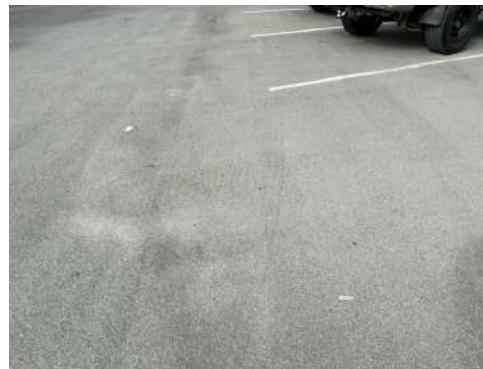
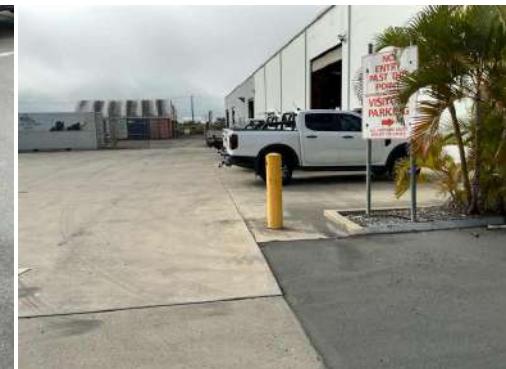
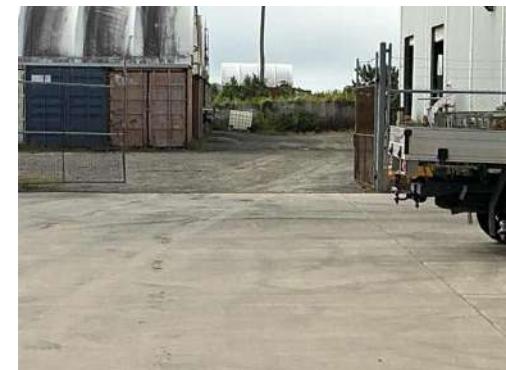
## Driveway Condition

On visual inspection, the general condition of the driveway is in a serviceable condition.

Common cracks & settlement were observed on the driveway. Maintenance is recommended. Note: Whilst these cracks appeared to be minor at the time of inspection, we strongly recommend you monitor these cracks and if worsening occurs contact a concreter for further advice.

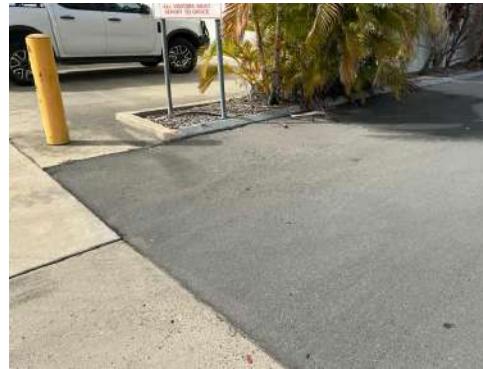
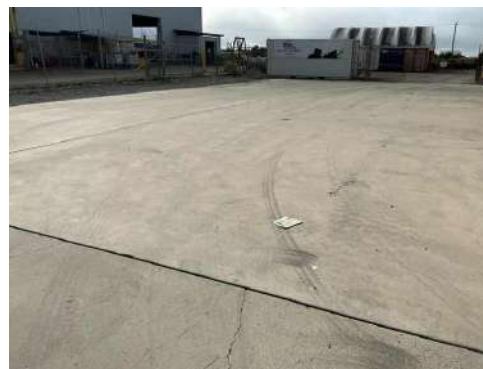
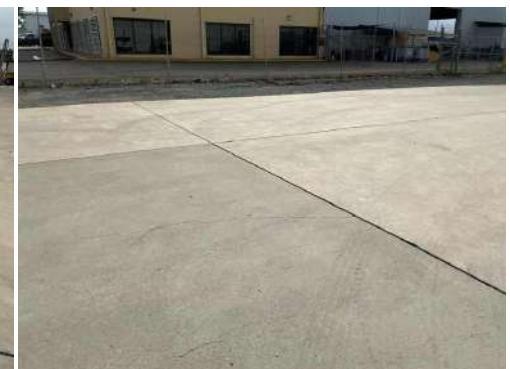
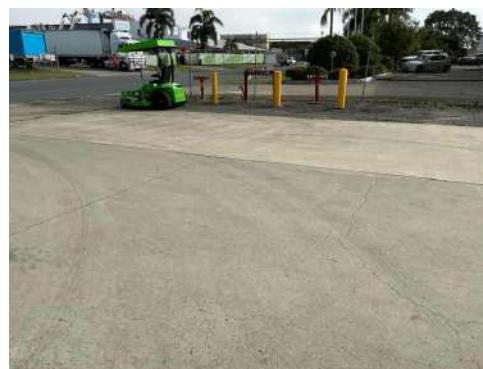
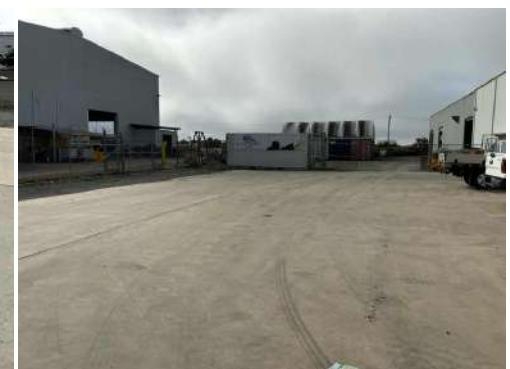
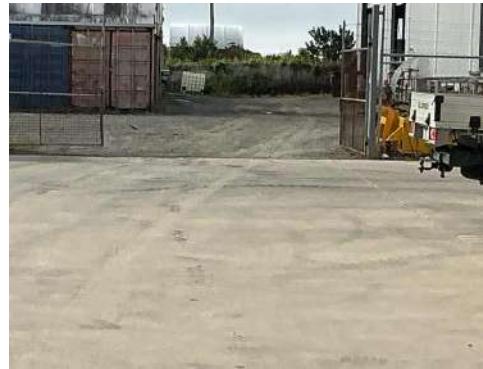
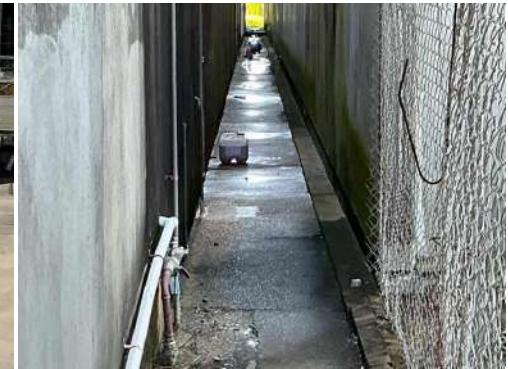
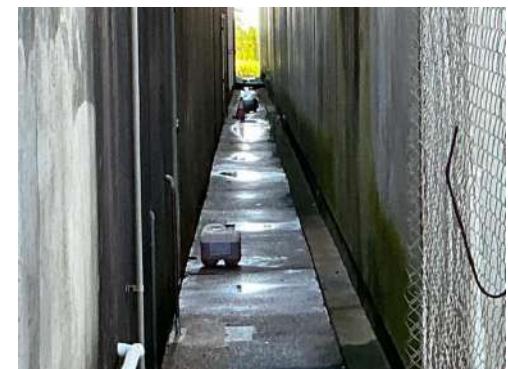
#2. There is evidence around the home paths that ponding near walls has occurred. Recommendations: A qualified landscaping contractor or a plumber should be engaged for advice and recommendations.

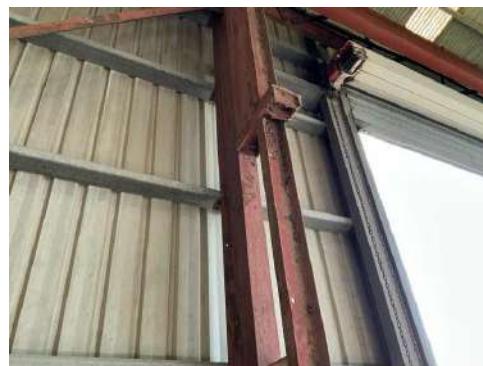
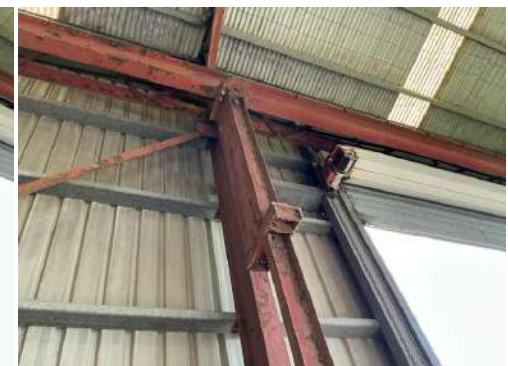
### Shed Condition

#4. Rust developing on steel frame  
recommend a full scope of works  
prior to settlement  
N/A

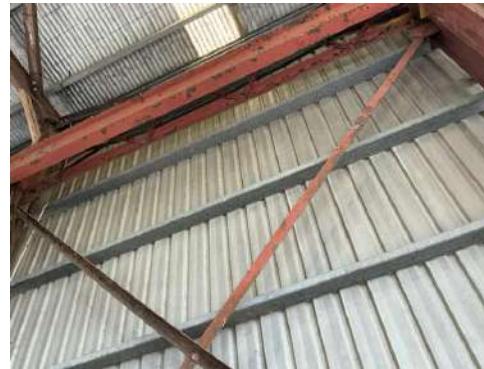
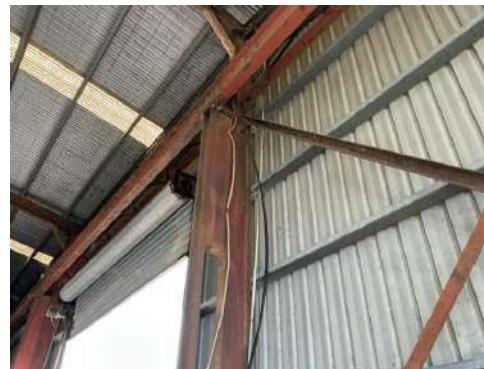
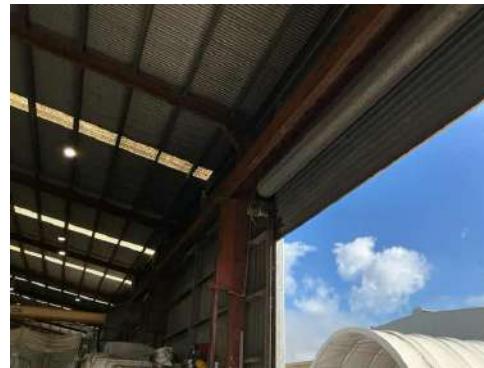
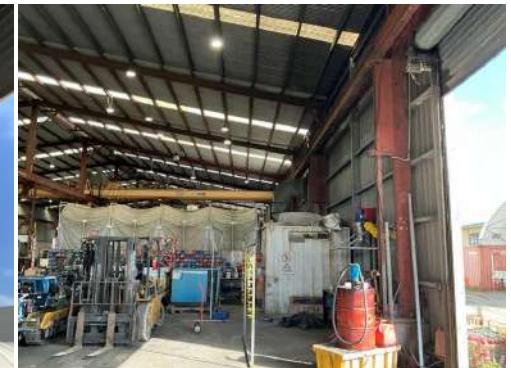
## Shed Condition(1)

#5. Rust developing on steel frame  
recommend a full scope of works  
prior to settlement

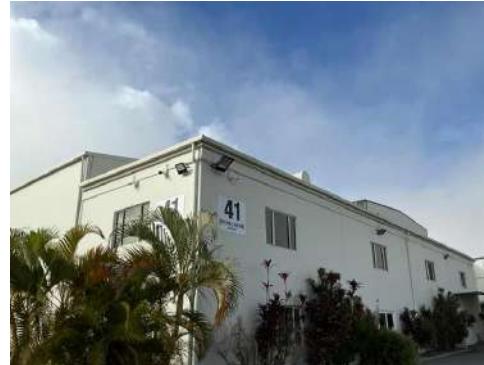
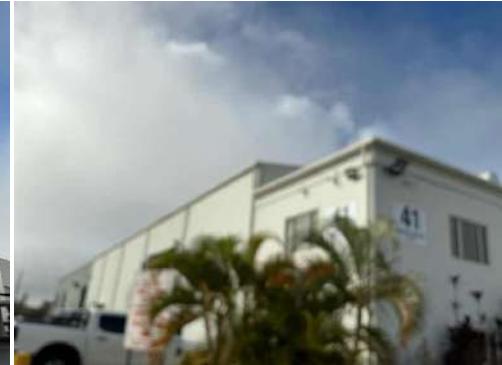
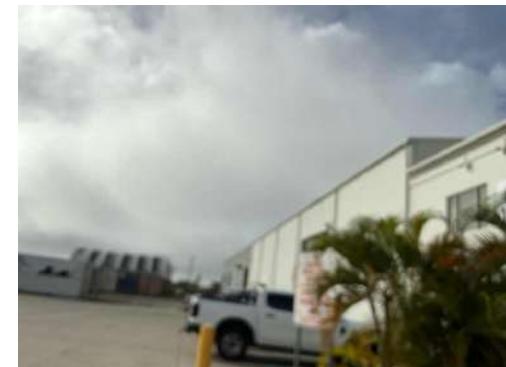
Not inspected as too high to reach by ladder. Viewed from a distance.

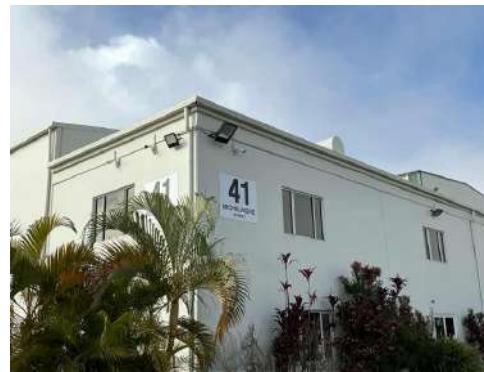
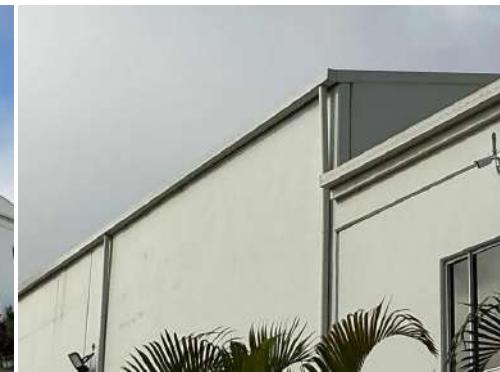
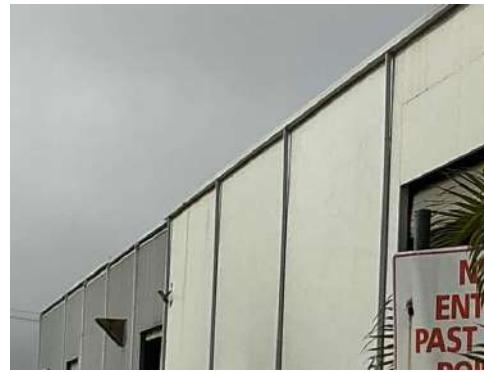
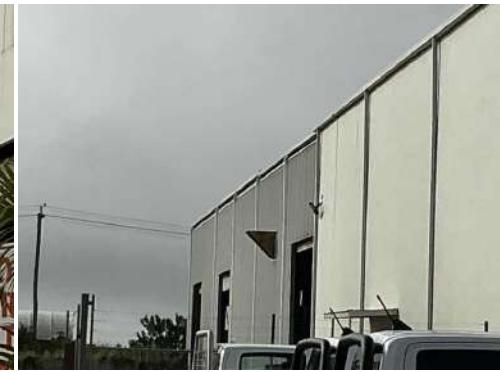
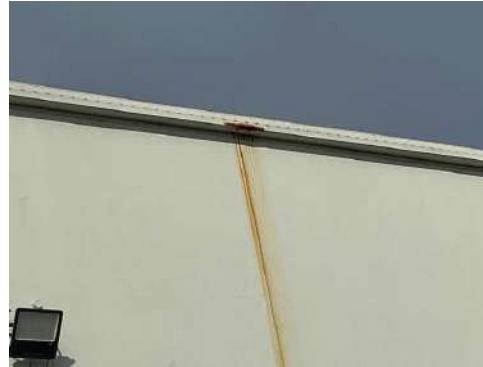
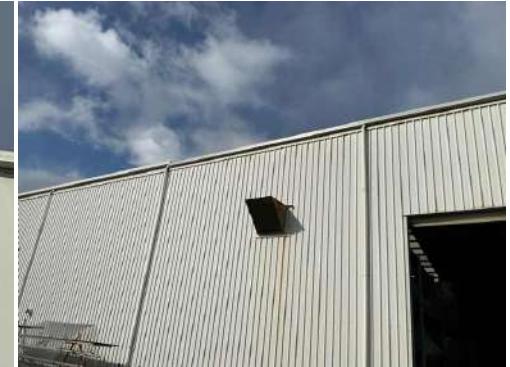
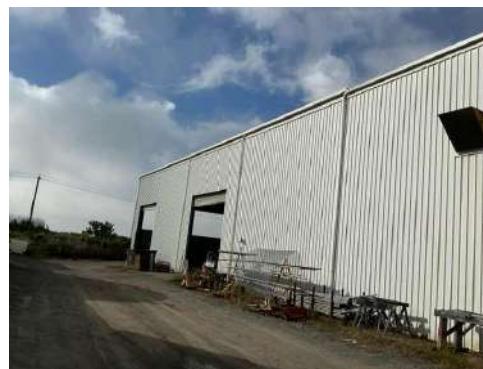
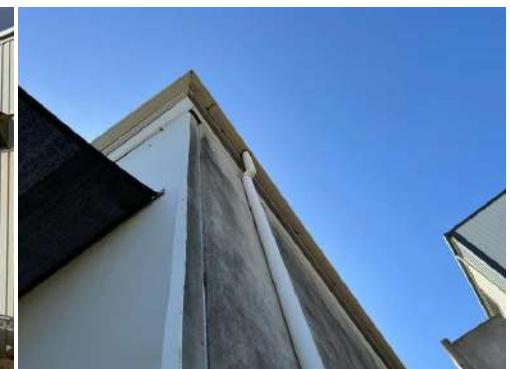
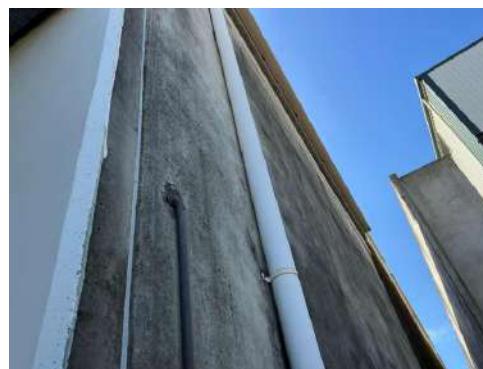
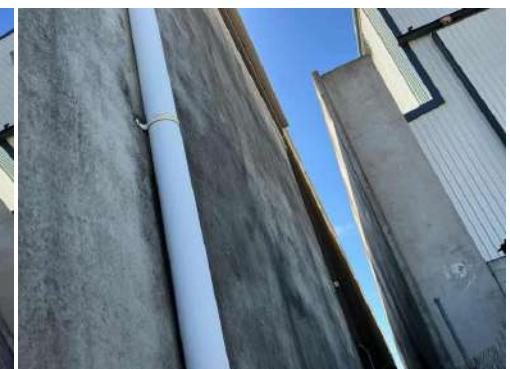
#6. The gutter join/s have separated and will leak in rainy periods.

#7. Gutter rust/penetrations- The guttering has excessive rust where leaking will occur.

Recommendations: A qualified roof plumber should be engaged for advice and recommendations.

Recommendations: The gutters require replacement by a roof plumber.

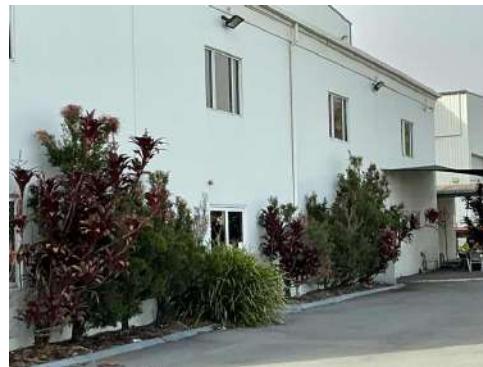
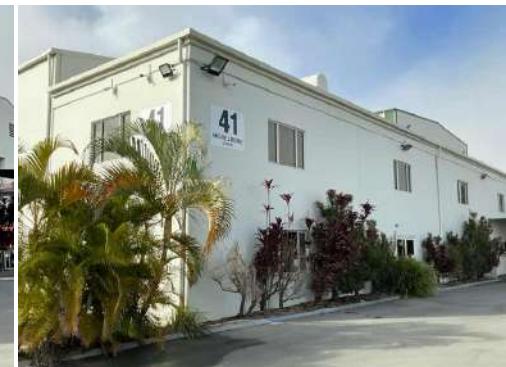
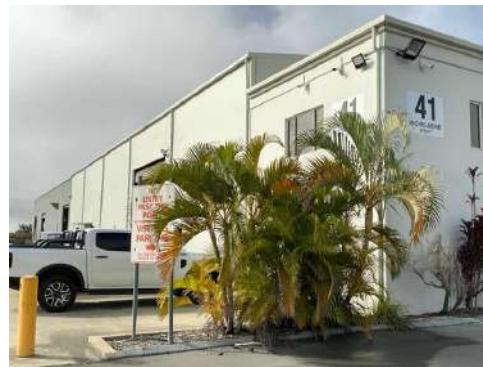
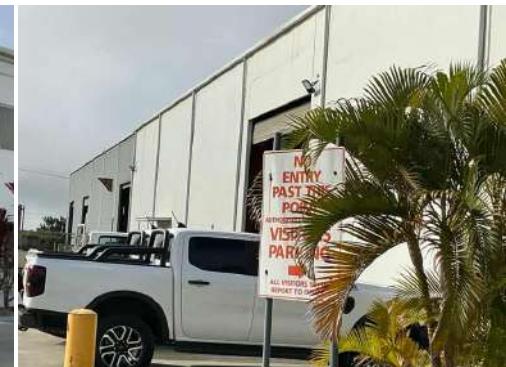
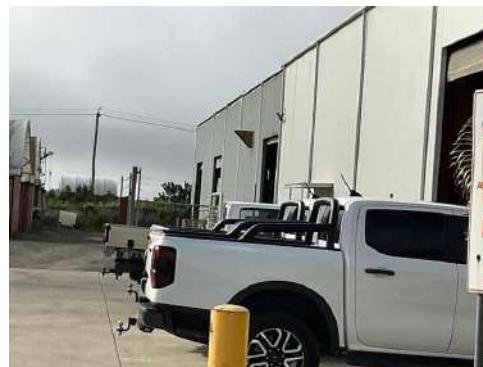
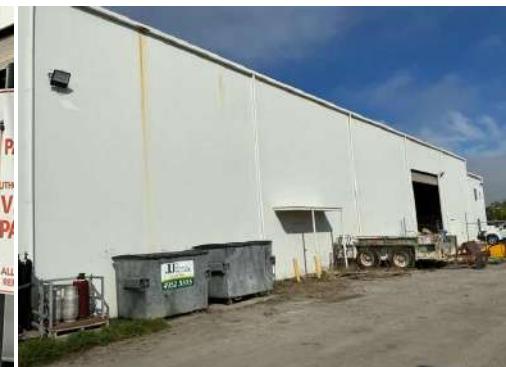
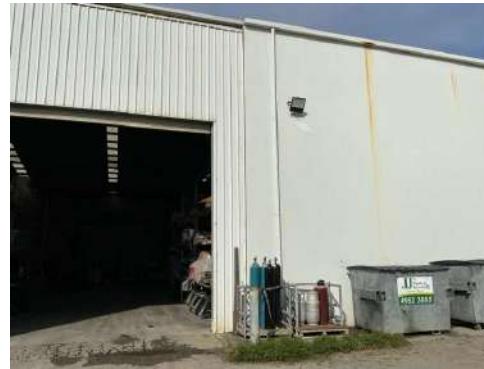
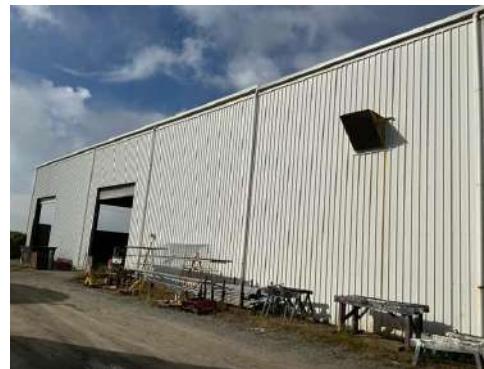
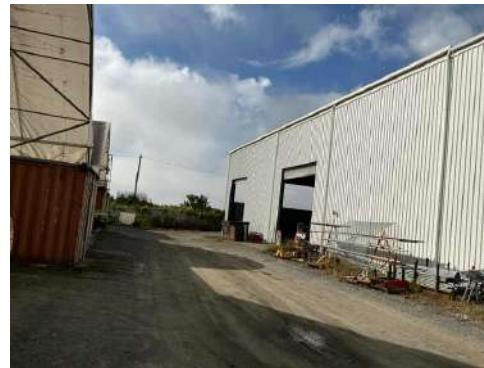
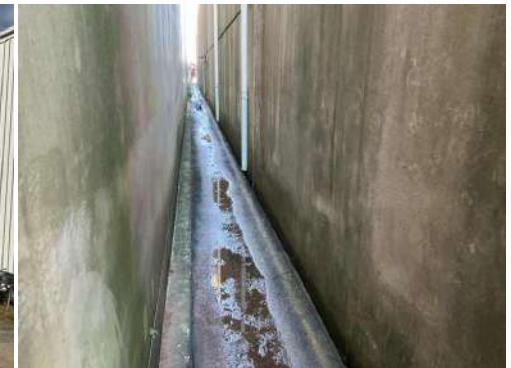
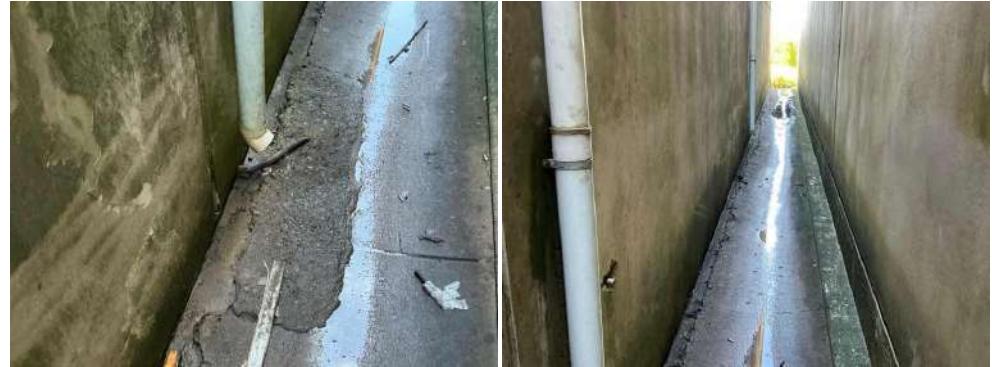
The down pipe/s wall clips is detached or missing.

#8. Down pipe/s not connected to storm water discharge - Down pipes not connected to storm water have the potential to cause differential settlement to the footings, cause rising damp and is also conducive to termite infestation.

#9. Minor down pipe rust visible.

Recommendations: Although minor and easily rectifiable, we recommend a licensed roof plumber be engaged for repairs

Recommendations: A qualified plumber should be engaged for advice and recommendations.

Recommendations: A qualified plumber should be engaged for advice and recommendations - Replacement may be necessary.

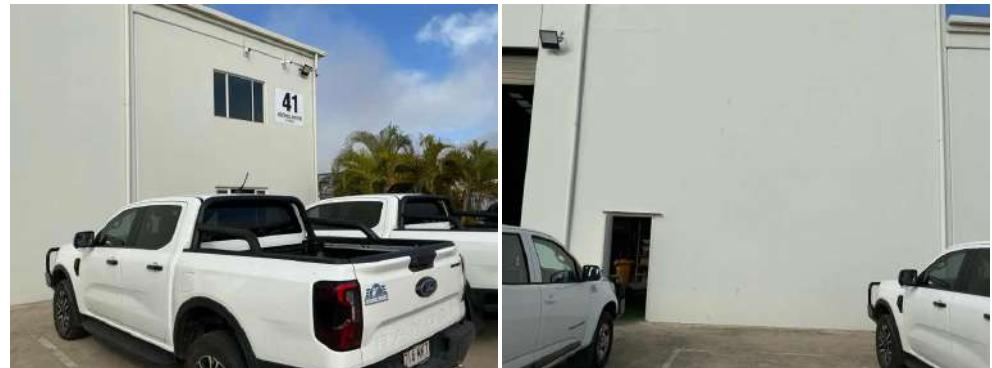
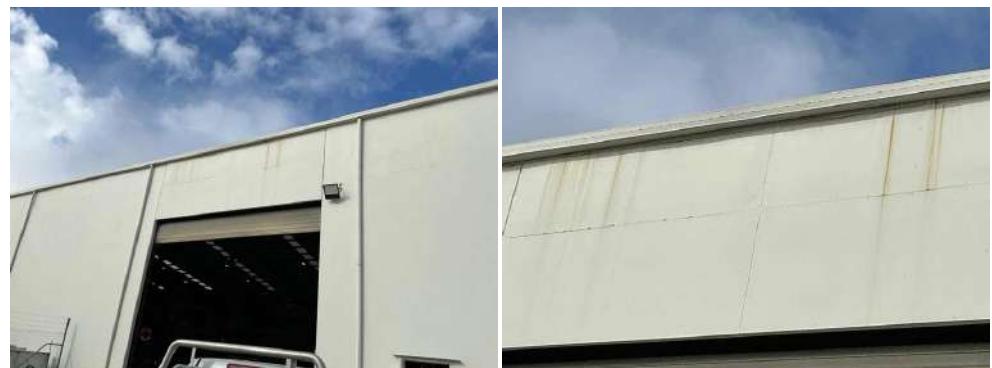
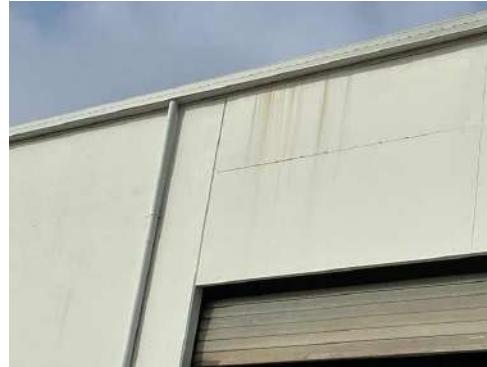
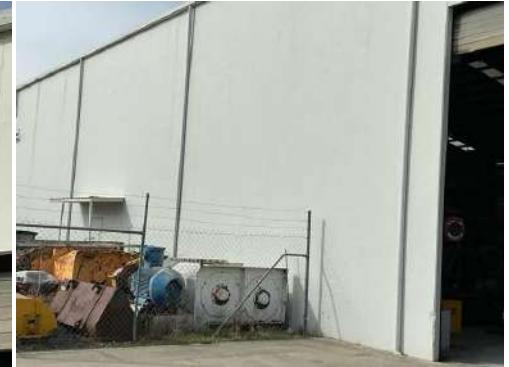
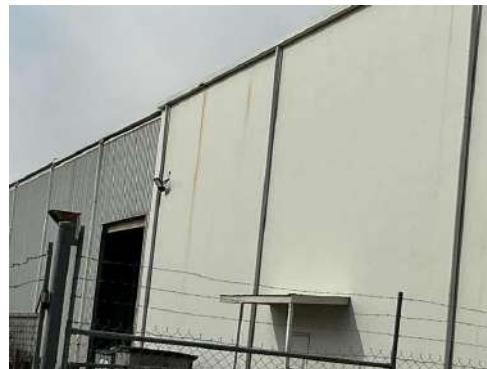
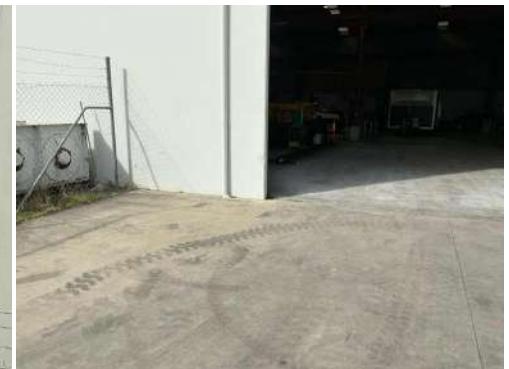
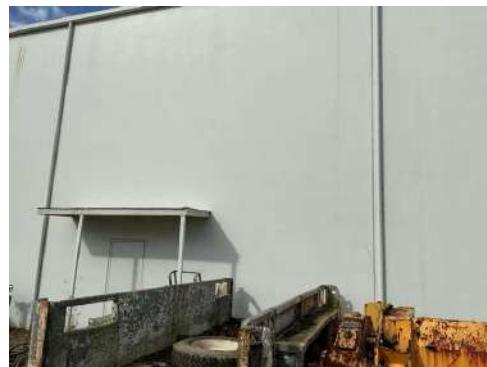
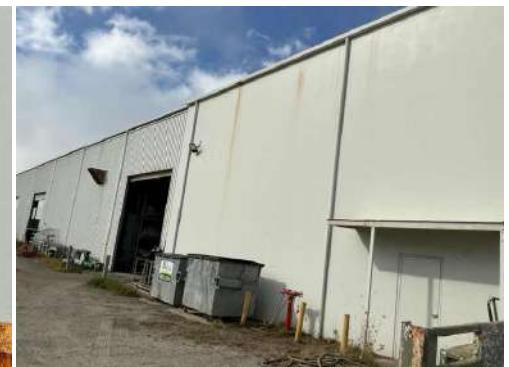
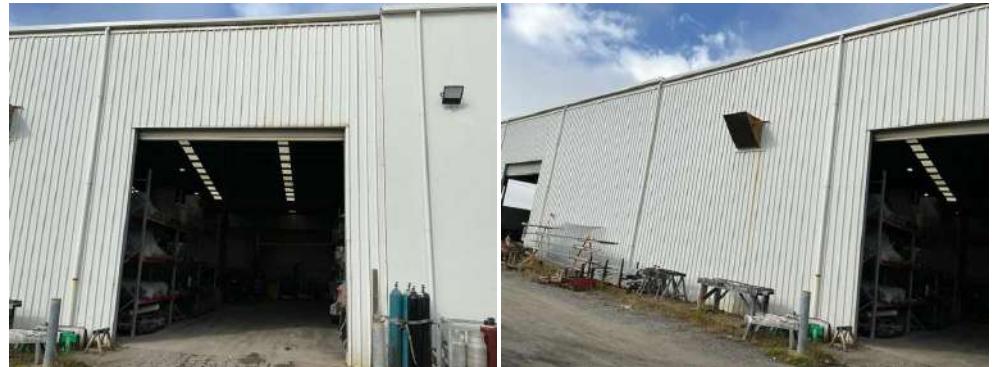
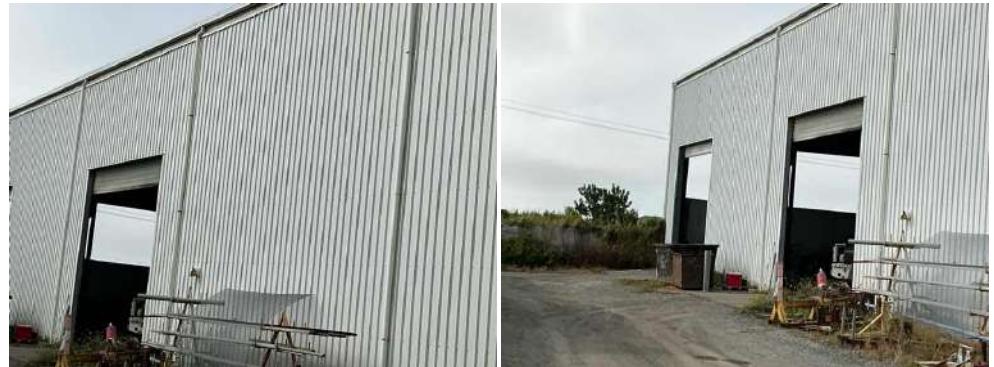
#10. There appears to have been some settlement in the building which has caused some cracking to the walls. These cracks are categorized as 0 to 2. This can also cause some doors to bind or be out of square. In the inspectors opinion these cracks are due to settlement, usually due to ground movement and subsequent movement to building materials can be expected. Any cracks should be monitored and if cracks increase in size, further investigation should be carried out by a structural engineer.

#11. Rising damp detected. A qualified damp proof specialist should be engaged for advice and recommendations. Accurate diagnosis of the cause and extent of the damp problem is very important. Note: It is imperative that specialist advice be sought to obtain accurate diagnosis of the cause and extent of the damp problem and it is advised that you have assessed prior to purchasing the dwelling as can be quite costly if a damp proof course has to be reinstated.

#12. Brick face deterioration - Age/damp related. Recommendations: Engage a brick layer for advice and recommendations.

#13. Penetration openings observed. I recommend sealing these off so as to avoid vermin and other pest infestation.

#14. Rust to metal cladding recommend a qualified professional to repair

#15. Mould is not part of the inspection it has been noted recommend a full scope of work

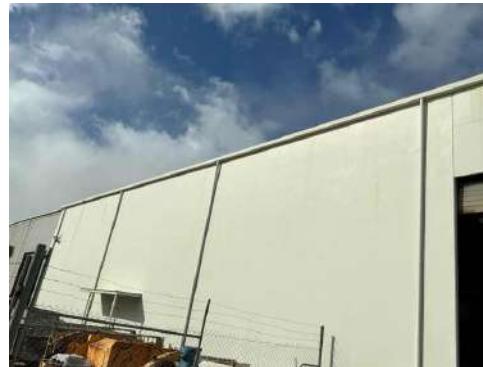
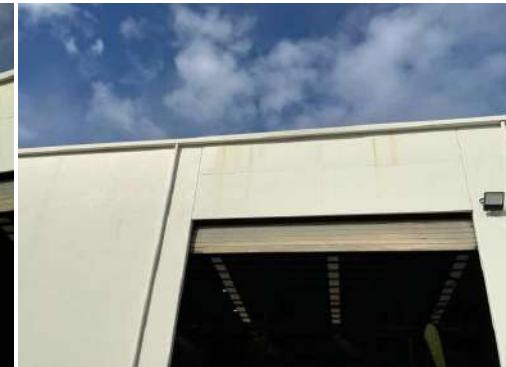
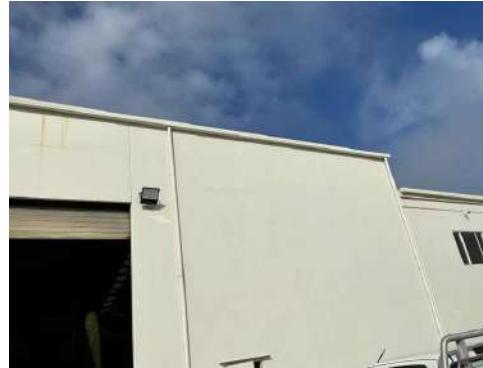
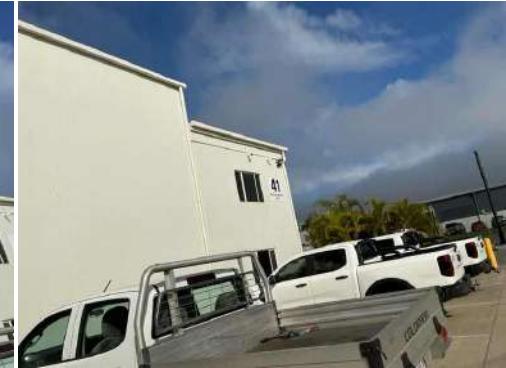
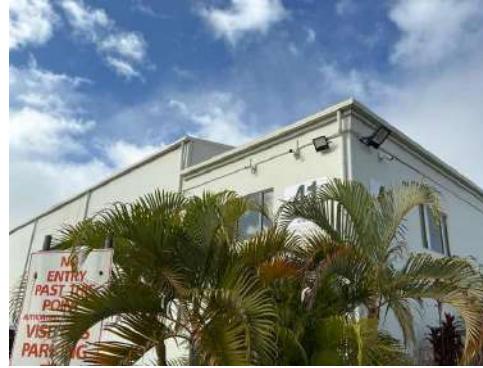
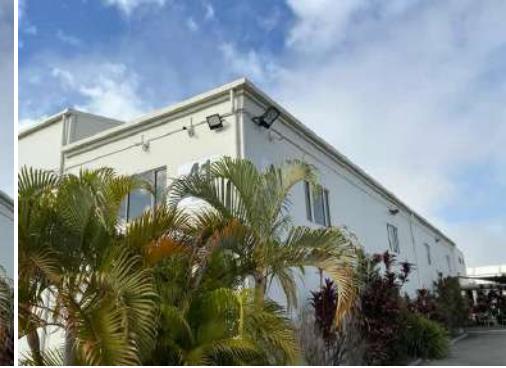
#17. Bowing/uneven.

Recommendations: A qualified carpenter should be engaged for advice and recommendations.

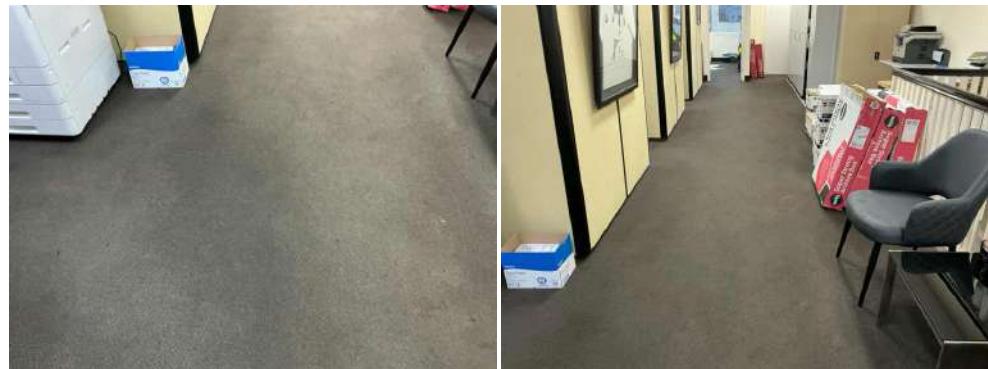
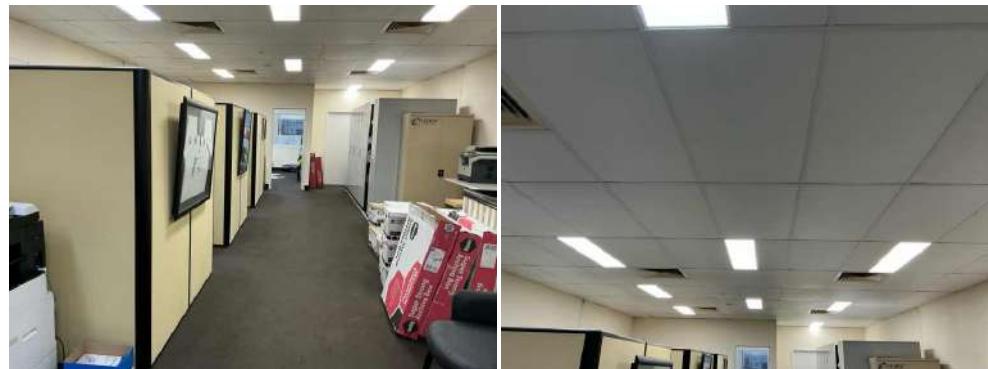
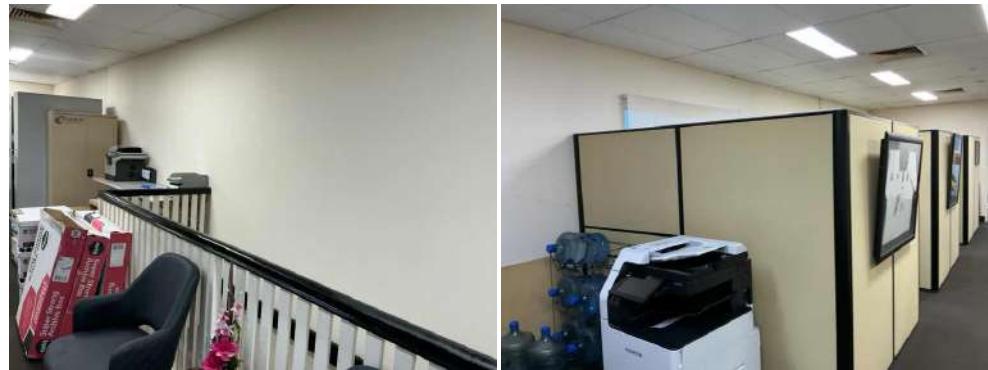
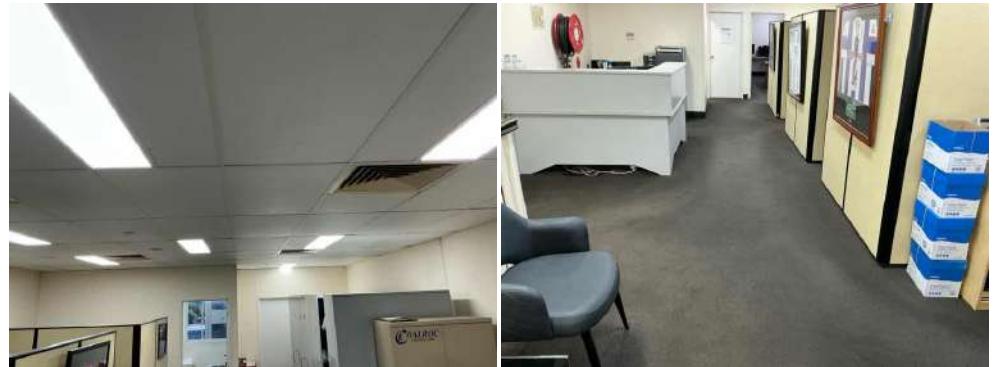
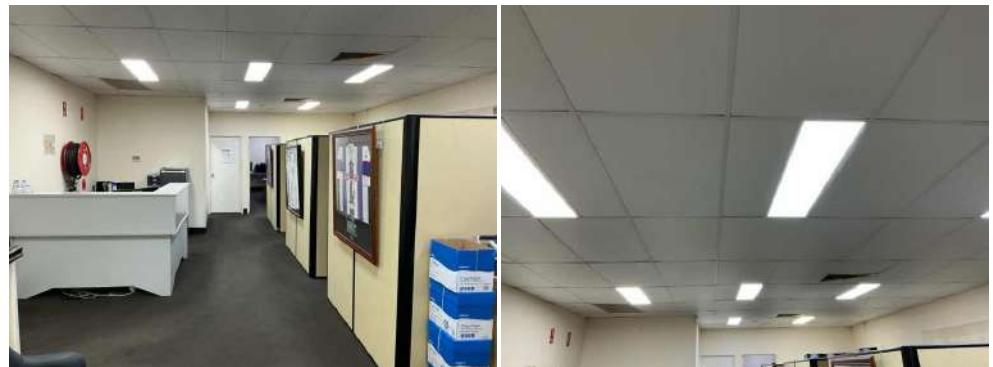
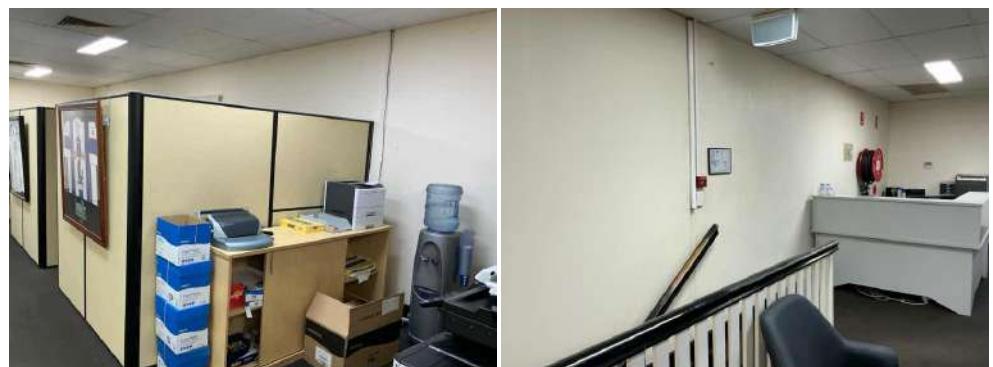
From the visible and accessible areas, the study/office appears to be in a serviceable condition for the age of the property with no notable structural defects sighted.

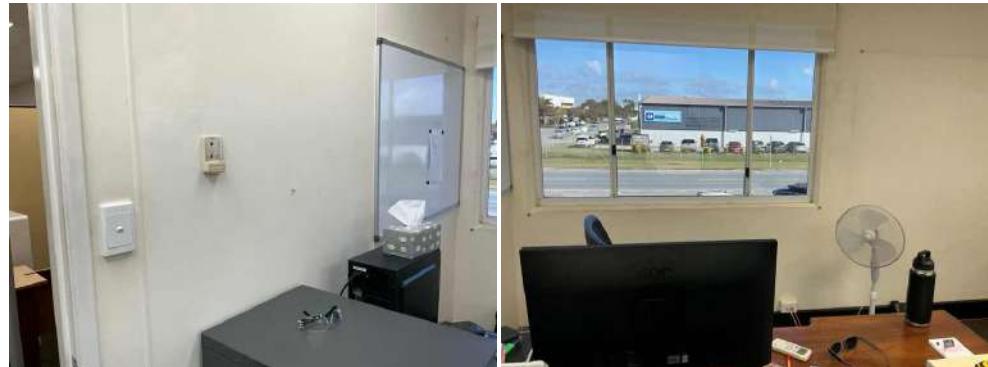
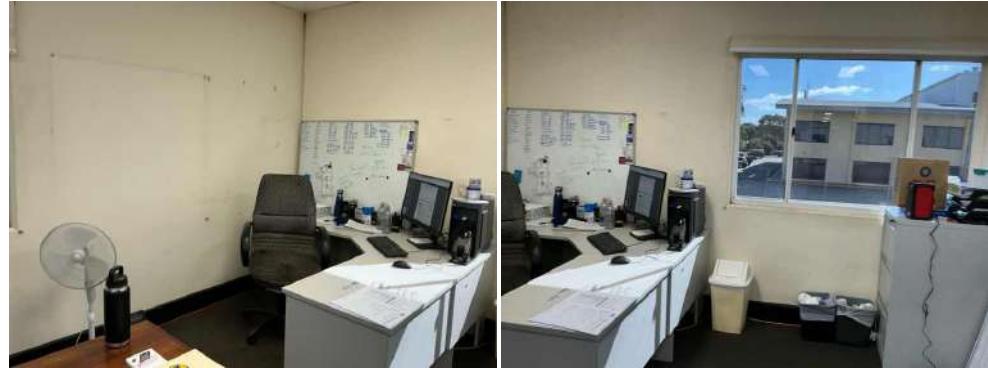
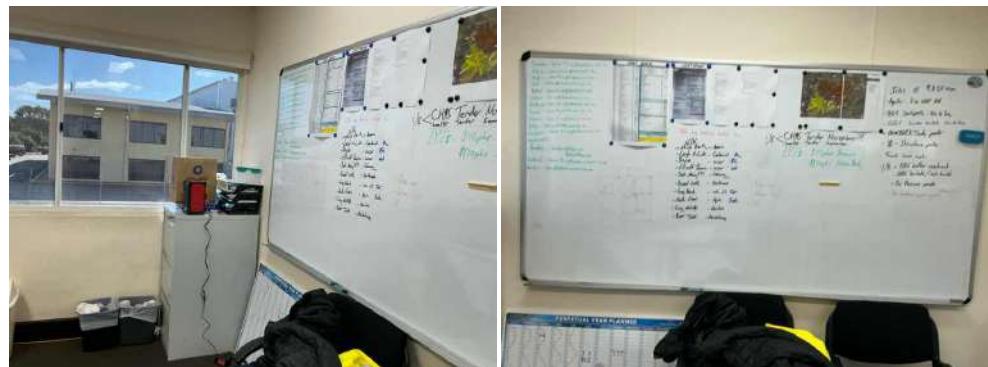
## Study/Office(3)

From the visible and accessible areas, the study/office appears to be in a serviceable condition for the age of the property with no notable structural defects sighted.

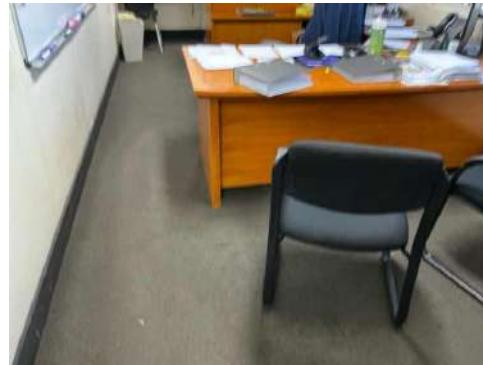
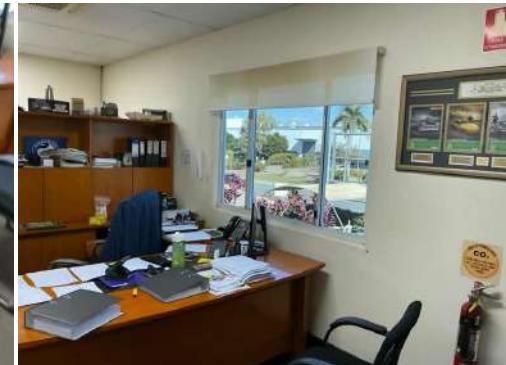
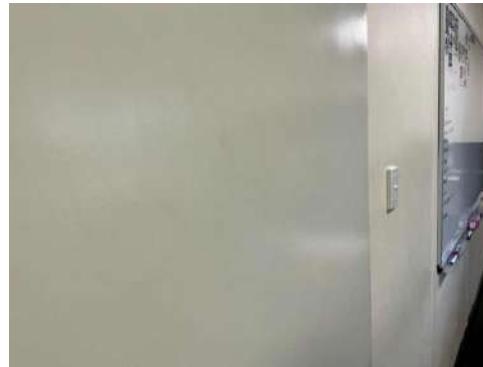
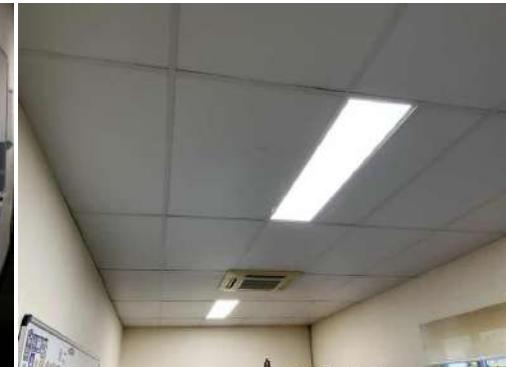
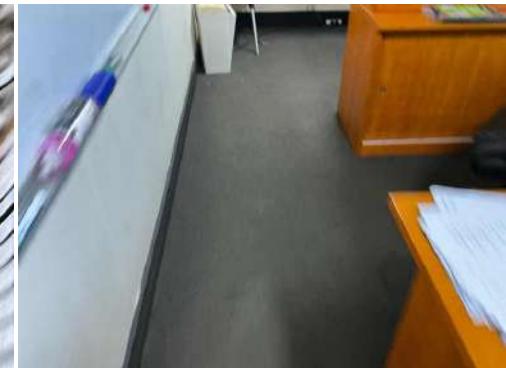
#18. General carpet deterioration - Recommendations: Replacement may be required A qualified carpet layer should be engaged.

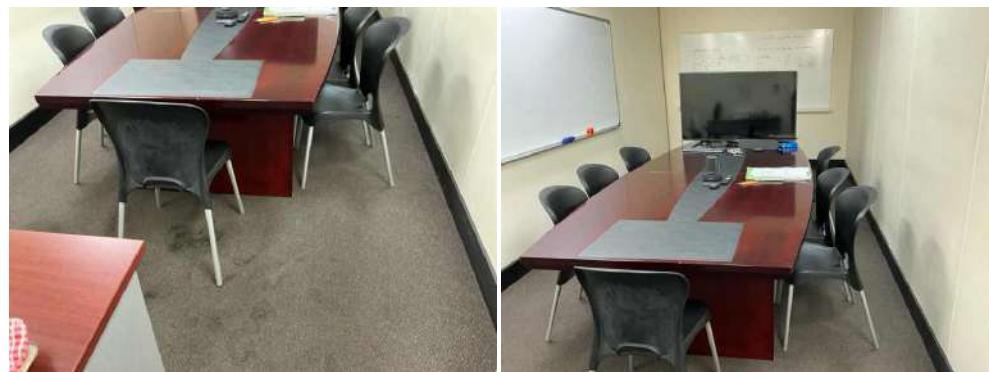
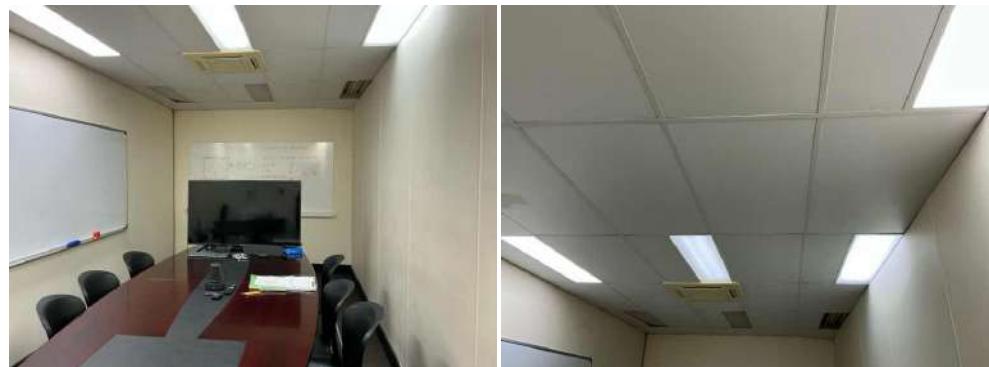
## Study/Office(5).

From the visible and accessible areas, the study/office appears to be in a serviceable condition for the age of the property with no notable structural defects sighted.

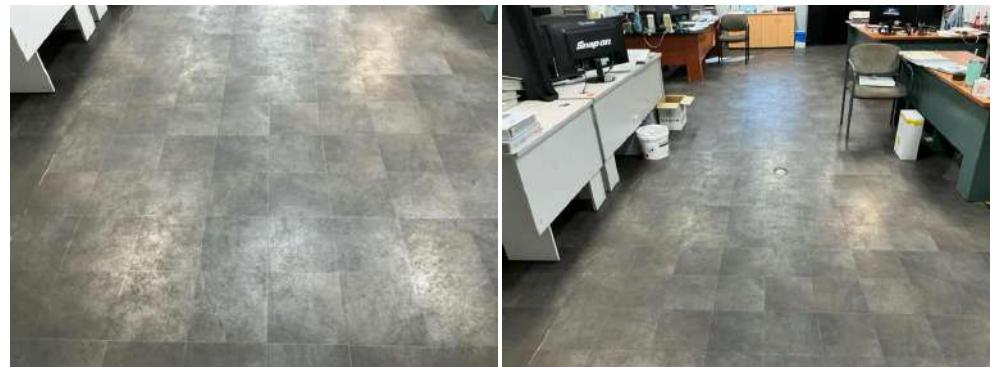
## Study/Office

On inspection, defects were present that will require further assessing and recommendations by a qualified trades persons, please read below for details.

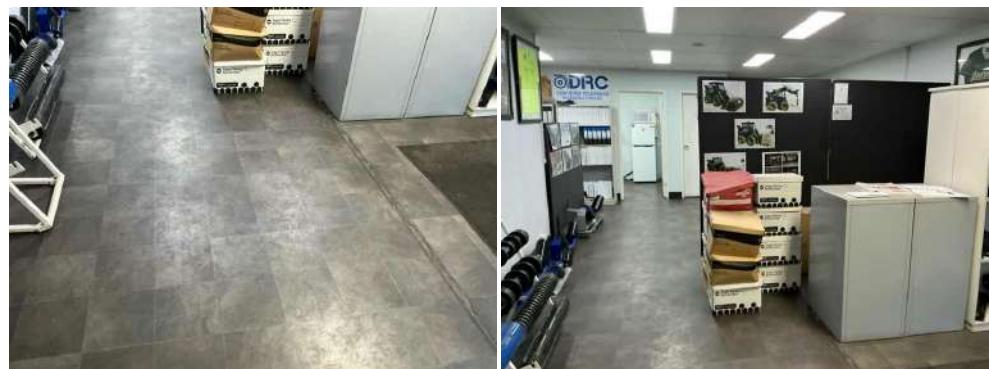
On inspection, defects were present that will require further assessing and recommendations by a qualified trades persons, please read below for details.

#20. Lino damaged recommend a qualified tradesman to repair/ replace

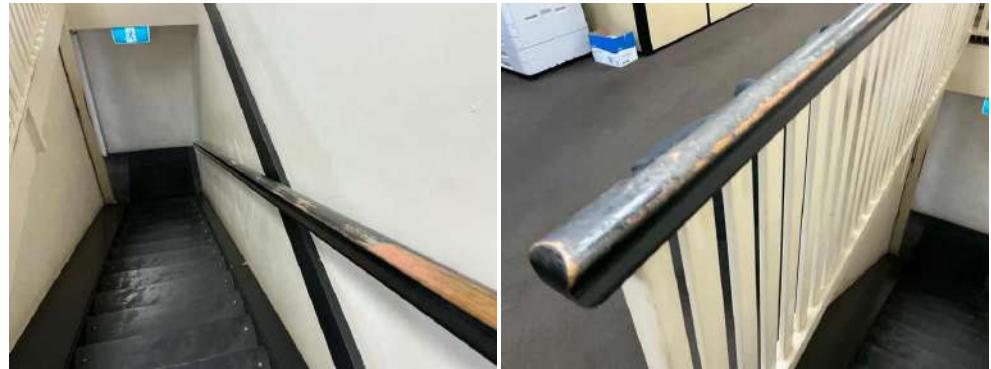
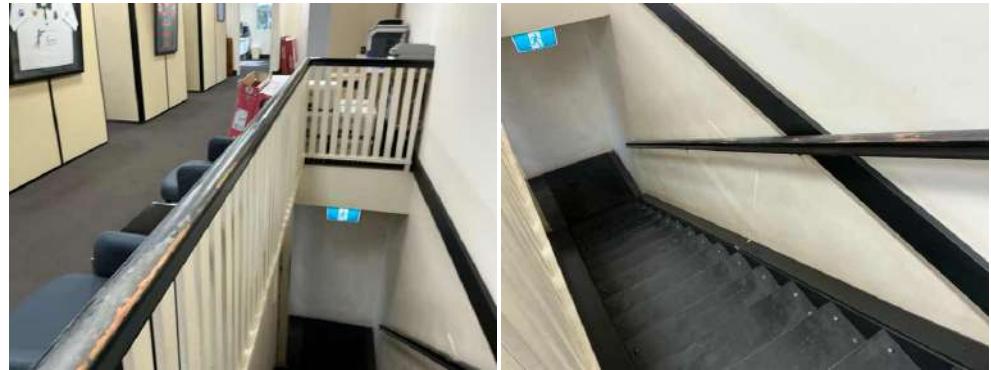
#21. Incomplete Patch/Paint repairs noted. Call a licensed painter for repairs

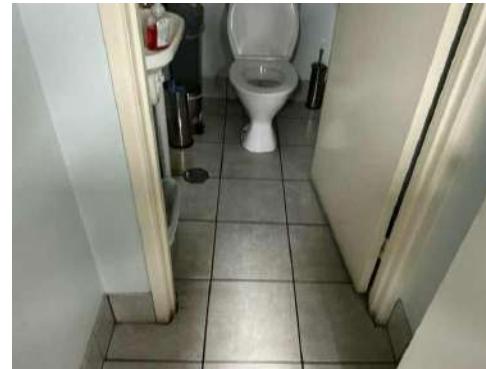
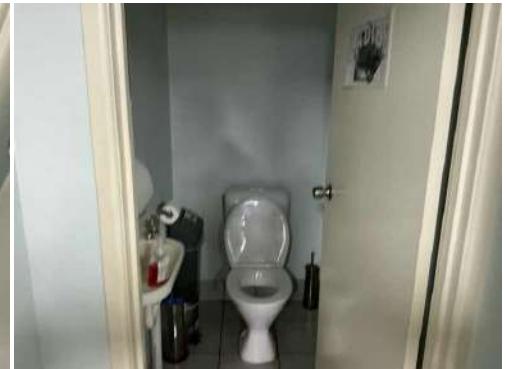
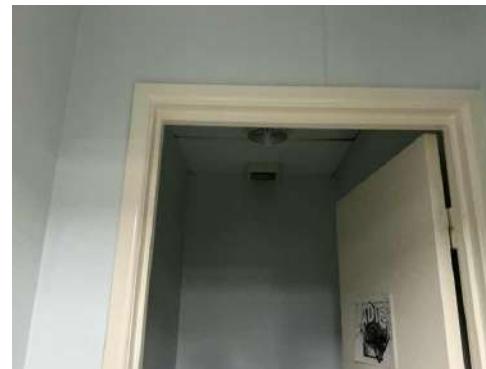
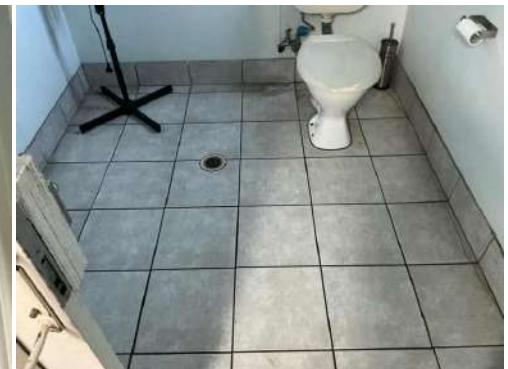
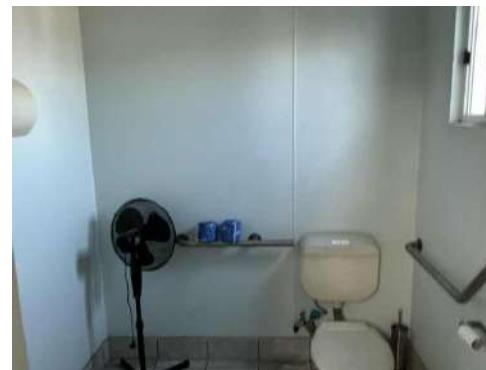
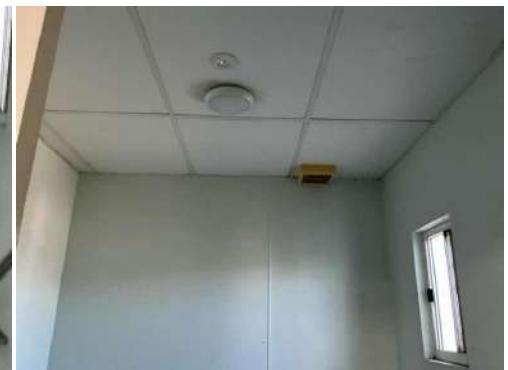
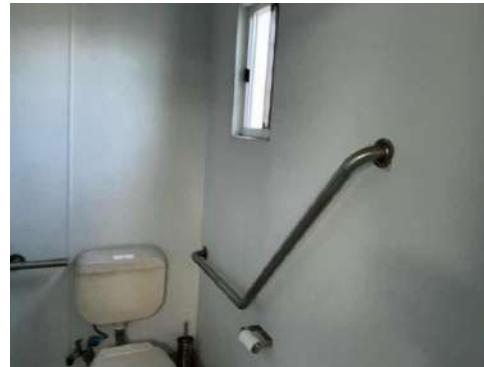
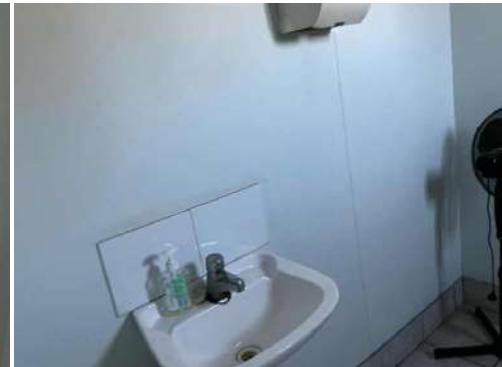
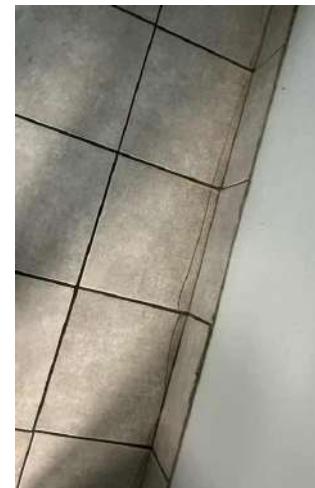
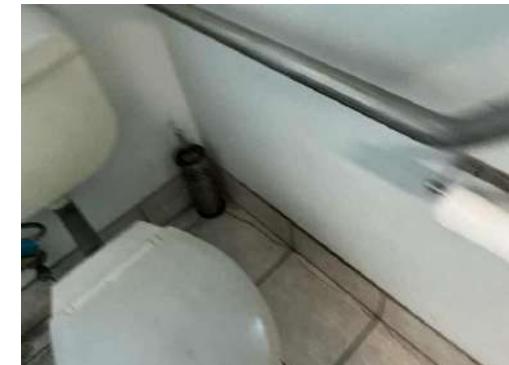
#22. Cracked tile/s noted. This can cause extensive floor and floor frame damage and is conducive to termite infestation if water is leaking through the cavity. A qualified tiler should be engaged for advice and recommendations.
