# Inspection Report 2025

## Complete Inspections

**John Smith Dr, Paget, Qld, 4740**

### Building Inspection

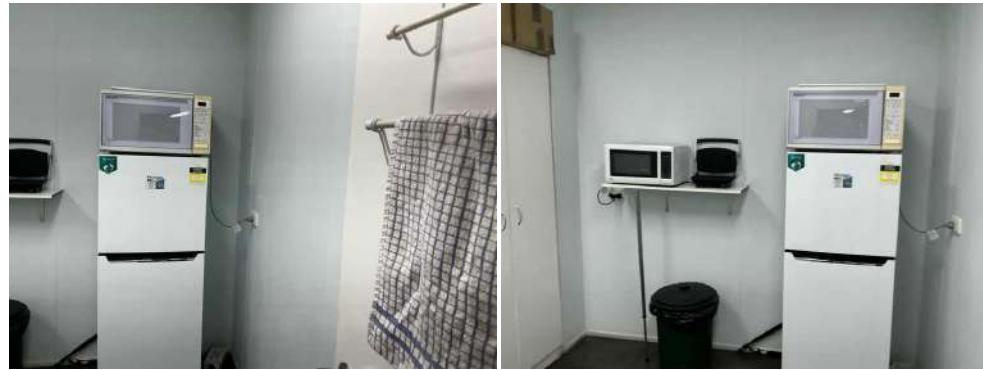
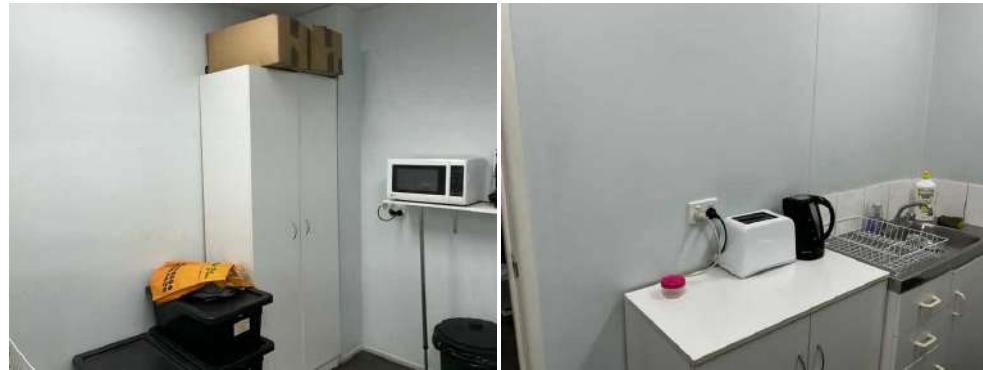
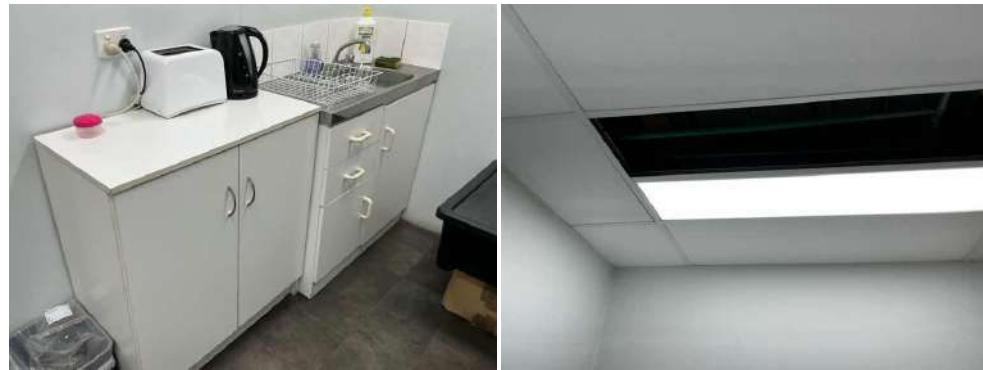
#23. Penetration opening recommend a qualified tradesman to repair

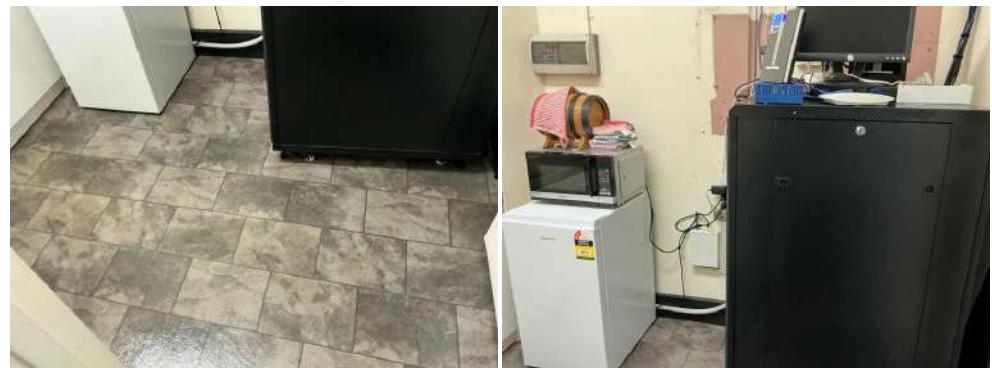
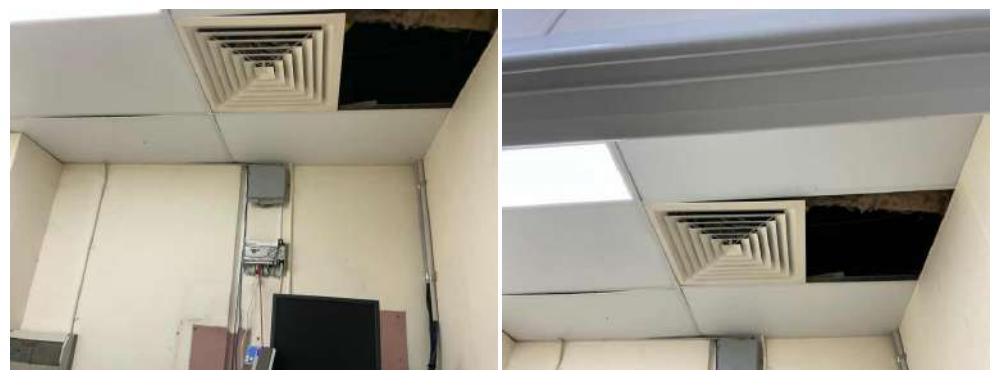
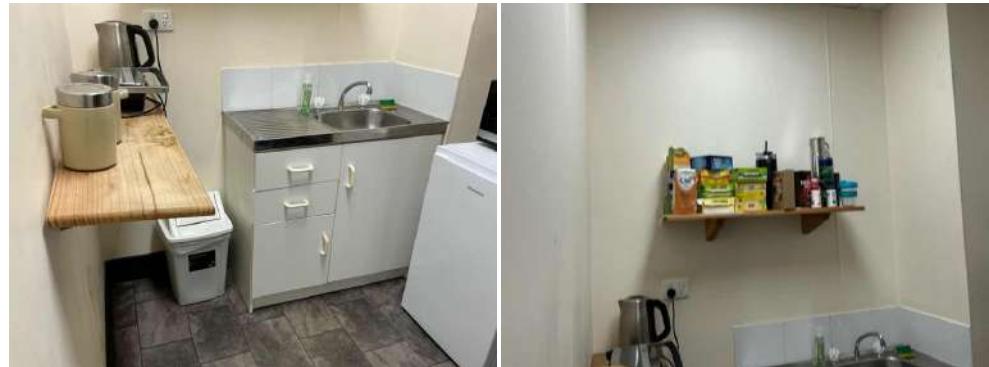
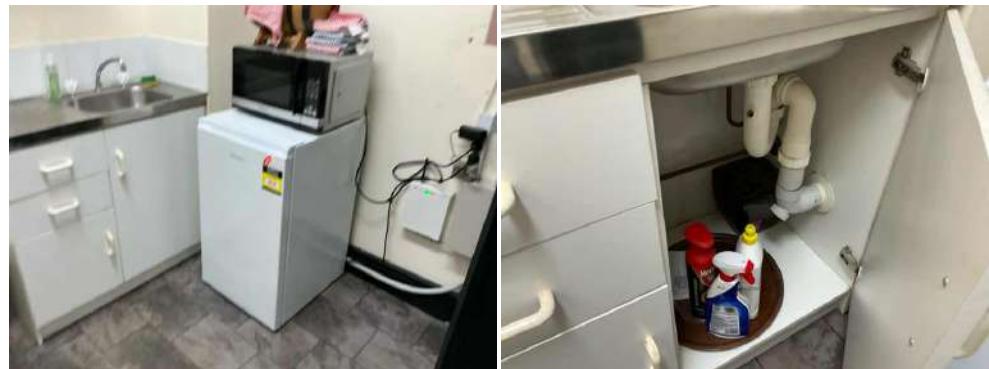
#24. Of the visible areas, the general condition deteriorated however serviceable, repairs should be considered in the foreseeable future
