# Inspection Report Qld 2021 Complete

**Complete Inspections**

**Smith St , Smithville, QLD , 4802**

### Pest And Building Inspection

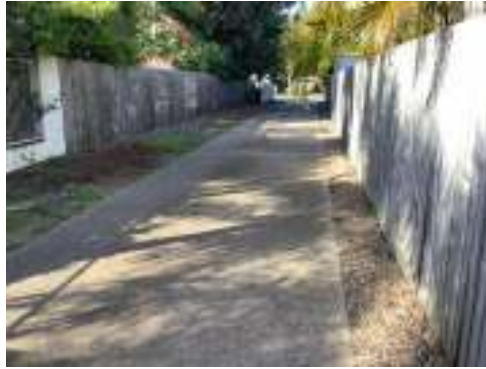
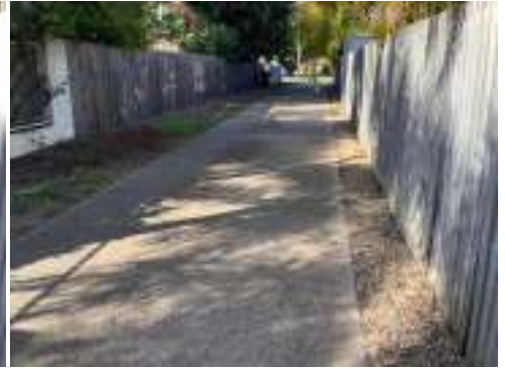
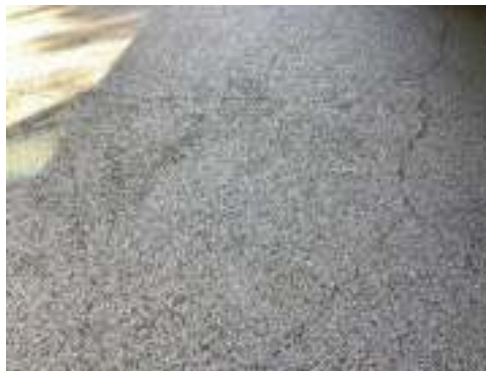
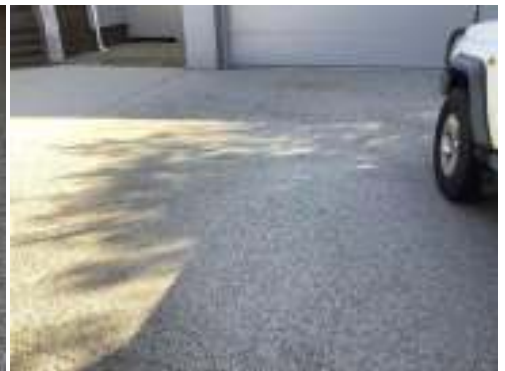
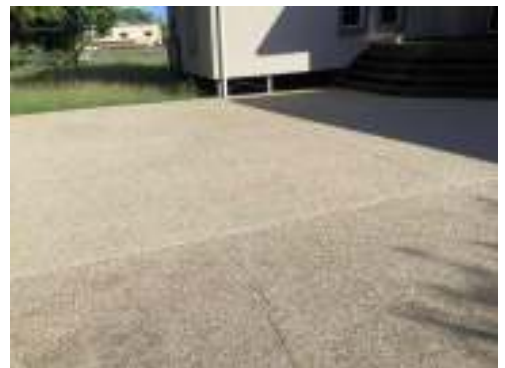
### Driveway Condition

On visual inspection, the general condition of the driveway is serviceable.

Common cracks were observed on the driveway. Whilst these cracks appeared to be typical at the time of inspection, we strongly recommend you monitor these cracks and if worsening occurs contact a concreter for further advice.

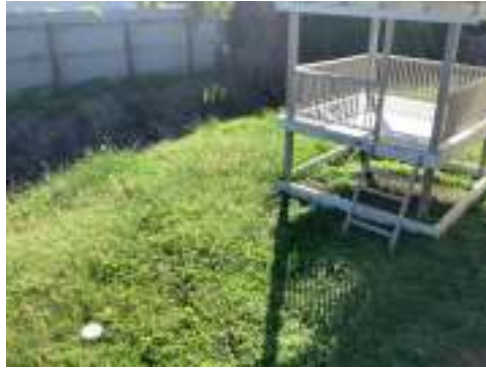
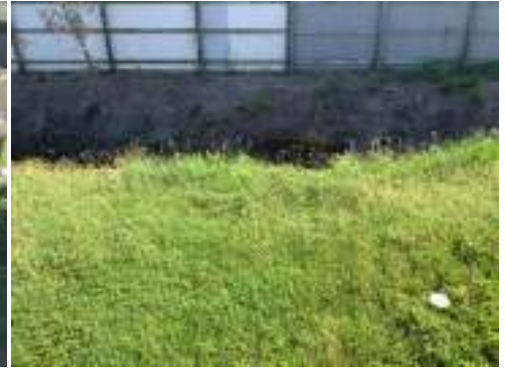
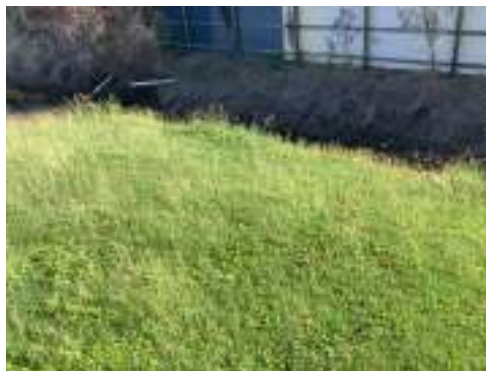
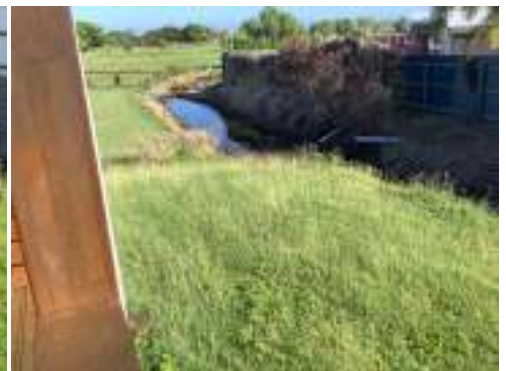
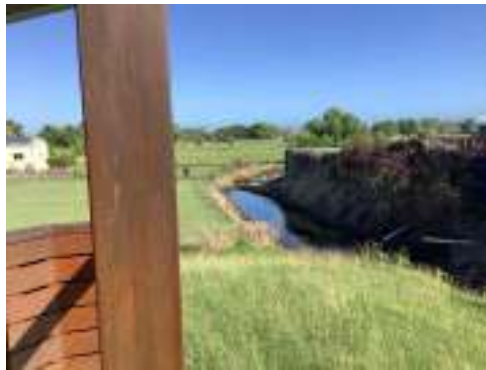
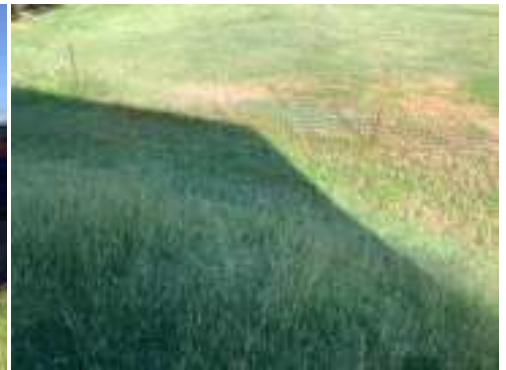
### **Drainage Findings**

The ground levels along the perimeter walls at the rear of the home did not appear to fall away from the property walls sufficiently due to the natural landscape and contour. This will need to be assessed during a period of rainfall and if surface water appears to be entering the sub floor if applicable or ponding against the perimeter walls, engage a plumber or landscaper to assess and rectify as required. All drains should be regularly checked by a plumber and kept clean of debris to allow surface water to be carried away from the dwelling.

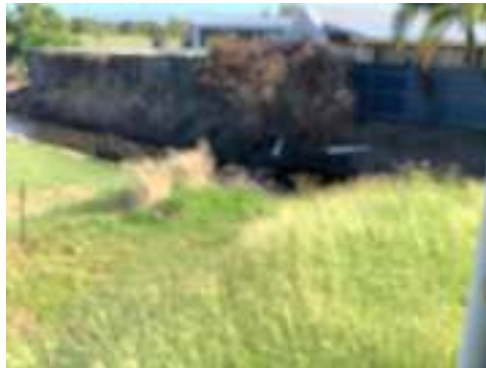
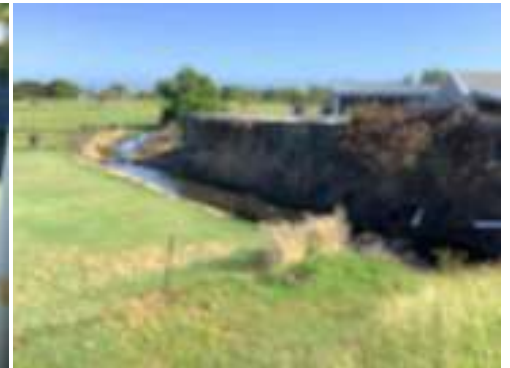
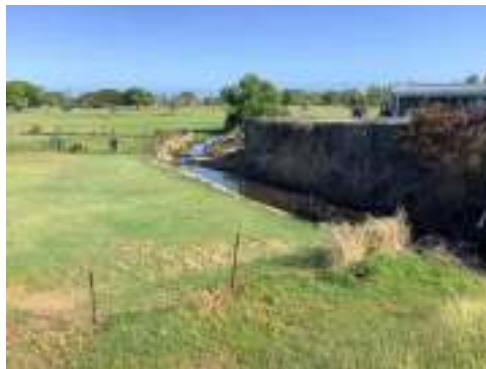
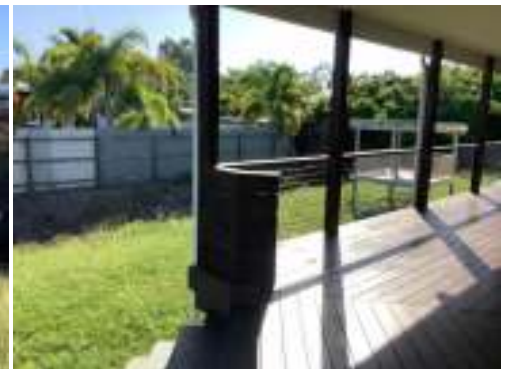
## Drains

| Section | Location | Name | Comment |
|---|---|---|---|
| SITE | Surface Drainage | Drains | There is evidence of drainage issues. Consult with the vendor regarding any plumbing/drainage issues prior to a decision to purchase as this will require the service of a licenced plumber for further advice and recommendations. |

There is evidence of drainage issues. Consult with the vendor regarding any plumbing/drainage issues prior to a decision to purchase as this will require the service of a licenced plumber for further advice and recommendations.

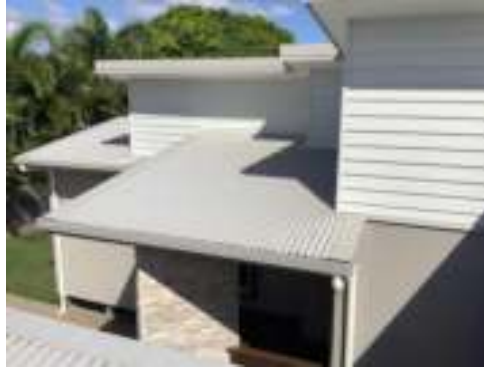
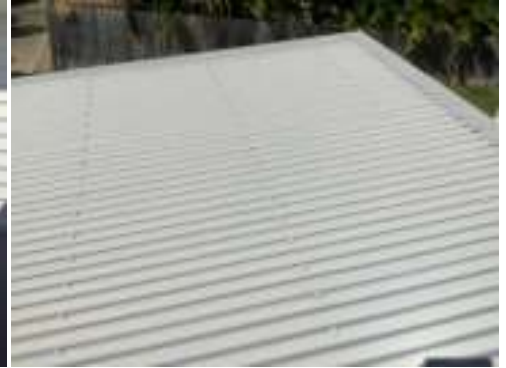
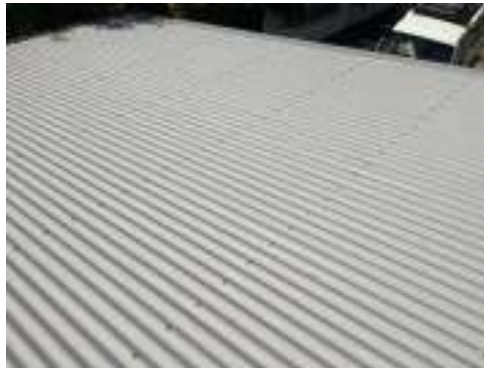
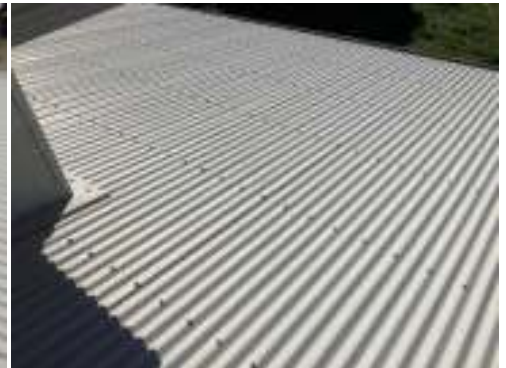
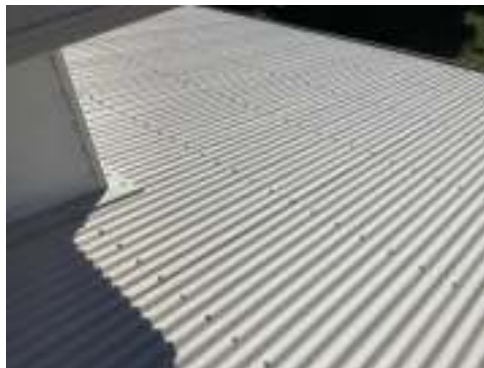
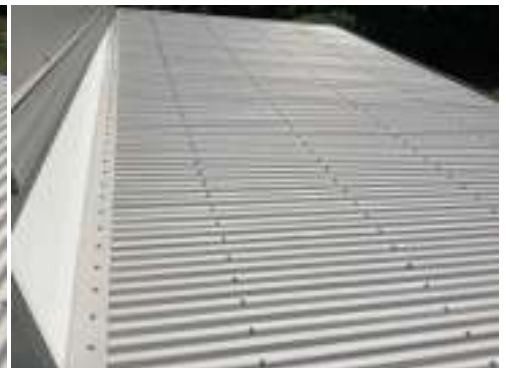
### Overall Condition

Of the visible areas, the general condition of the roof is in serviceable condition for the age.

Note: In the absence of rainfall there is no guarantee that the roof won't leak.

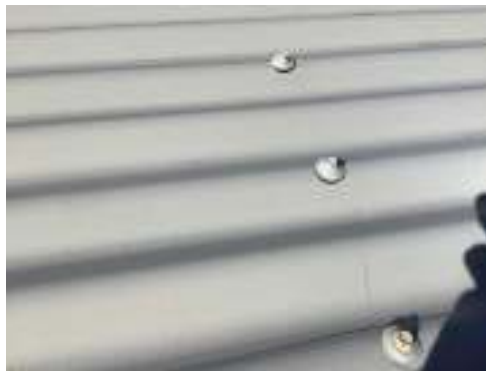
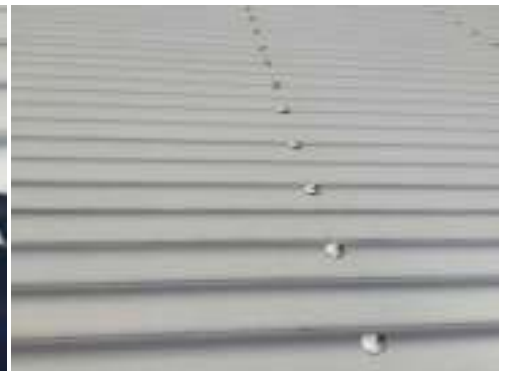
### Roof Clad Condition

Corrosion noted to the screw fixings of the metal roof. Have these checked and replaced by qualified roofing contractor.

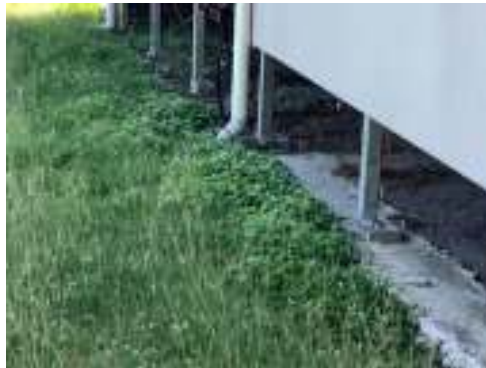
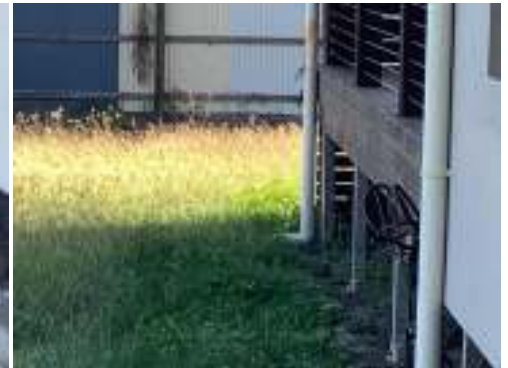
### **Downpipe Findings**

The downpipe base is damaged/ cracked. This has the potential to cause leaking. Recommendations: A qualified plumber should be engaged for repairs.

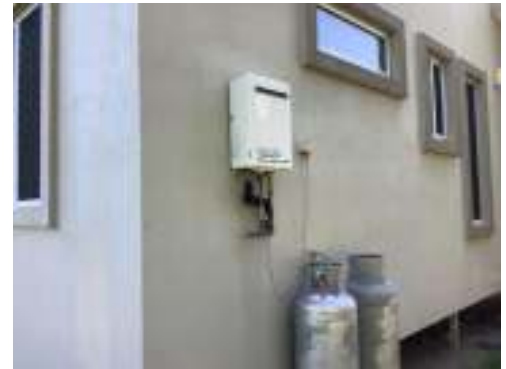
### System Make

The make of the hot water unit is rinnai.

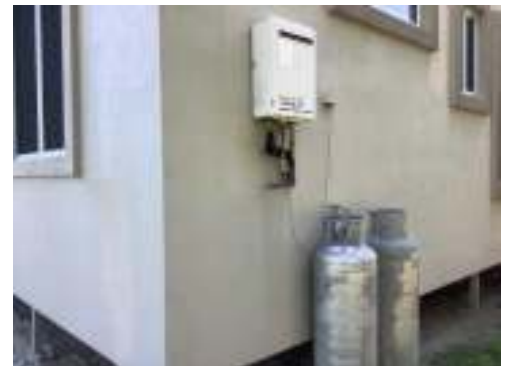
### Plumbing Pipes

On visual inspection the external plumbing pipes appear serviceable, but should be checked by a qualified plumber.

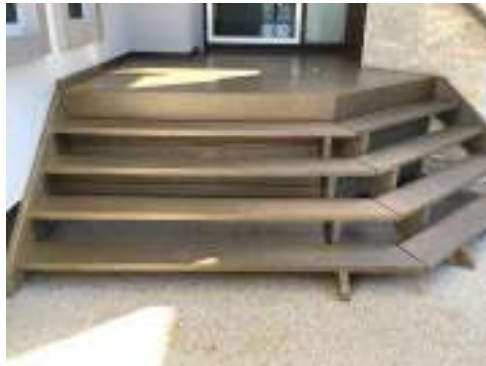
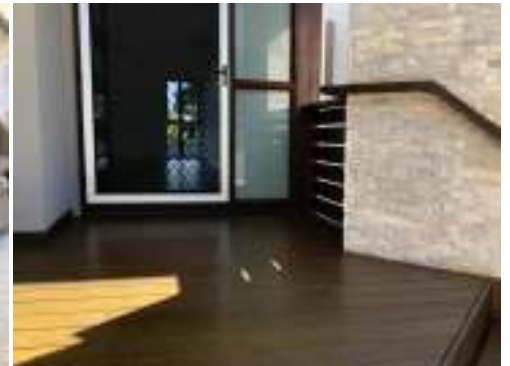
### Entry Porch Area

As above

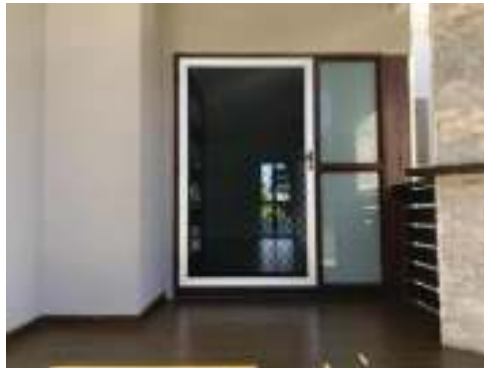
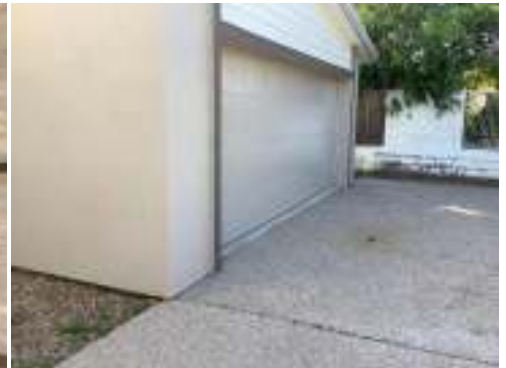
### **Door Findings**

On Visual Inspection the external condition of the doors is serviceable.

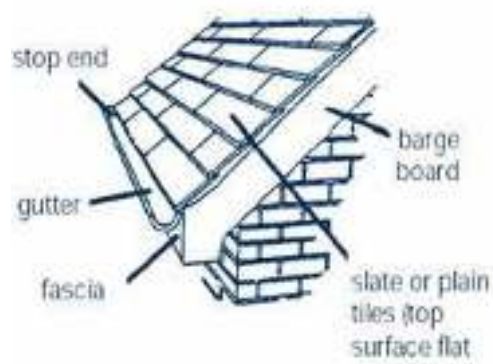
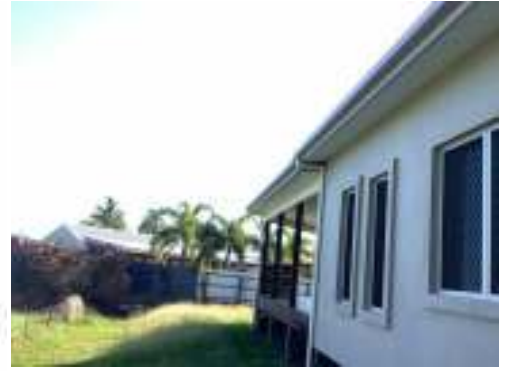
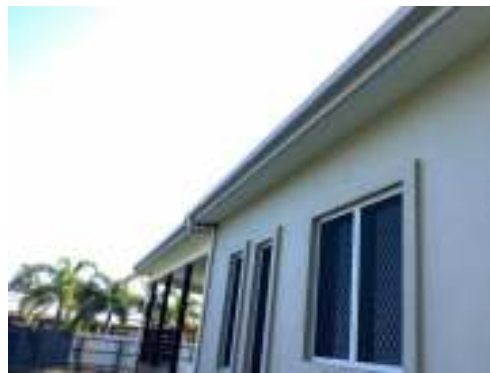
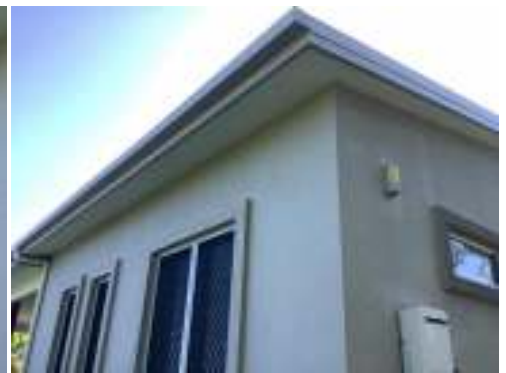
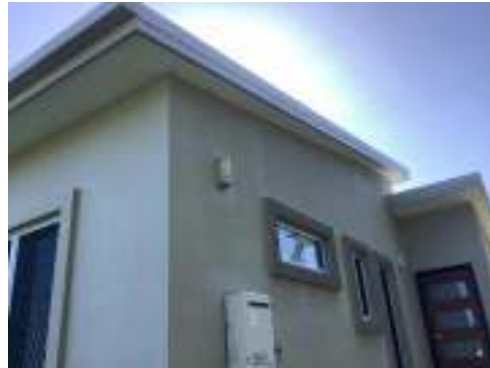
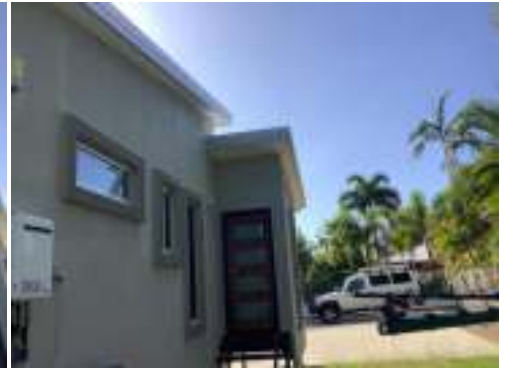
## Fascia and Barge Boards

On visual inspection, the general condition of the fascia/barge boards is serviceable.

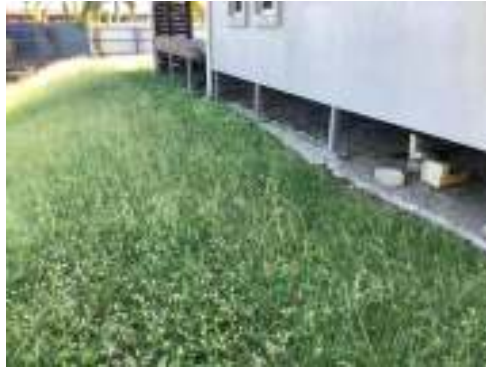
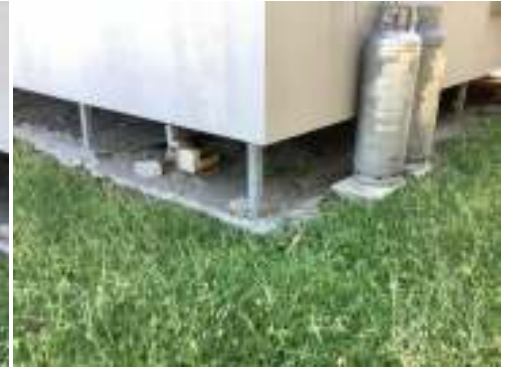
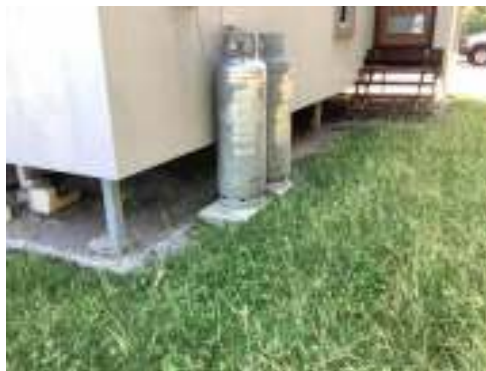
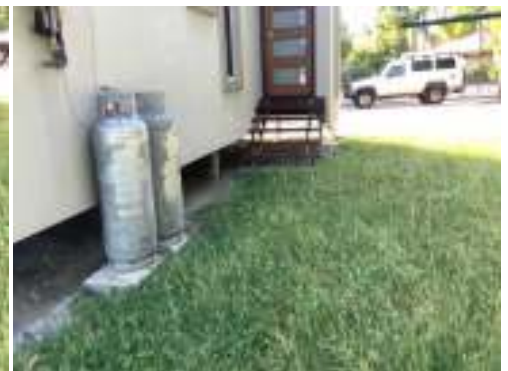
### **Rising Damp Findings**

Of the visible and accessible areas, there was no visible evidence of excessive rising damp on the external walls at time of inspection.

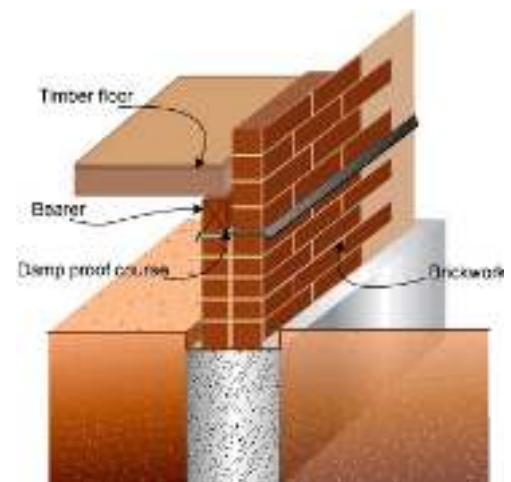
### **Damp Proof Course**

A damp proof course (DPC) was noted.

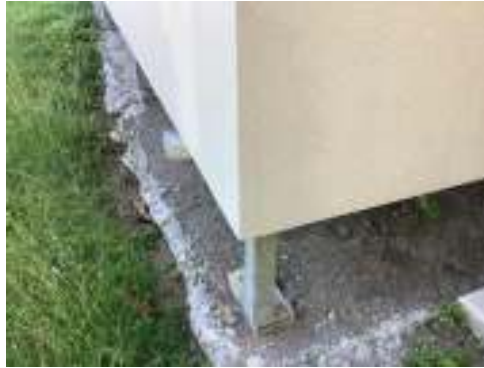
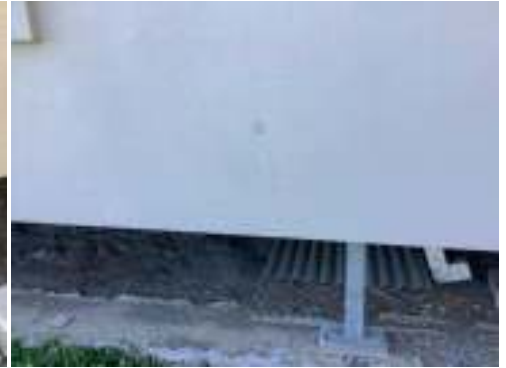
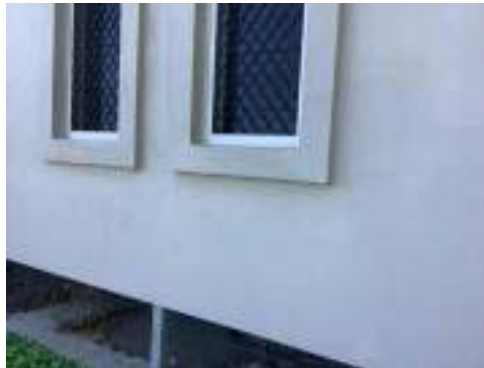
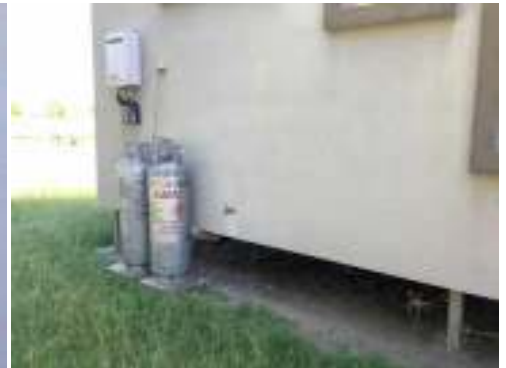
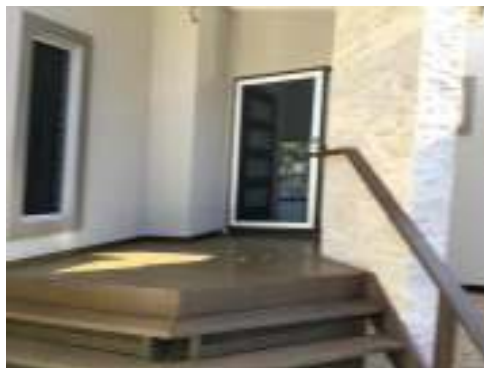
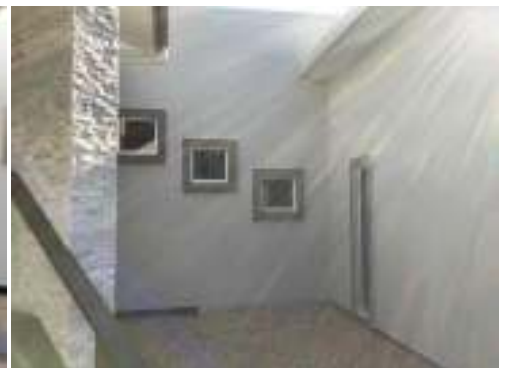
There appears to have been some settlement in the building which has caused some cracking to the walls. These cracks are categorized as 0 to 2. This can also cause some doors to bind or be out of square. In the inspectors opinion these cracks are due to settlement, usually due to ground movement and subsequent movement to building materials can be expected. Any cracks should be monitored and if cracks increase in size, further investigation should be carried out by a structural engineer.

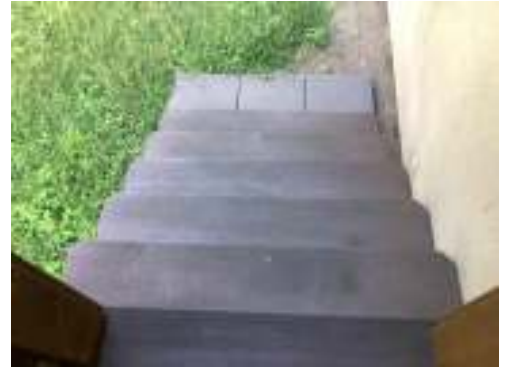
On inspection, defects were noted that may require further assessment and recommendations by licensed tradesman.

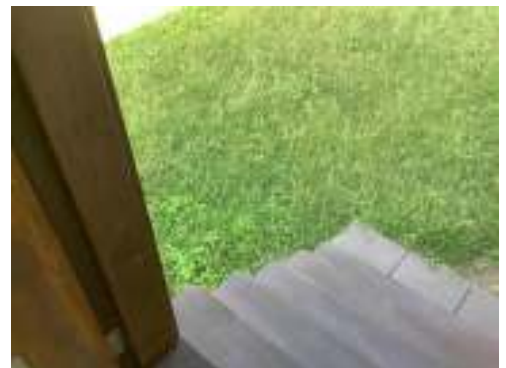
There are no rails on the stairs. This presents a fall risk. Have repaired immediately.

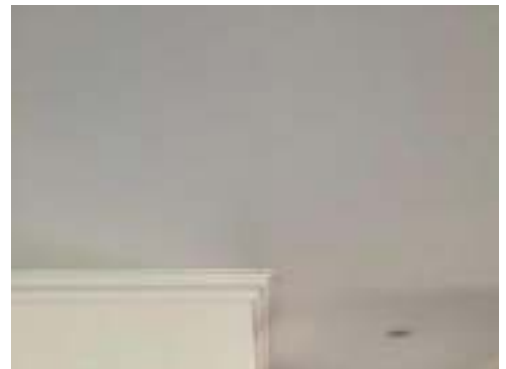
Settlement Cracks Noted. These are typical and generally patch and paint will suffice, however monitoring these cracks is advised for 12 months and if they become worse, further investigation by a suitably qualified professional is advised.

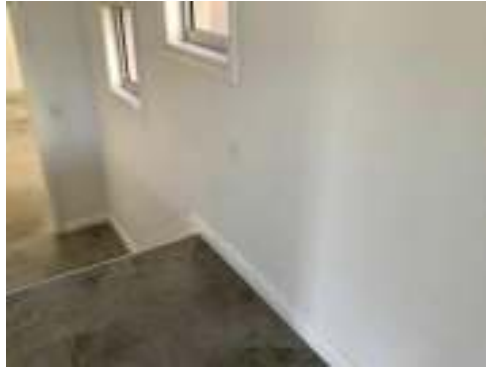
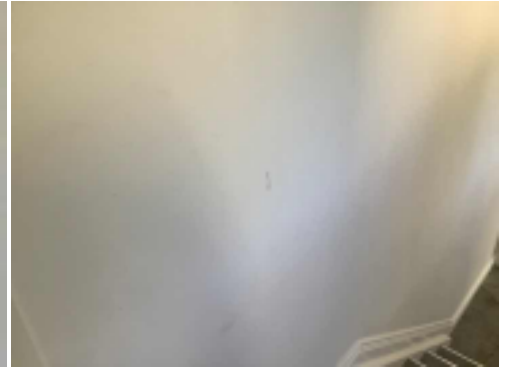
Incomplete Patch/Paint repairs noted. I recommend you contact a qualified painter for repairs.

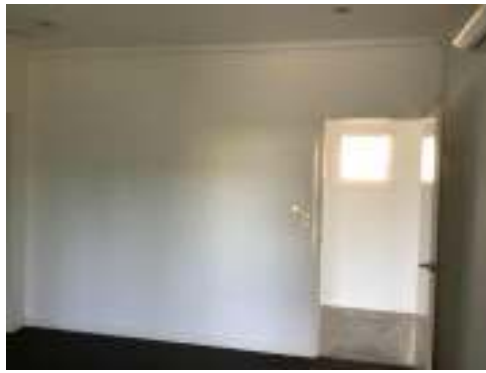
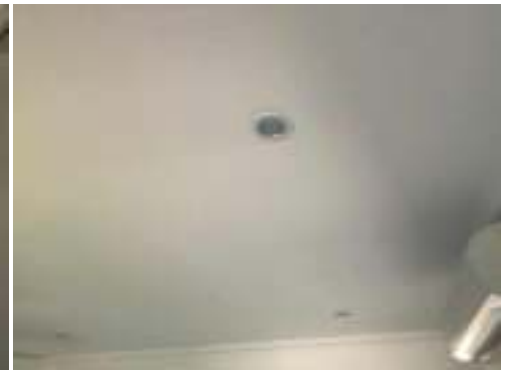
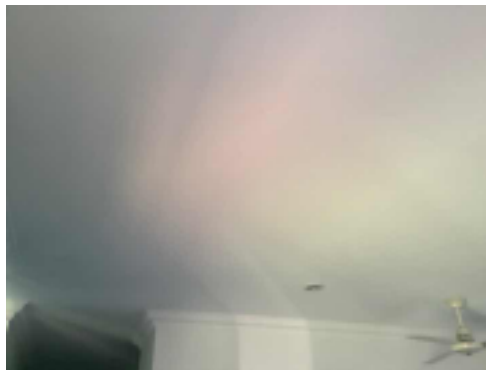
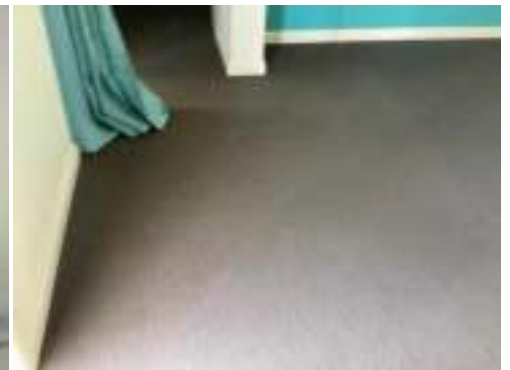
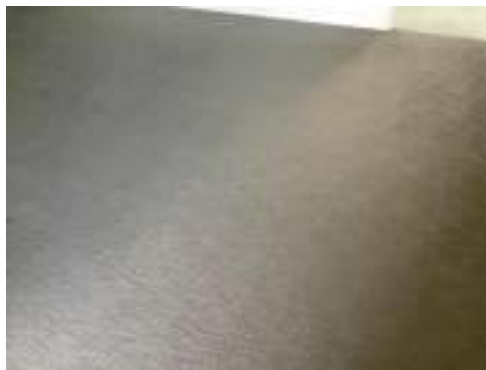
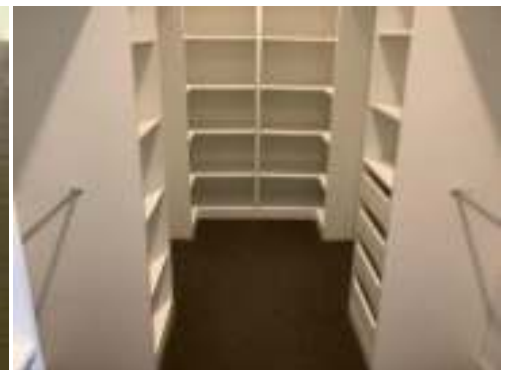
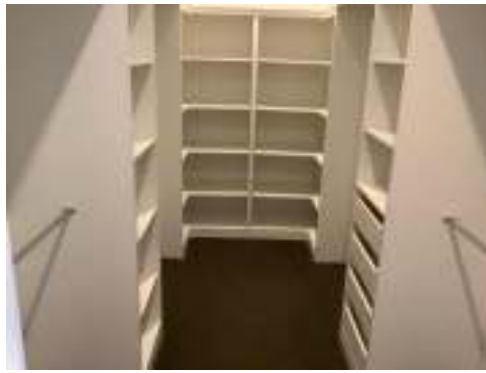
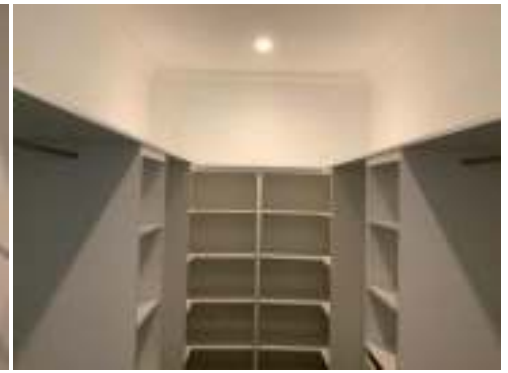
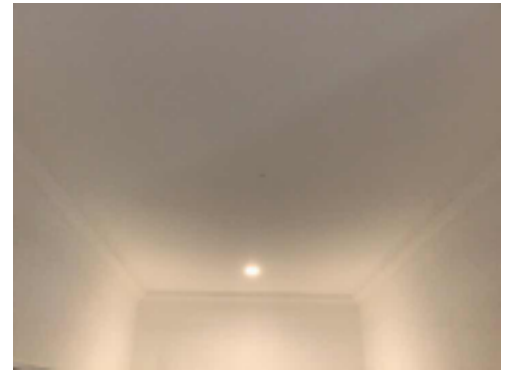
From the visible and accessible areas, this bedroom appears to be in a serviceable condition for the age of the property with no notable structural defects sighted.

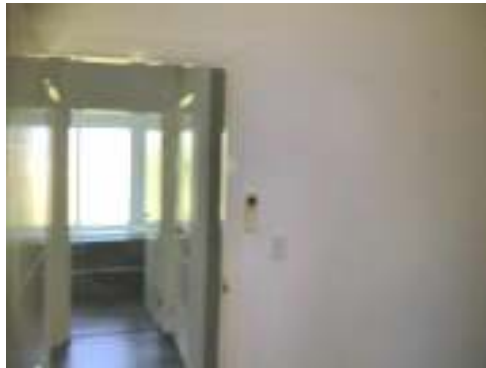
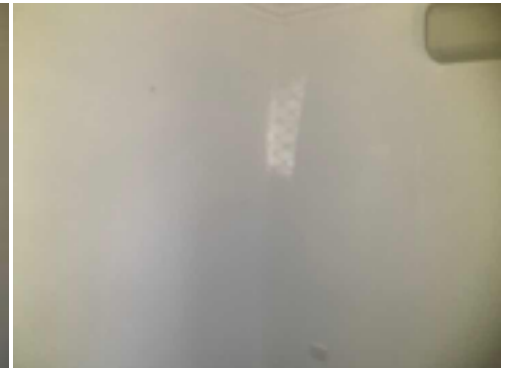
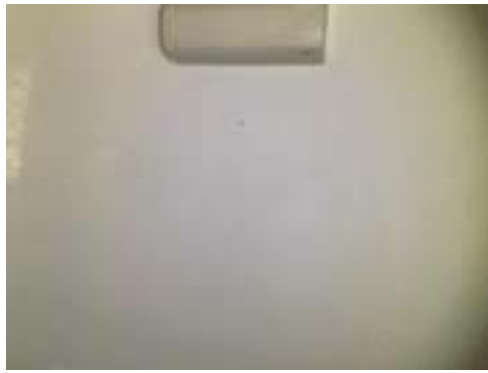
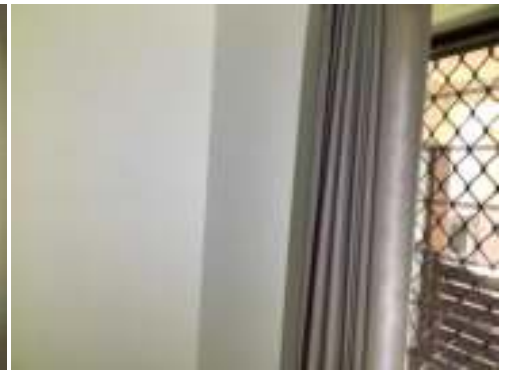
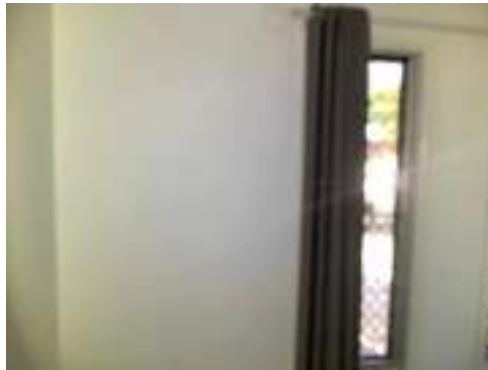
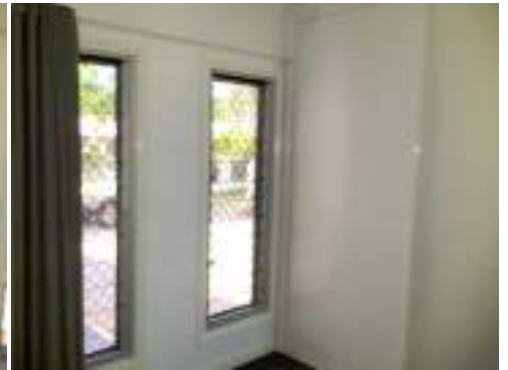
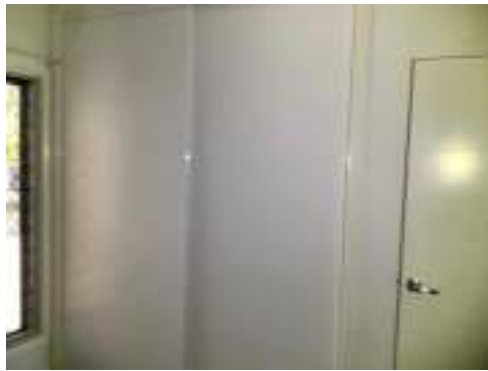
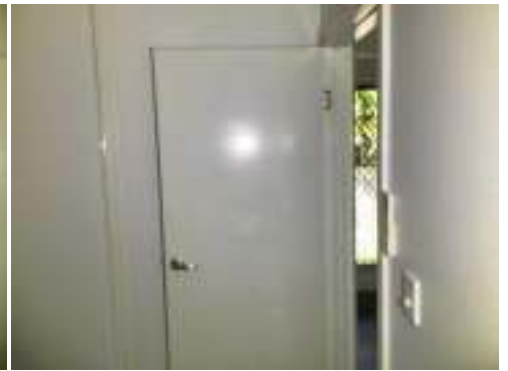
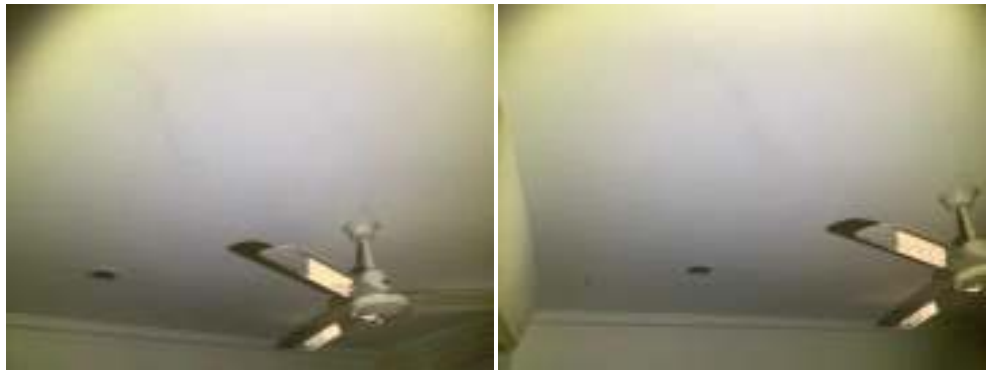
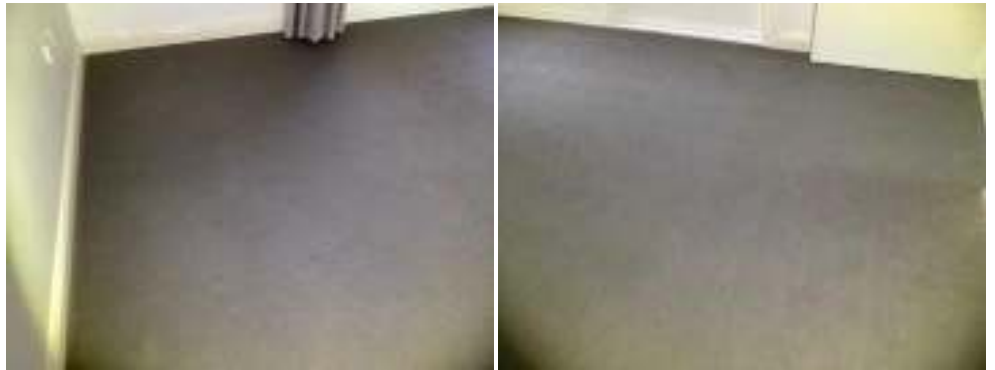
## **Bedroom 2**

From the visible and accessible areas, this bedroom appears to be in a serviceable condition for the age of the property with no notable structural defects sighted.

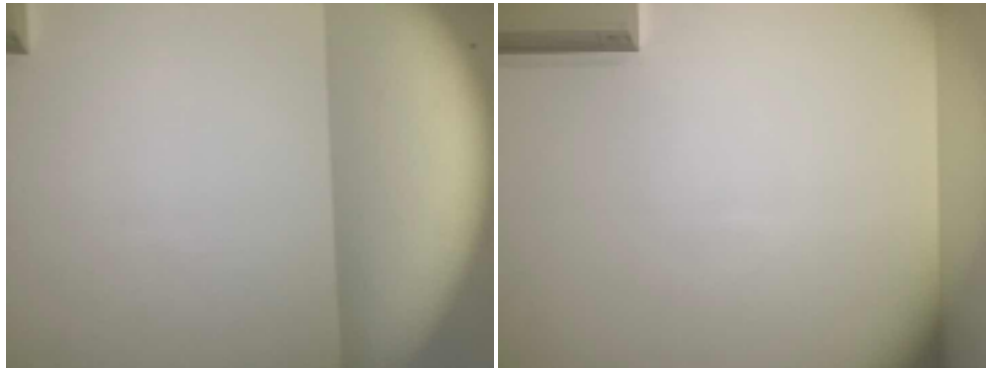
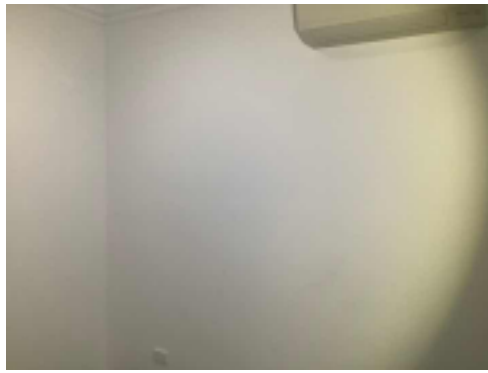
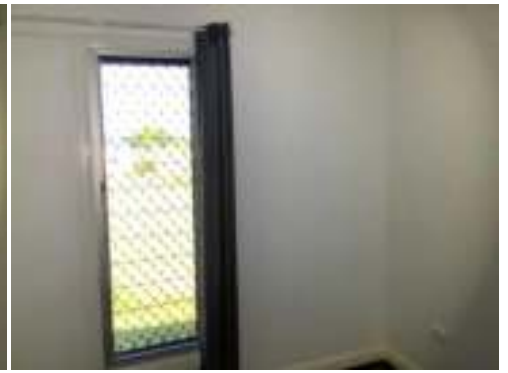
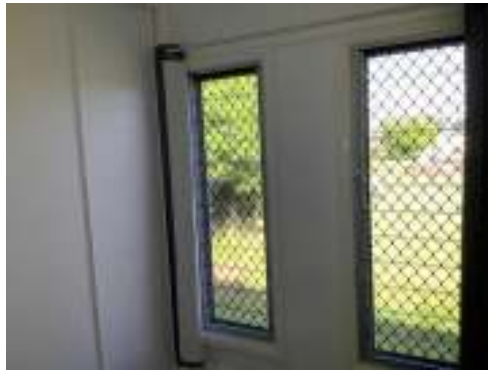
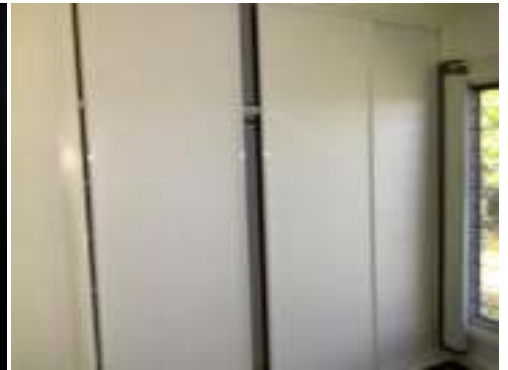
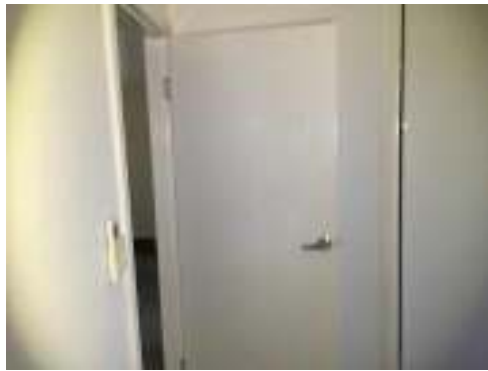
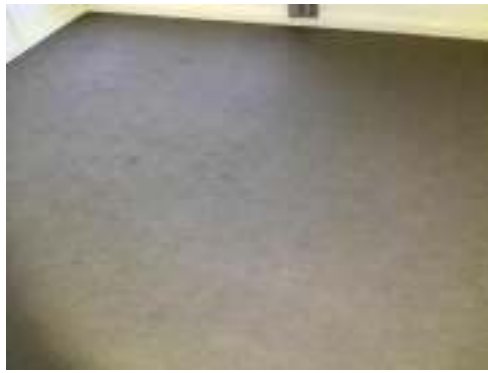
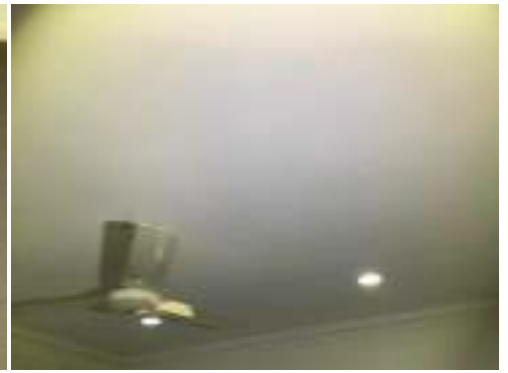
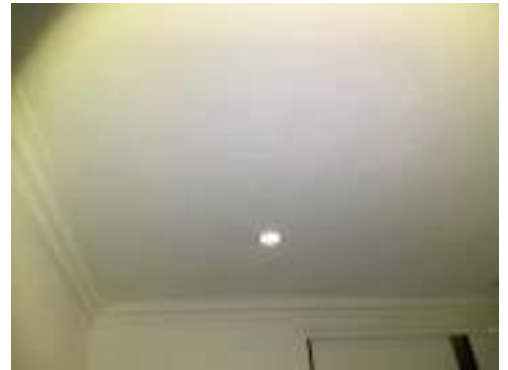
### **Bedroom 3**

From the visible and accessible areas, this bedroom appears to be in a serviceable condition for the age of the property with no notable structural defects sighted.

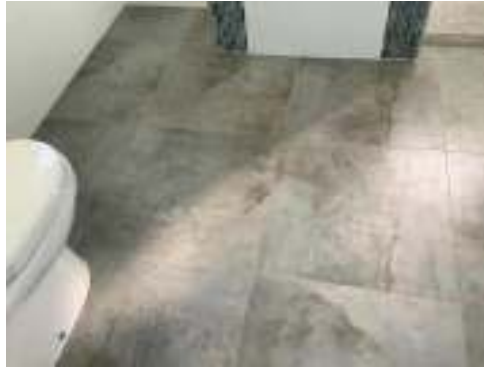
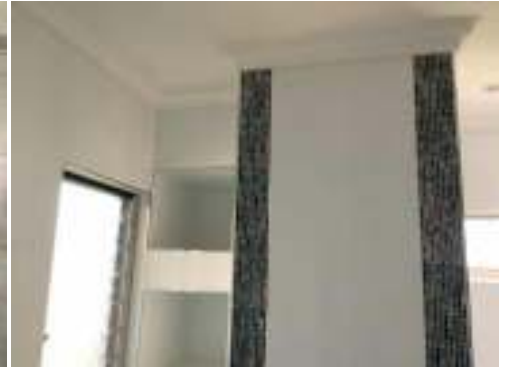
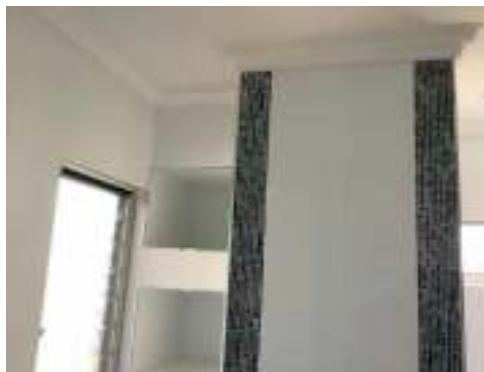
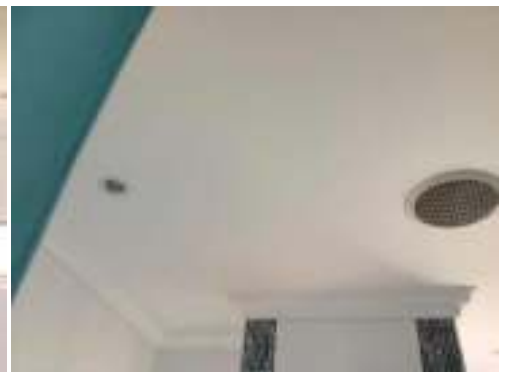
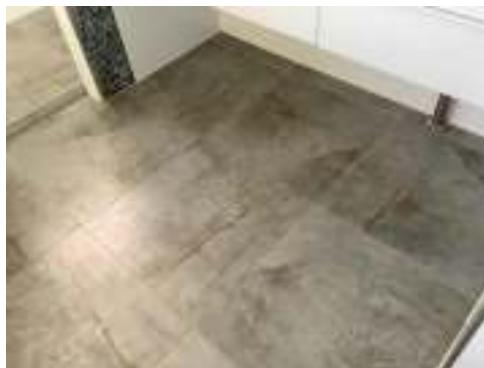
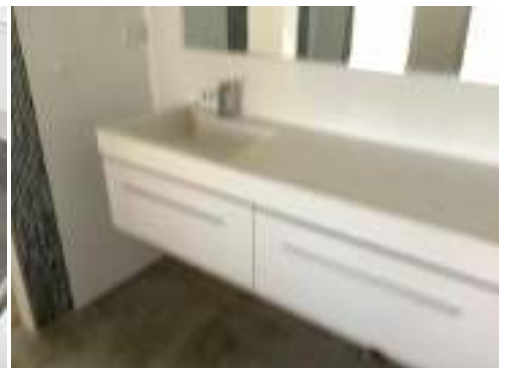
### Bathroom 1

Of the visible areas, the general condition of this bathroom is serviceable or in reasonable condition for age of dwelling.

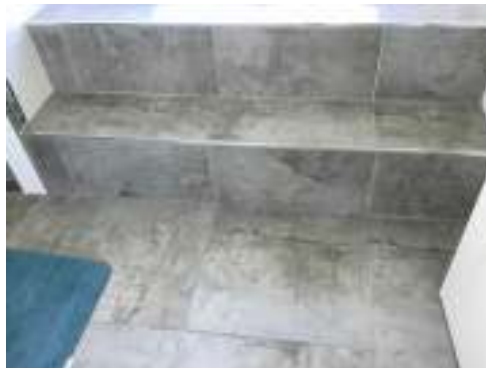
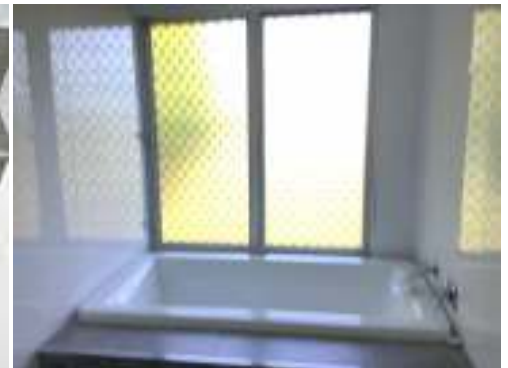
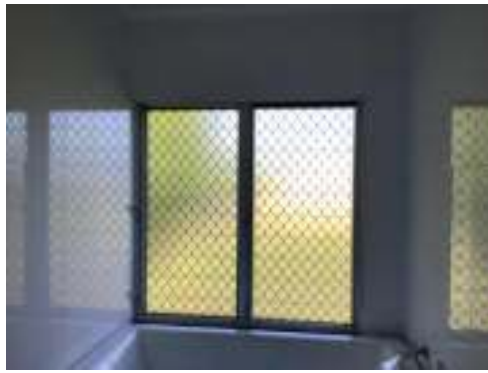
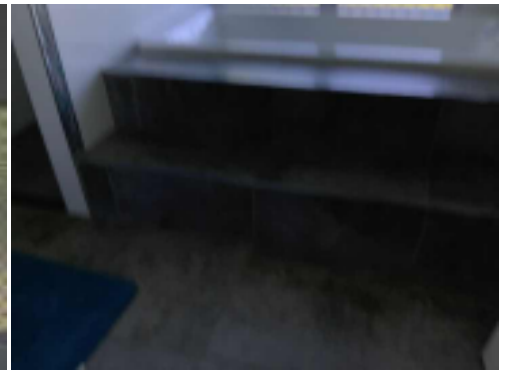
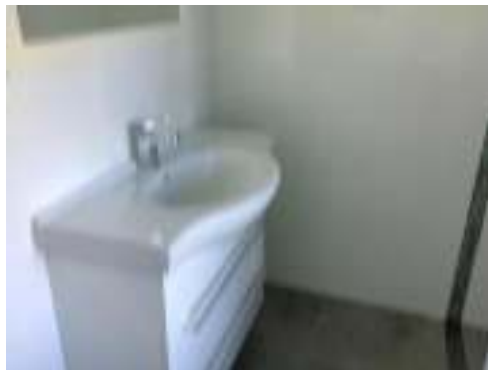
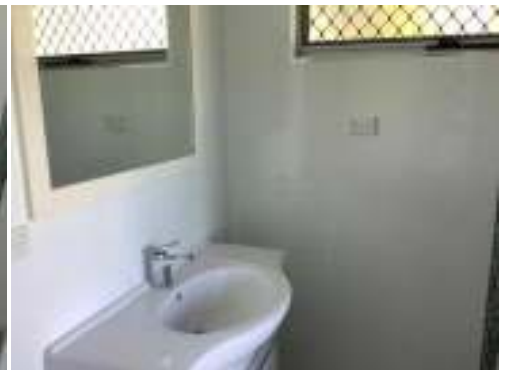
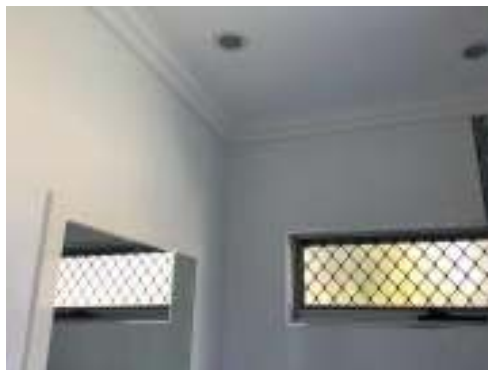
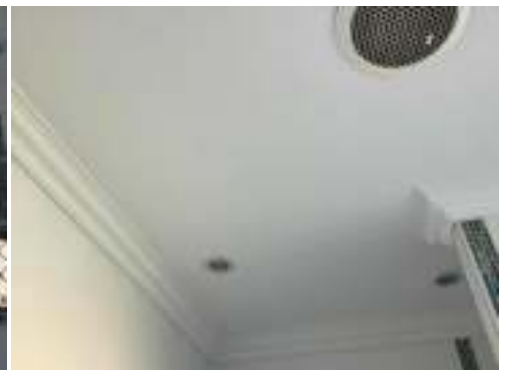
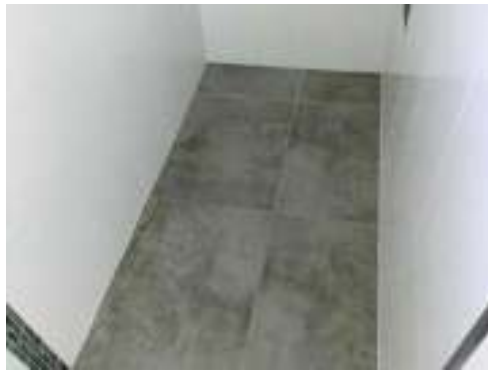
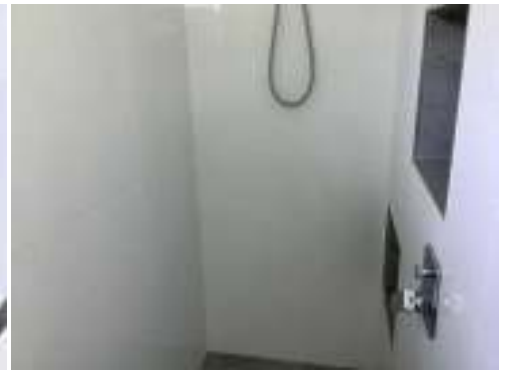
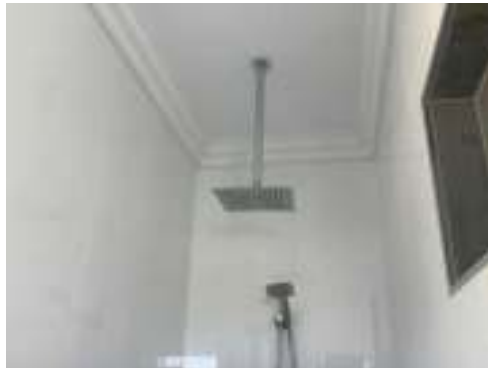
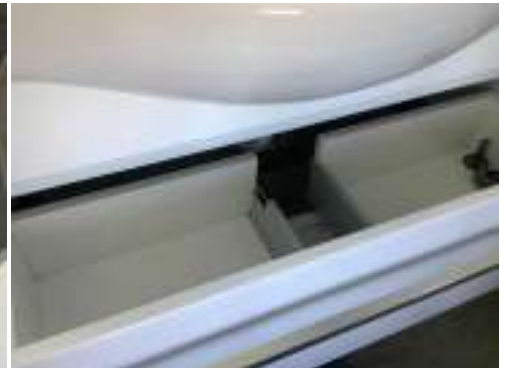
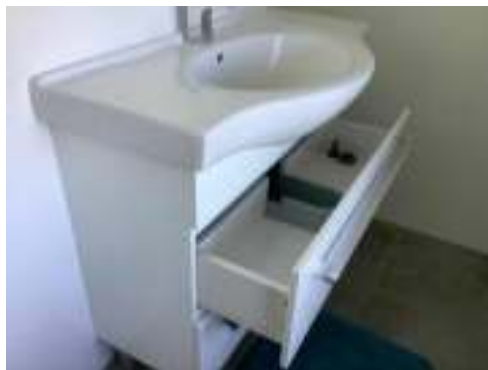
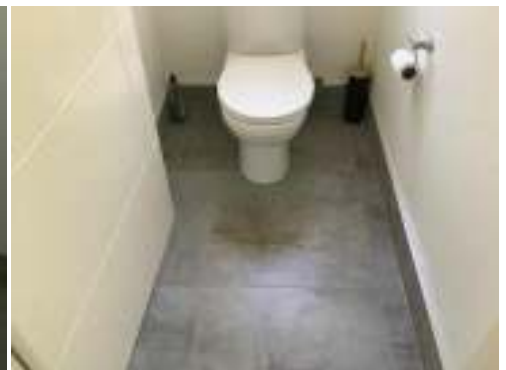
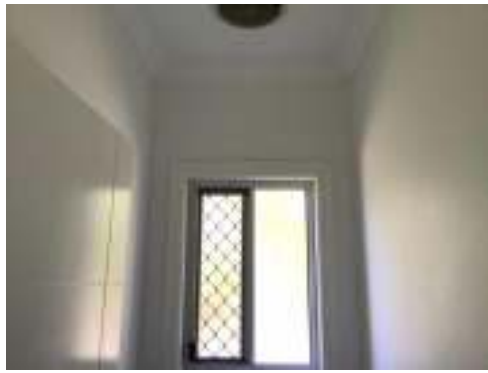
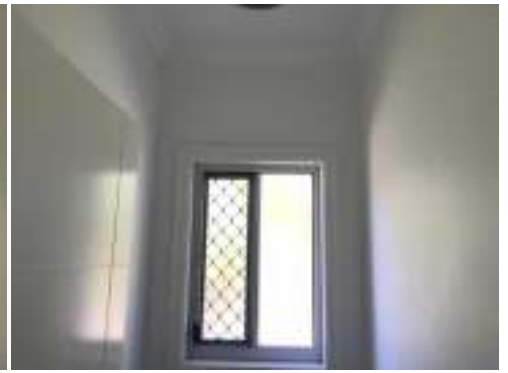
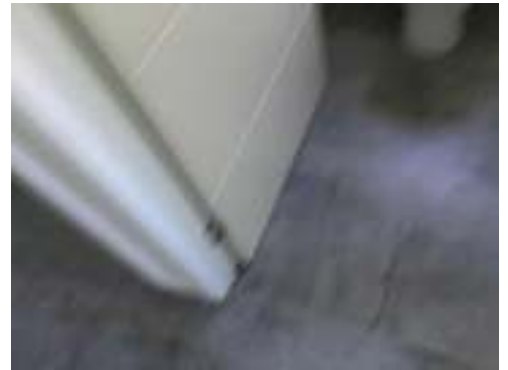
Of the visible areas, the general condition of this bathroom is serviceable or in reasonable condition for age of dwelling.

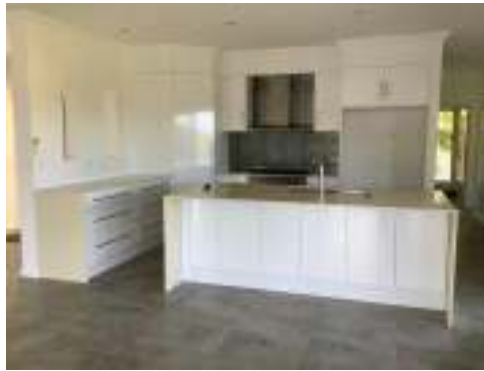
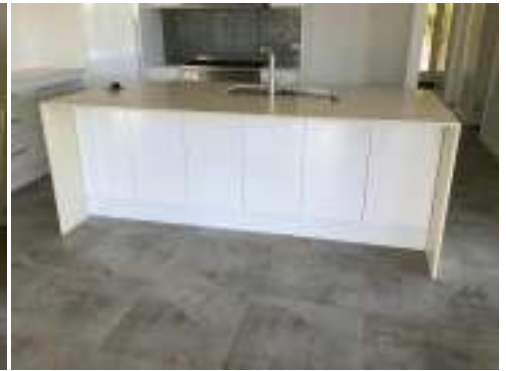
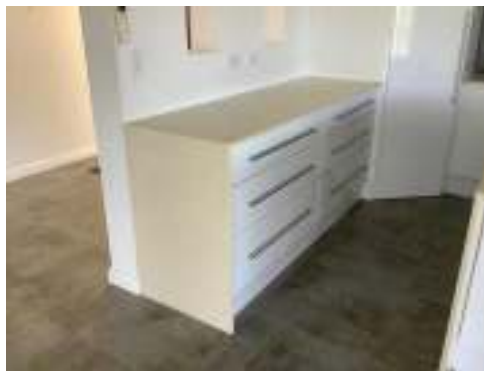
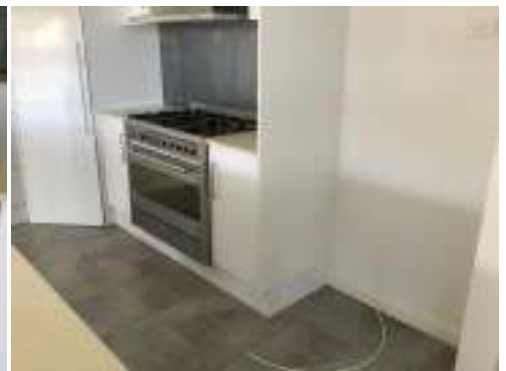
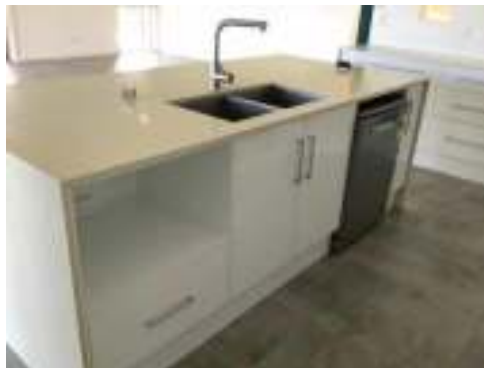
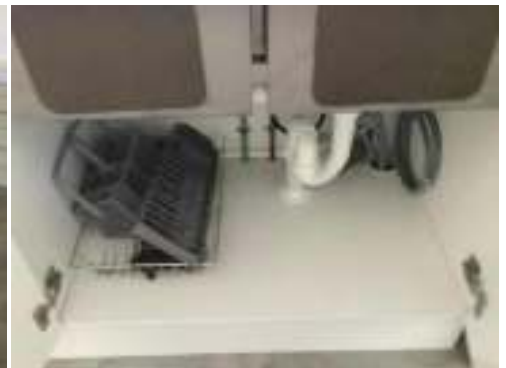
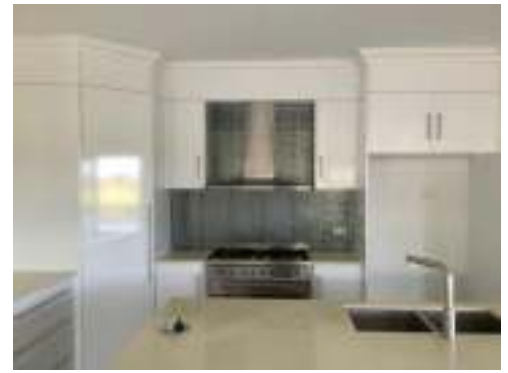
Of the visible areas, the general condition of the kitchen is serviceable or in reasonable condition for age of dwelling.

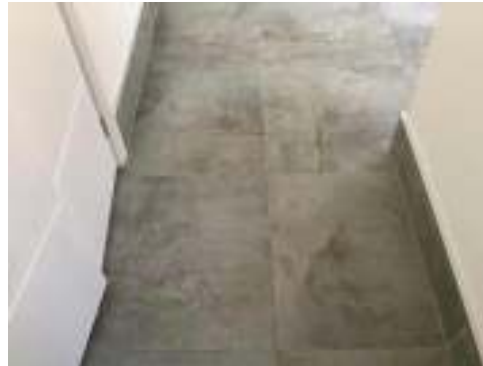
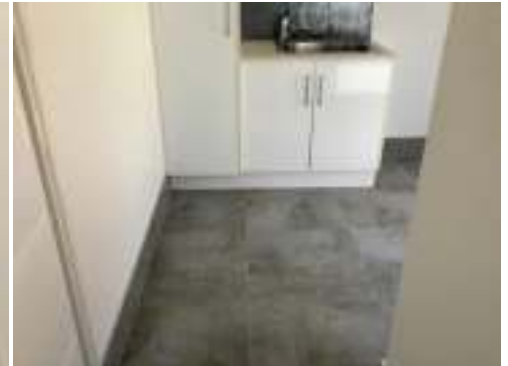
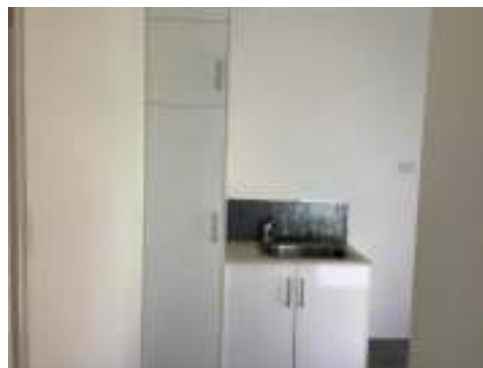
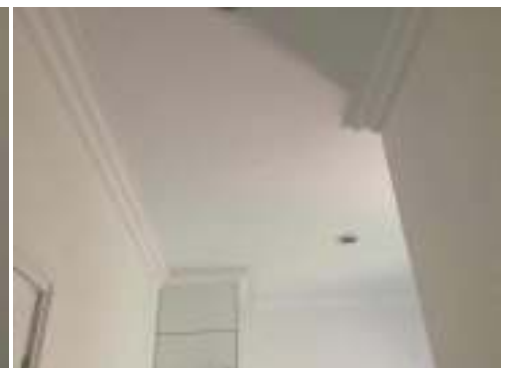
Of the visible areas, the general condition of the laundry is serviceable or in reasonable condition for age of dwelling.
