# Inspection Report Qld 2021 Complete

**Complete Inspections**

**Smith St , Smithville, QLD , 4802**

### Pest And Building Inspection

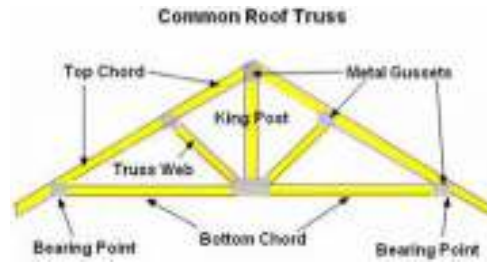
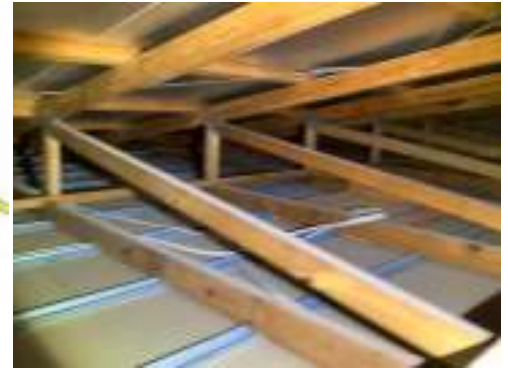
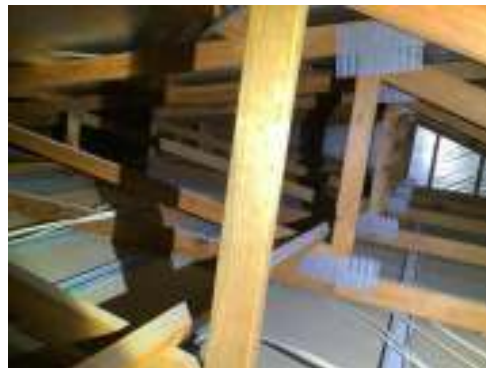
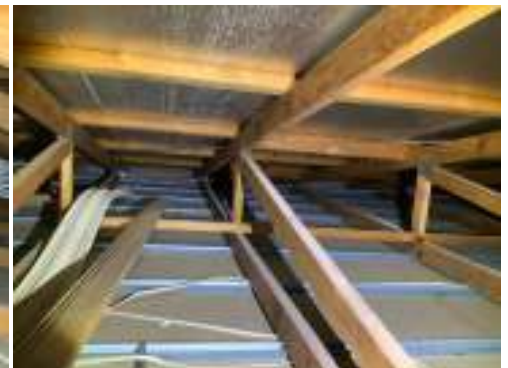
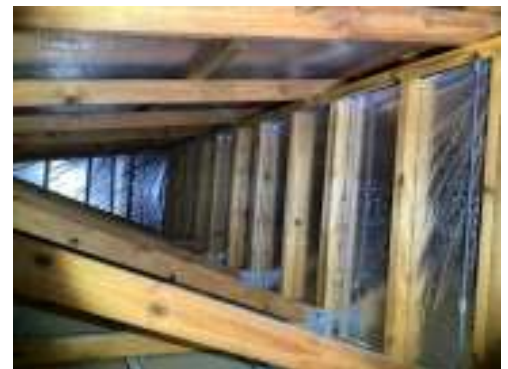
Visible sections of the roof void is in a serviceable condition for age of this dwelling.

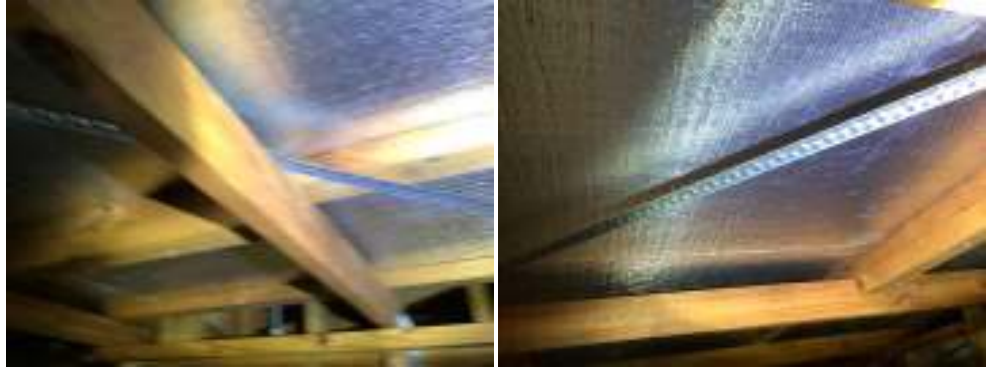
The roof space is insulated with reflective fibreglass batts under the roof cladding.

Where visible and accessible, the insulation appears to be in a serviceable condition.

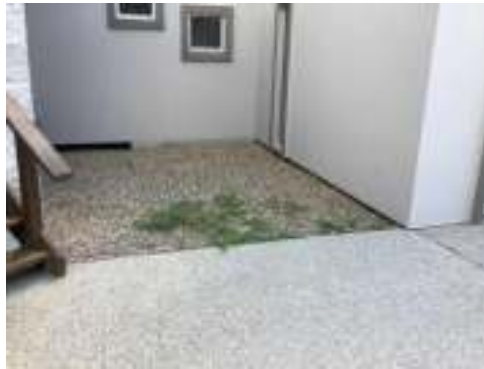
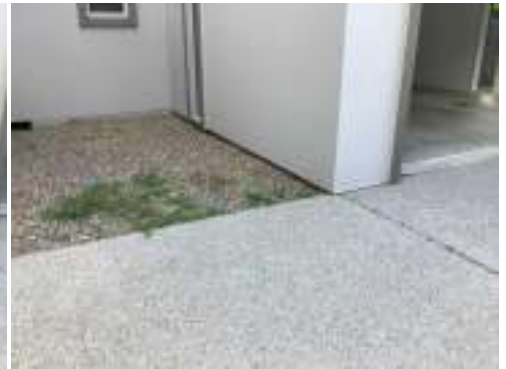
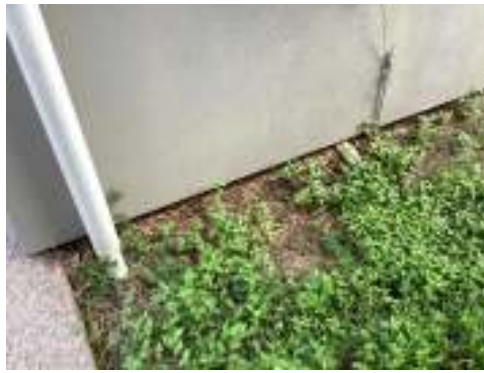
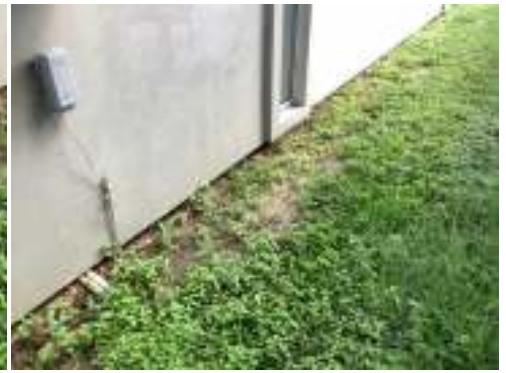
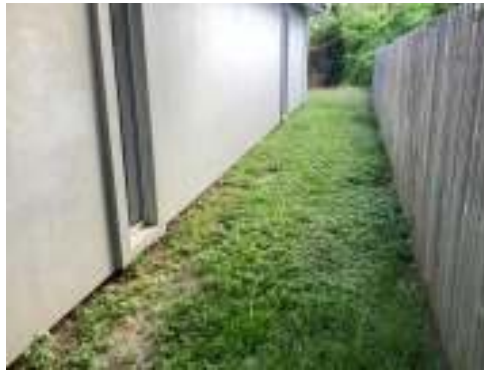
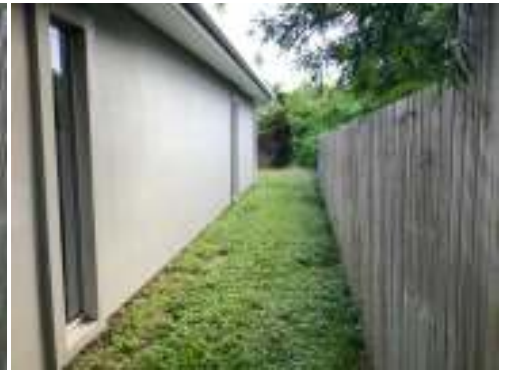
### **4.4 Slab Edge Exposure**

Yes in some areas.

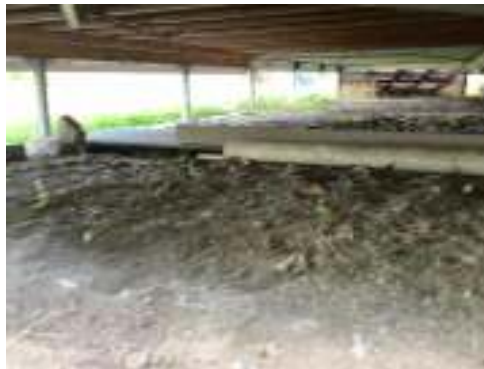
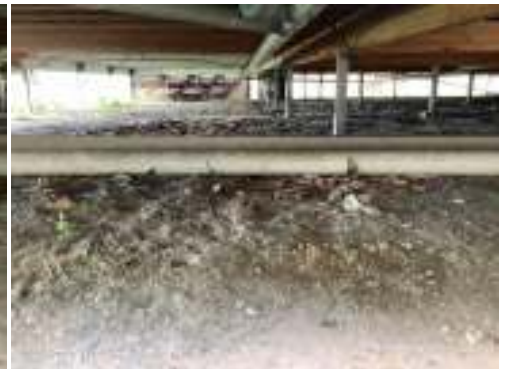
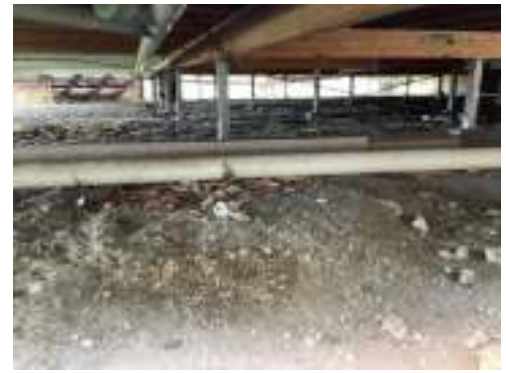
The ant capping is generally considered adequate.

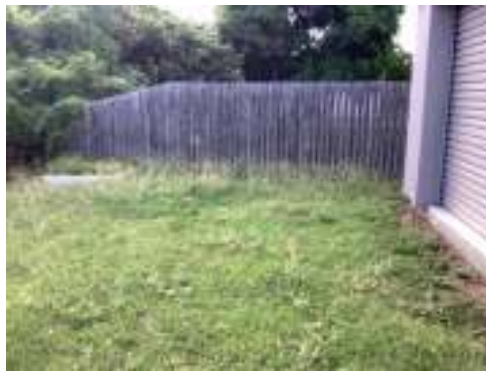
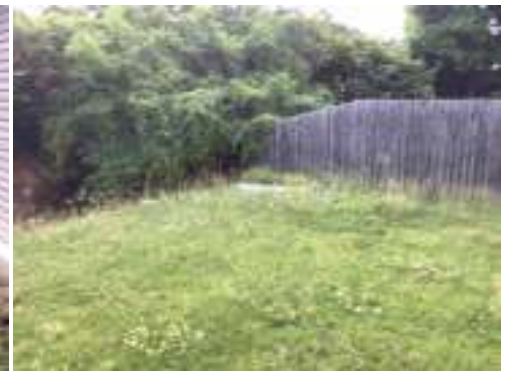
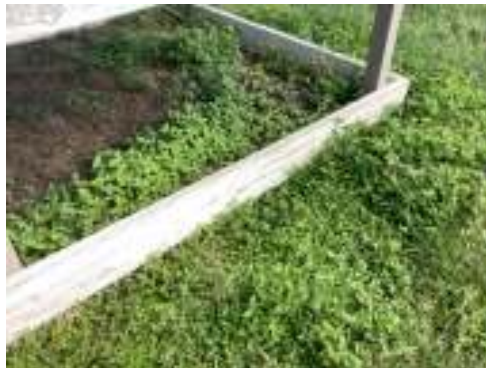
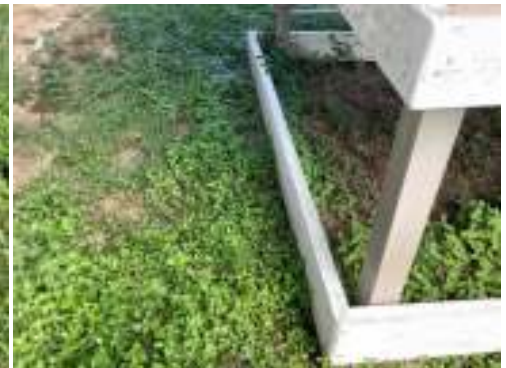
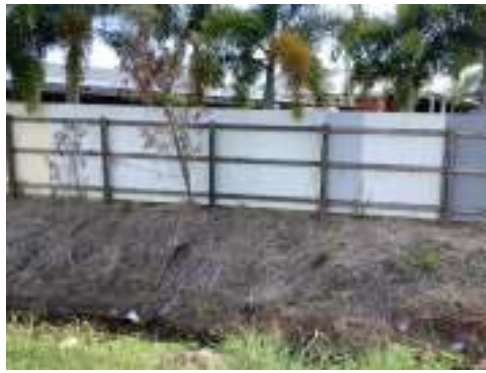
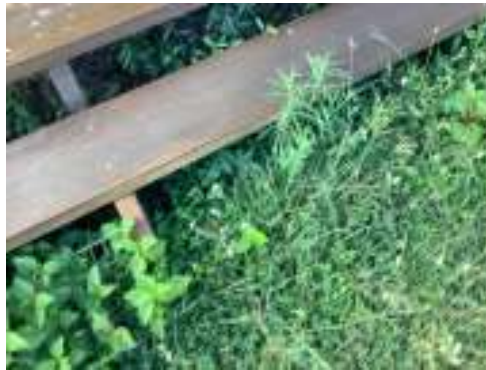
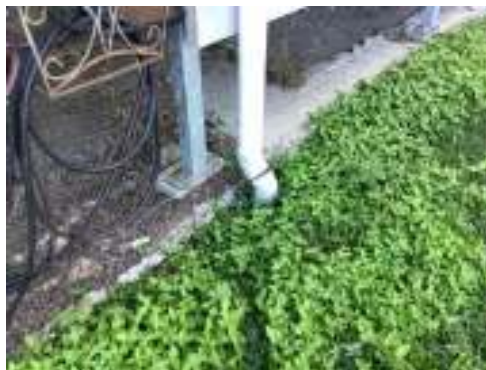
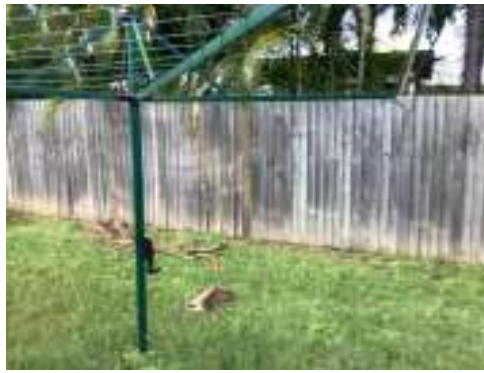
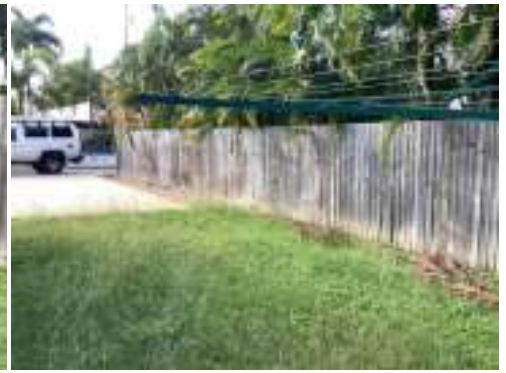
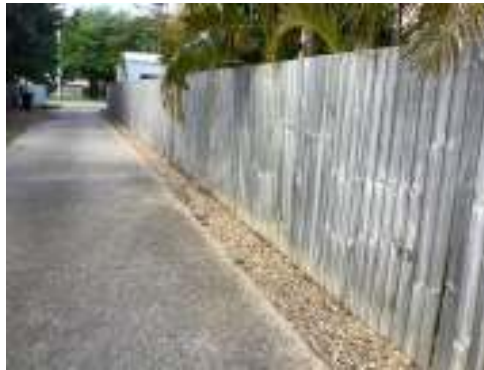
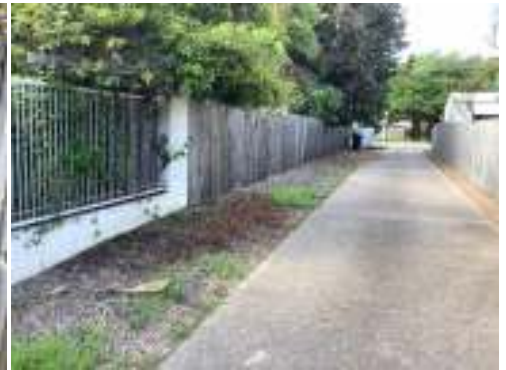
Downpipes not connected to storm water. This causes moisture and excess moisture is conducive to termite infestation.

The fence is in contact with soil in areas. This is conducive to decay and termite attack.

The slab edge is not exposed. The slab edge must be exposed at least 75mm so that a thorough inspection can be conducted for any termite infestation/entry points.

Timber in contact with ground. This provides conducive and concealed conditions and concealed entry for termite infestation.

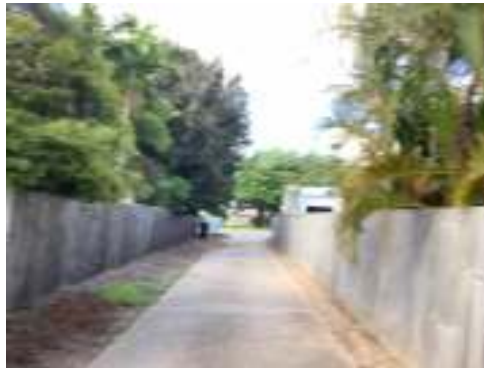
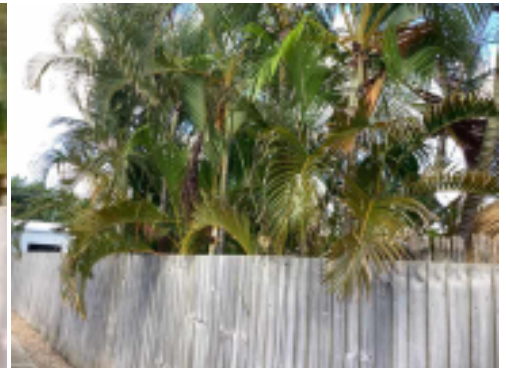
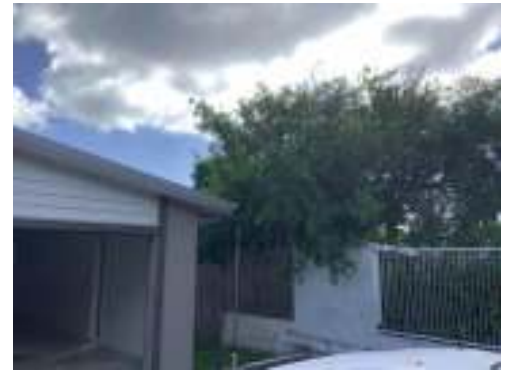
Trees are in close proximity to the dwelling and within the termite foraging area. These are a favorable influence for termite infestation. Regular inspections recommended.
